**FINAL**  
**Drainage Feasibility Study**  
**Volume II (Geotechnical Component Vol. 1)**

Community of Rimforest  
County of San Bernardino, CA

**GEOLOGICAL INVESTIGATION AND FEASIBILITY  
EVALUATION OF PROPOSED MITIGATION  
PROCEDURES TO REDUCE THE POTENTIAL  
FOR ACTIVE LANDSLIDING IMMEDIATELY SOUTH  
OF THE COMMUNITY OF RIMFOREST  
SAN BERNARDINO COUNTY, CALIFORNIA**

PROJECT NO.: 168-H09  
REPORT NO.: 1

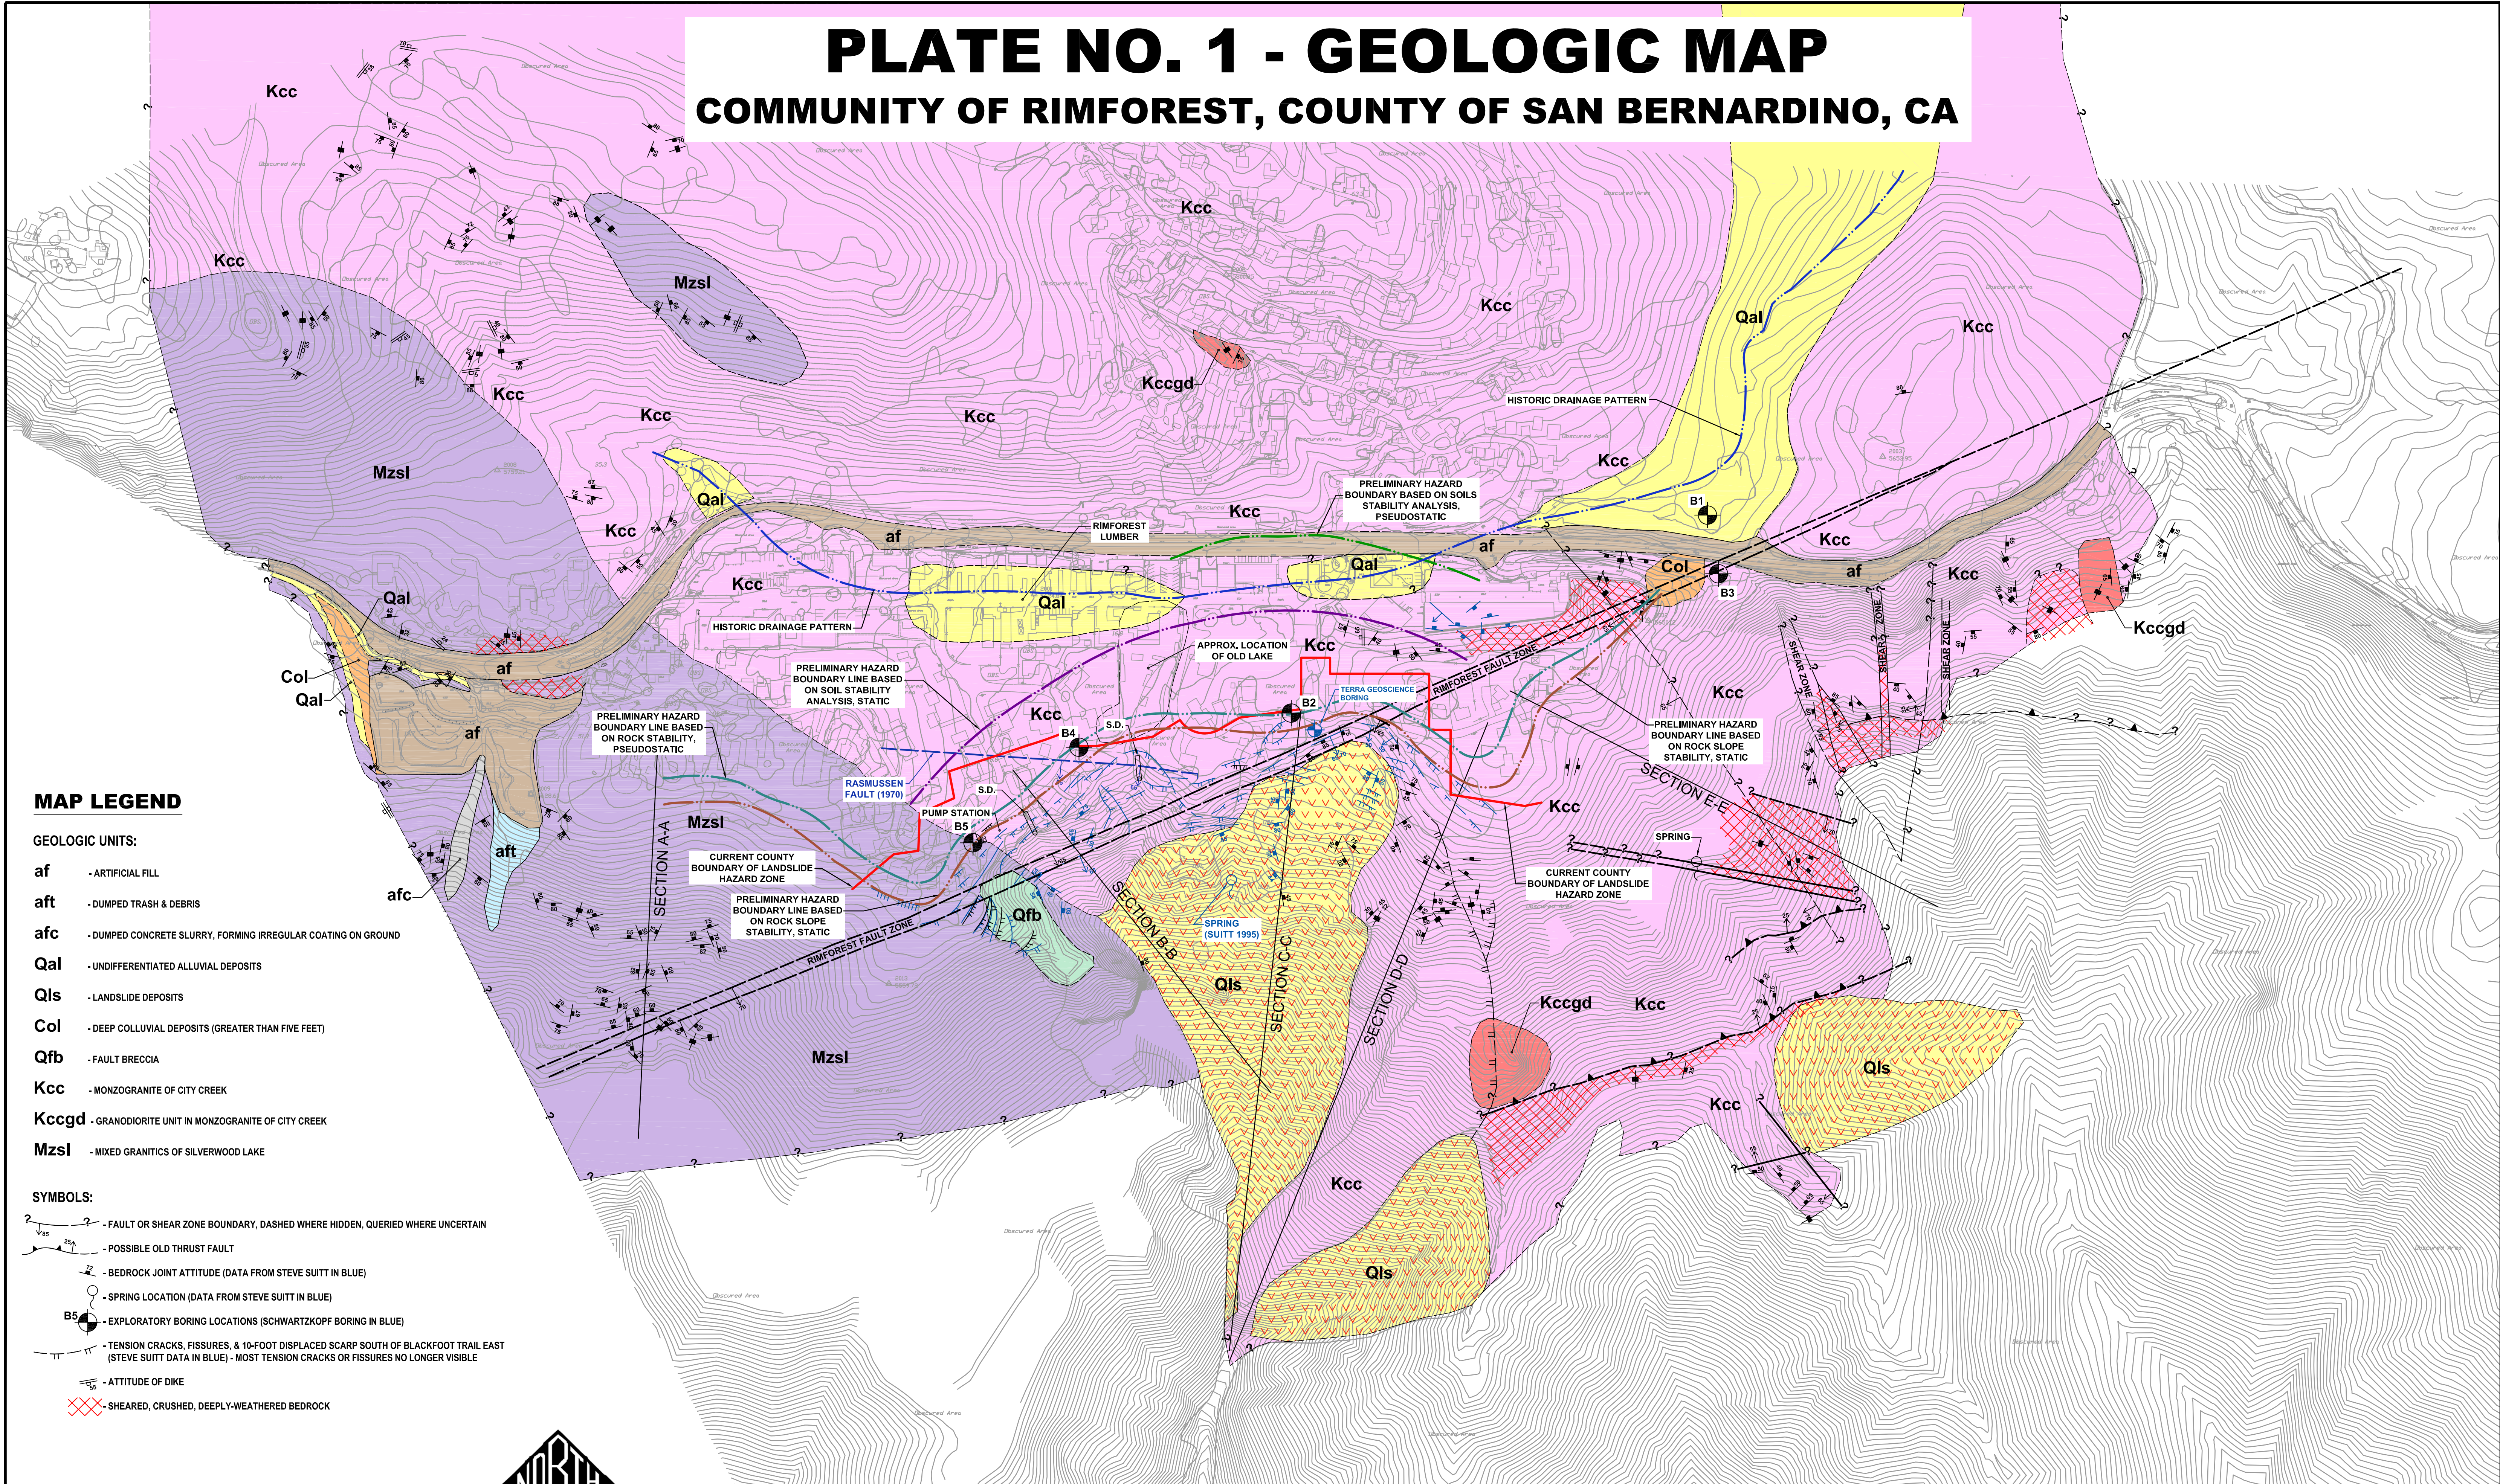
# PLATE NO. 1 - GEOLOGIC MAP

Slope stability analyses, carried out using rock slope stability and soil slope stability parameters and methods, determined that significant areas of potential slope failure extend beyond the present top of slope and incorporate some currently occupied residences. Preliminary hazard boundary lines have been created as a result of this investigation. The preliminary hazard boundary lines represent estimated limits of increased landslide risk and are depicted on Plate No. 1.

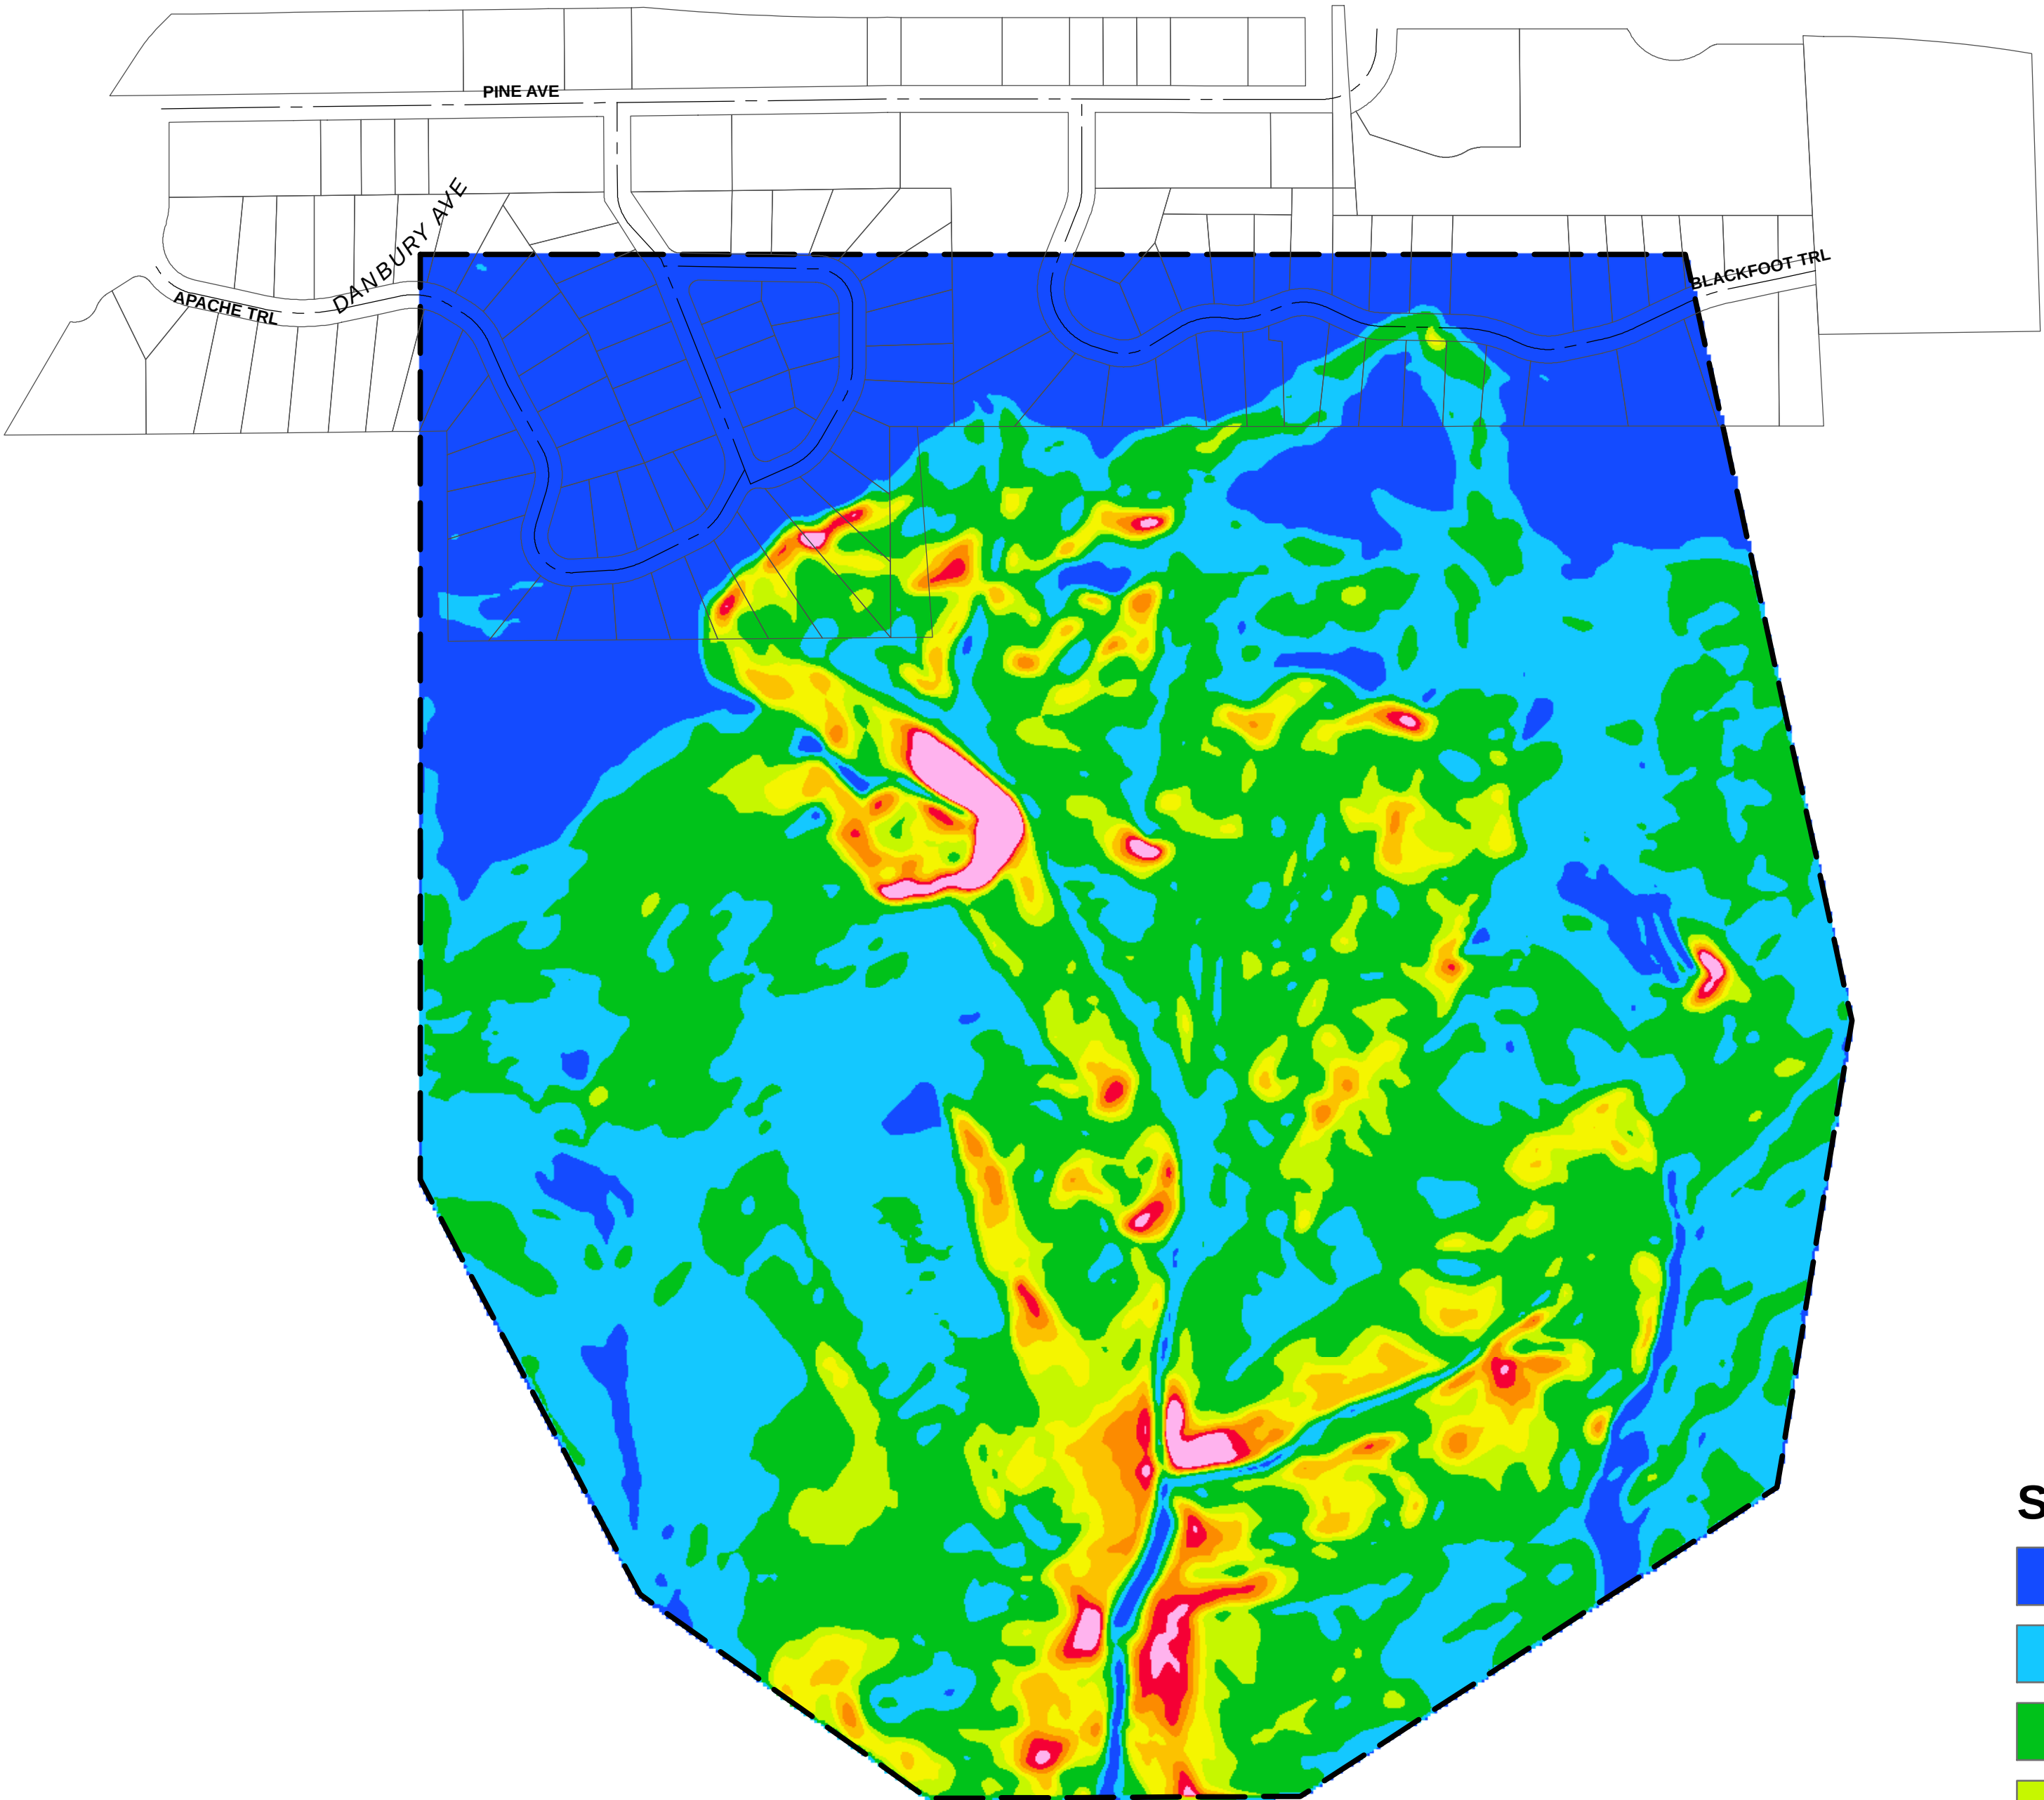
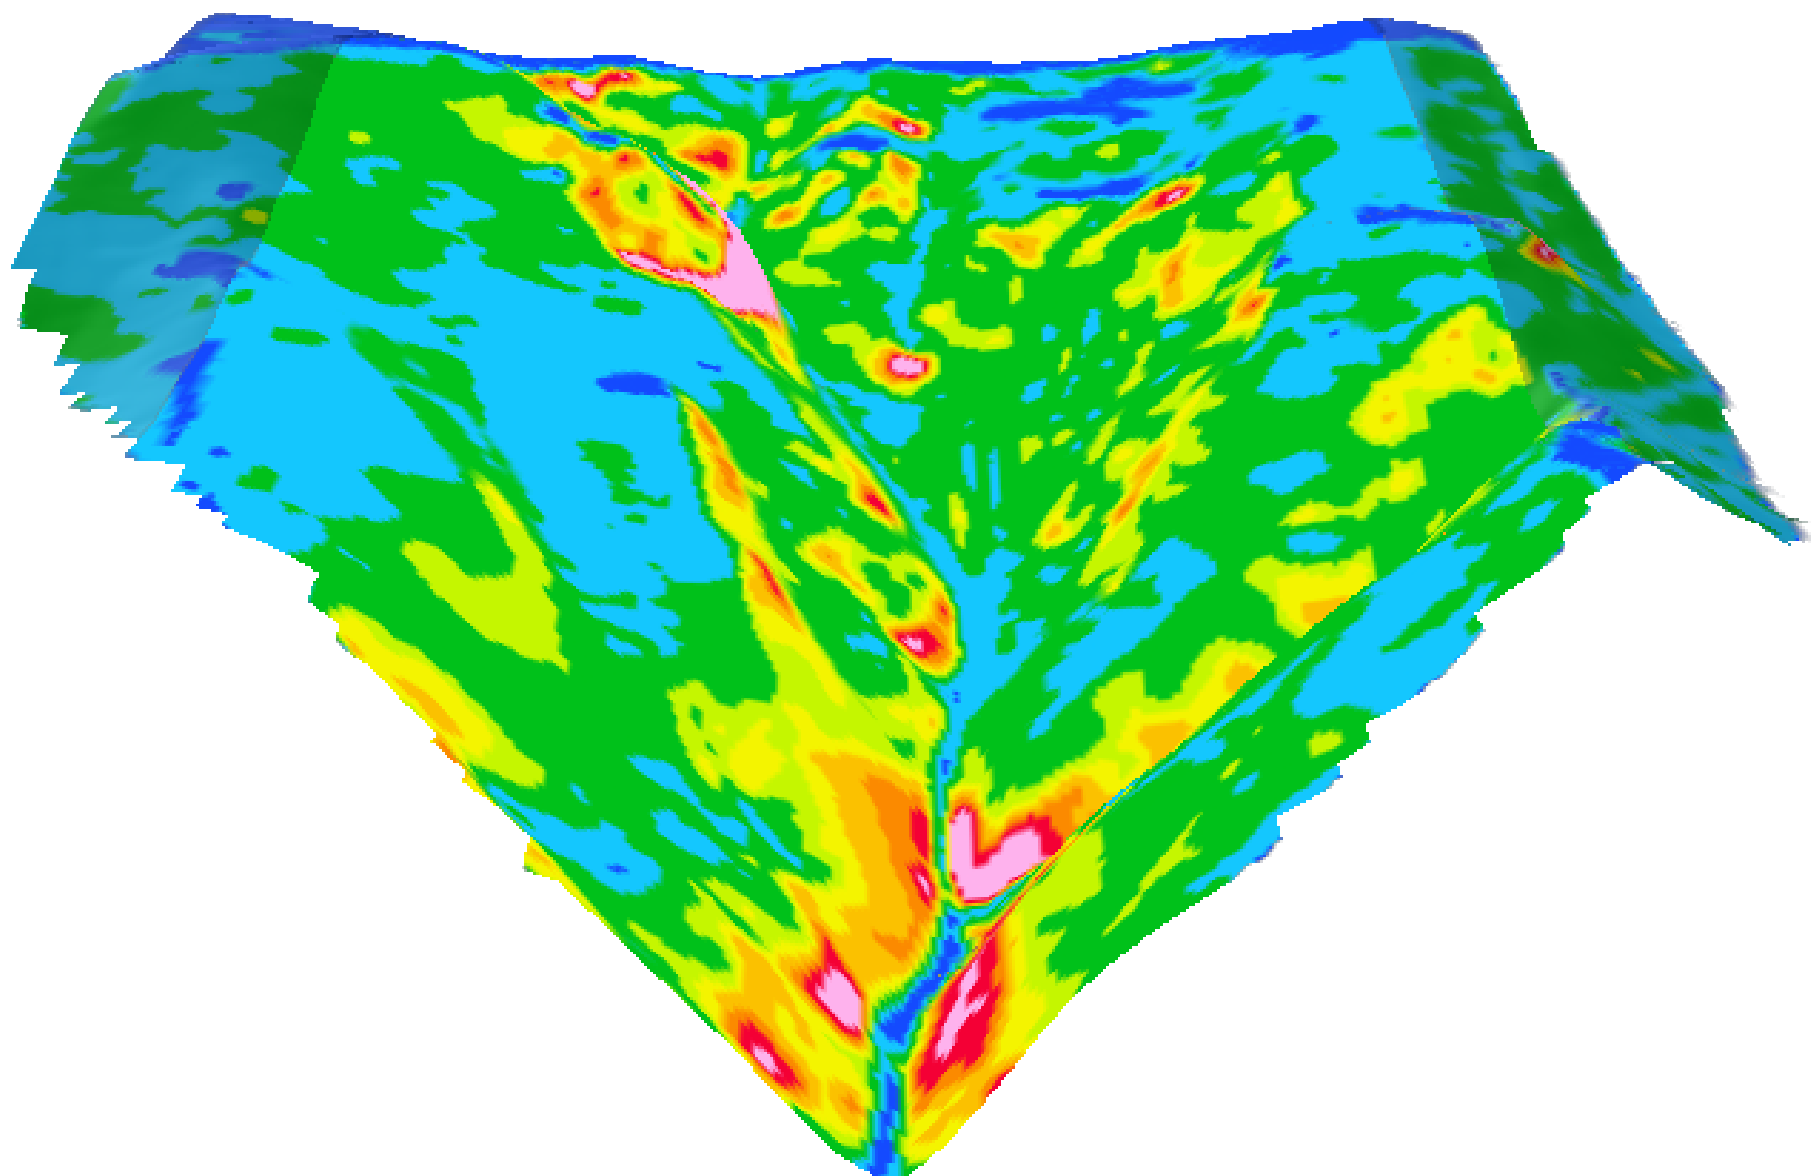
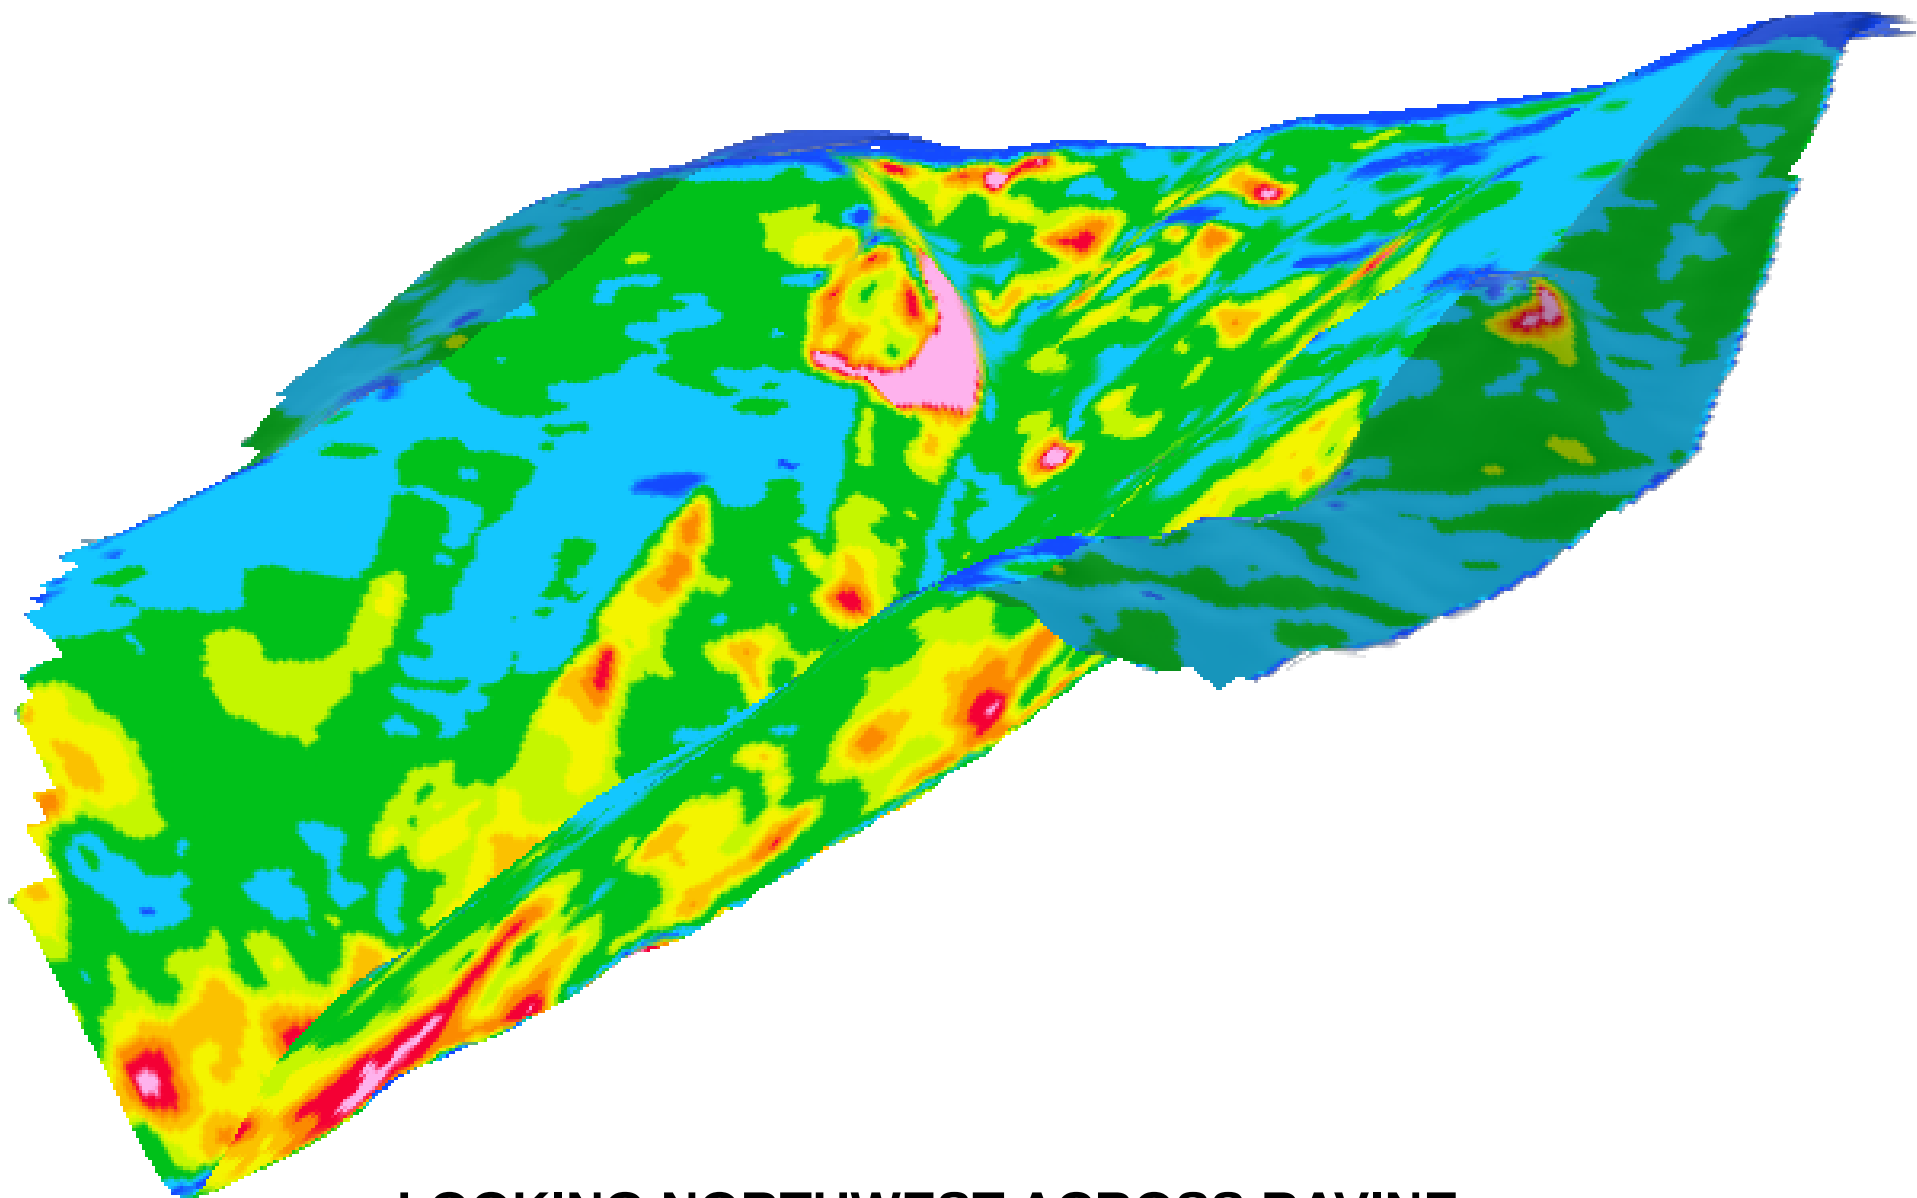
SLOPE DENSITY ANALYSIS  
VICINITY OF THE COMMUNITY OF RIMFOREST  
IN THE COUNTY OF SAN BERNARDINO, CA

Landslide activity within the Rimforest area over the last 30+ years has left many slopes below the town over-steepened and unstable to marginally stable, at best. Slope gradients in the Rimforest landslide area are shown on Plate No. 2. Localized over-steepened conditions have made much of the area more susceptible to additional failure. The over-steepened slopes act to undermine otherwise more stable areas above the slopes and, as such, produce larger areas beyond the slopes that are potentially unstable. Rock integrity, slope geometry and geomorphology, tectonics, seismicity, bedrock orientation, fractures, faulting, shear zones, groundwater and surface water runoff are all components that contribute to the future stability of slopes below Rimforest.

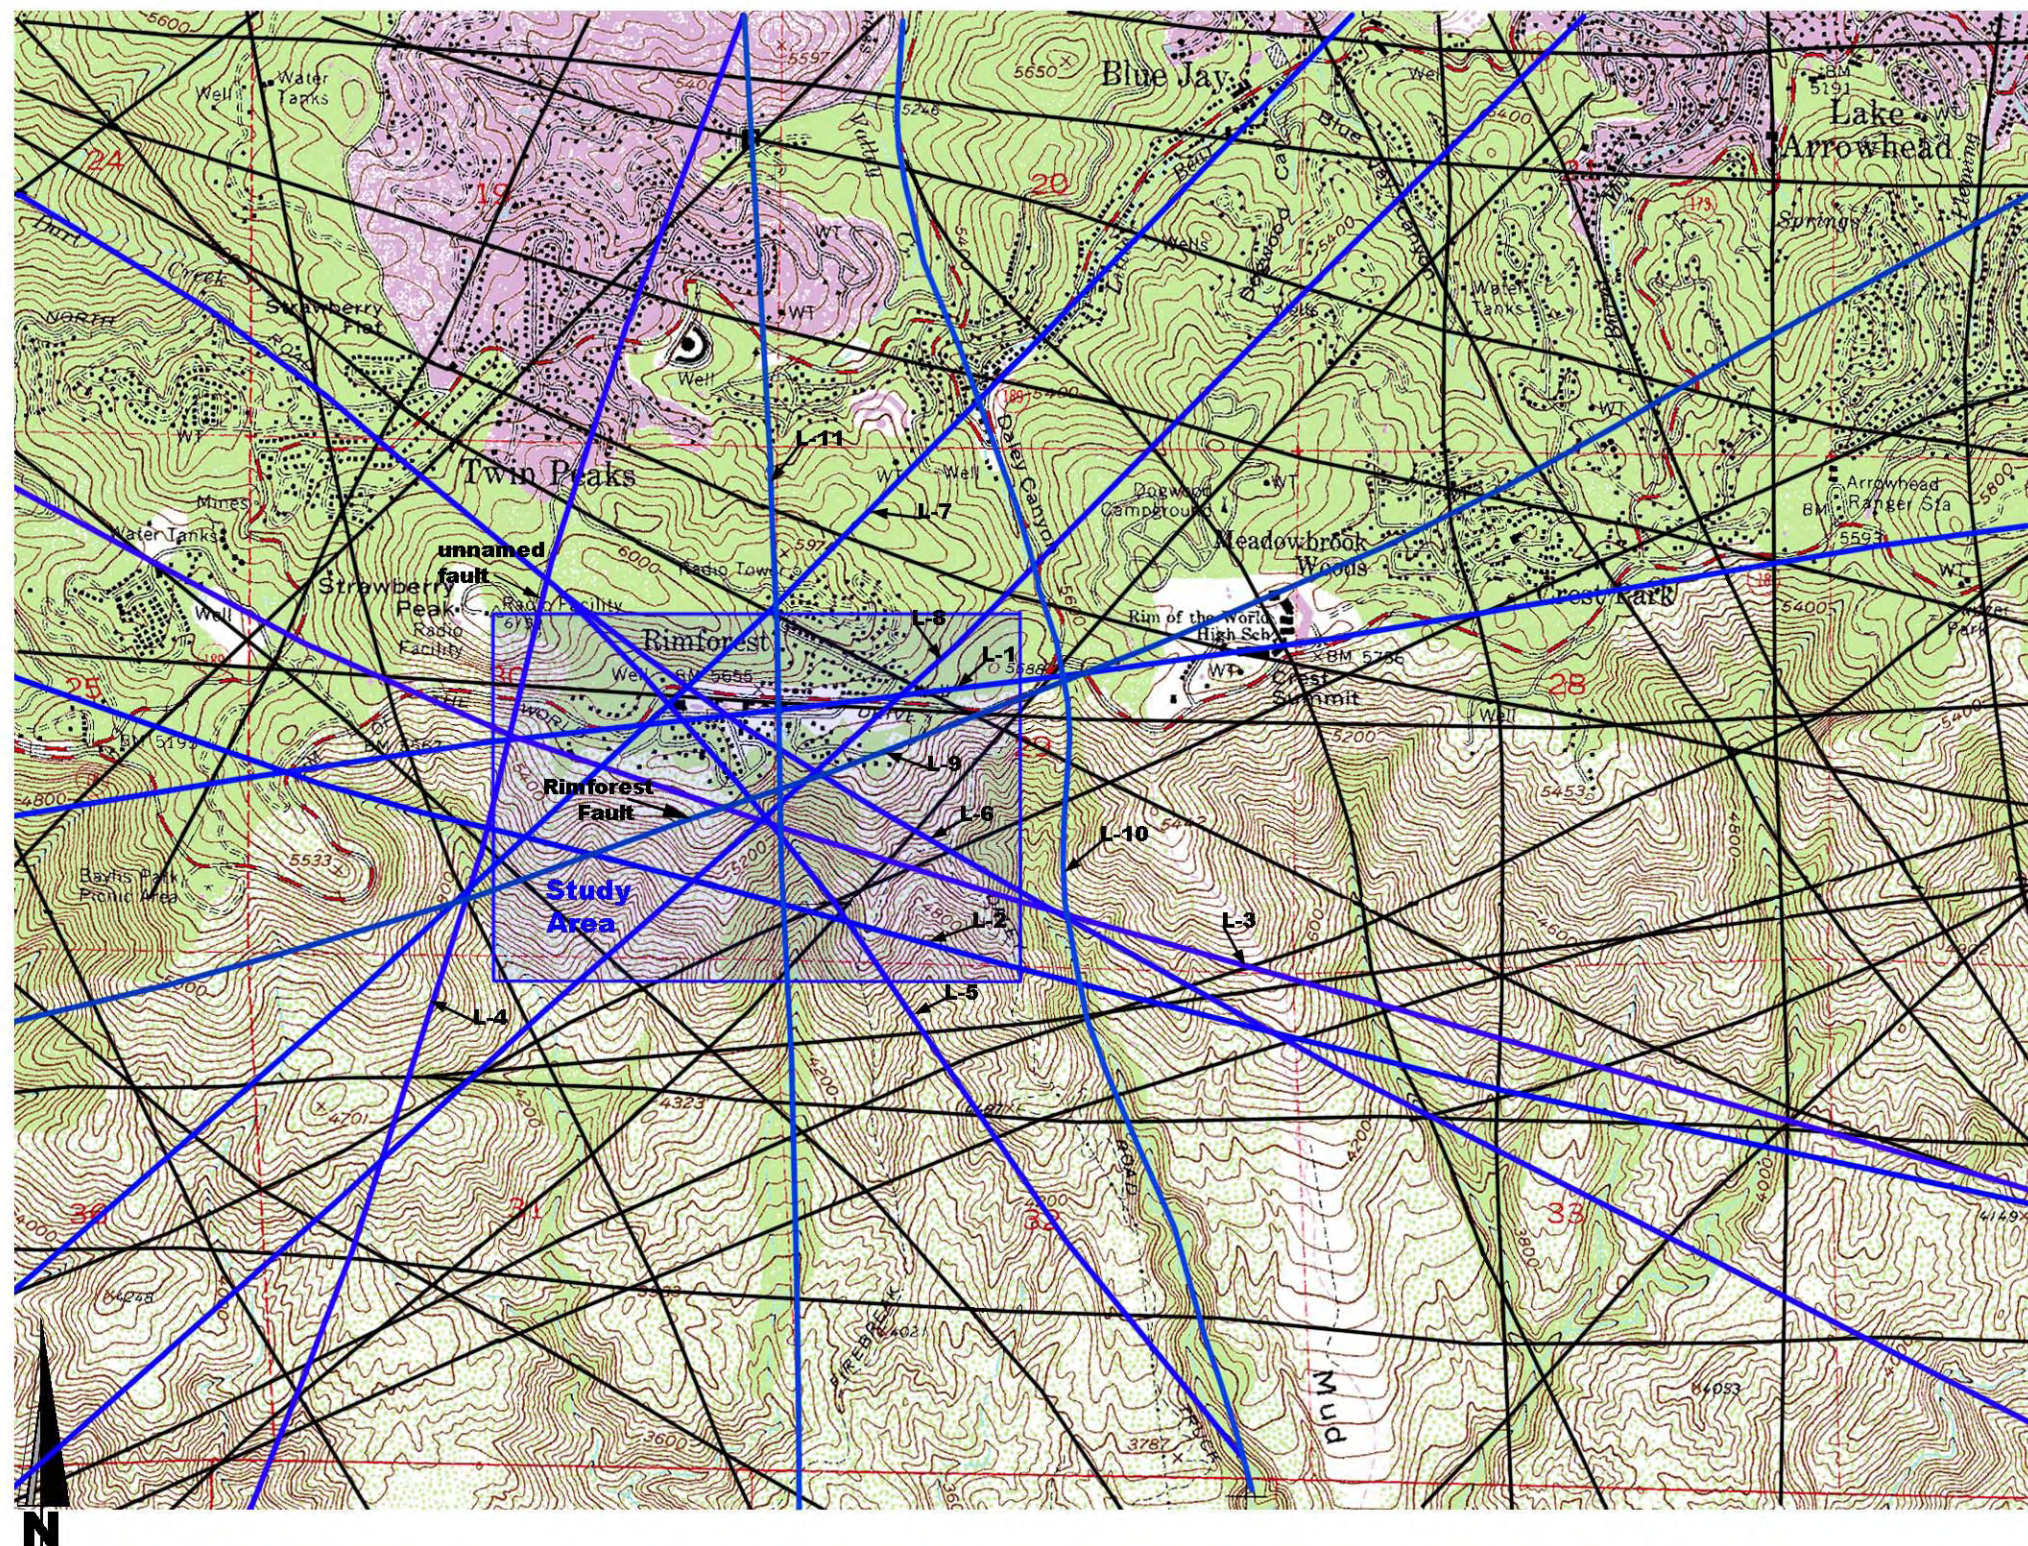
Looking at Plate No. 8, it is clear that not all visible lineaments are likely to be associated with faults or shear zones. Many likely result from joint trends, near linear contacts between rock types, large dikes, or other features. However, as noted on Plate No. 8, six lineaments that either crossed Rimforest or were located nearby and were deemed important for this investigation were field checked. All six locations, correlating with aerial photo lineaments, were found to contain shear zones (in which displacement could not be readily identified) or faults. As such, it seems likely that a relatively high percentage of photo lineaments identified during this investigation correlate to structurally important features and most likely represent zones of weakness that may relate to future stability of affected areas.

At least eleven photo lineaments cross into or adjacent to the community of Rimforest. The locations and identifying numbers can be found on Plate No. 8. Lineament No. L1 passes through the topographic saddle and a hairpin turn on Highway 18, both of which are north of Red Rock Wall Point, then continues east-northeast through a topographic bench, which is located southeast of Strawberry Peak and is occupied by Rimforest. Lineament L1 continues east-northeastward through the campus of Rim-of-the-World High School, approximately one-half mile east-northeast of Rimforest. The western location of this lineament was verified
