Watershed Emergency Response Team (WERT) 2024 Bridge Fire

CA-ANF-243334 October 24, 2024

REPORT TITLE: Watershed Emergency Response Team (WERT) Evaluation – 2024 Bridge Fire

Bridge Fire – WERT REPORT EXECUTIVE SUMMARY

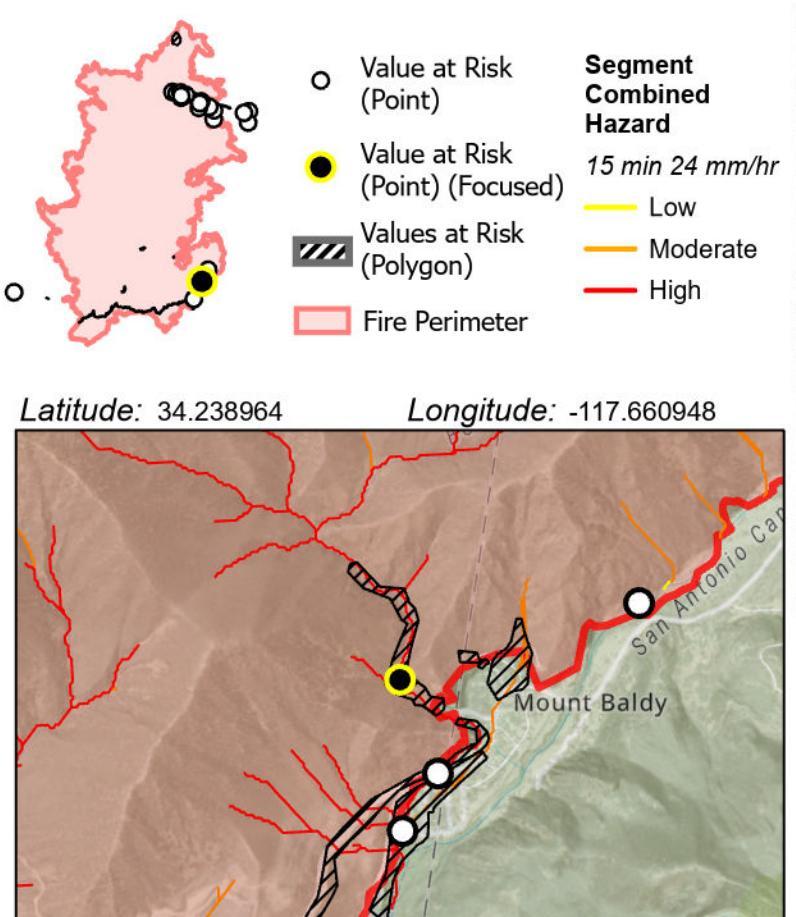
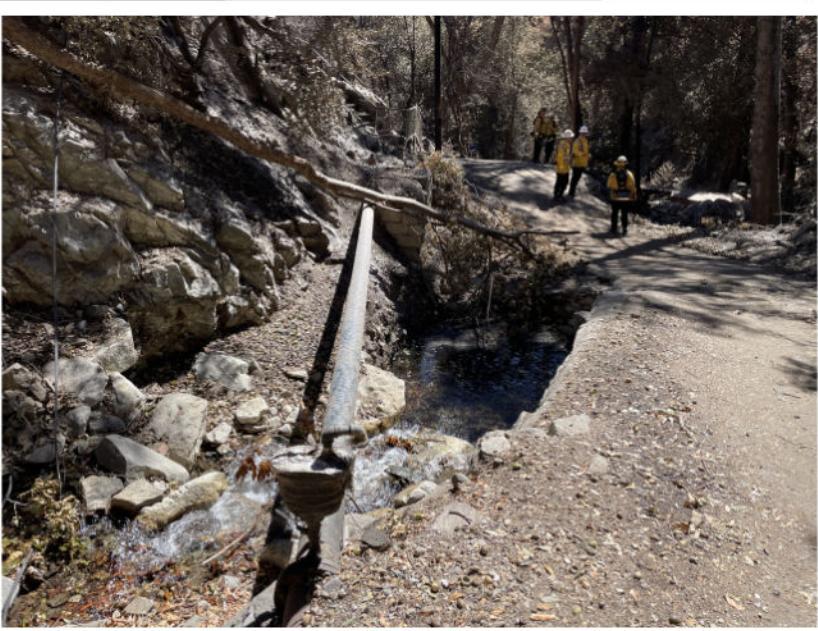
Incident: Bridge Fire Community: Mt Baldy Site Number: MB 07 Feature: Crossing structure. Feature Category: drainage structure Field Observation or Debris blocking culvert forcing overtopping flows. Potential Hazard: Very likely occurrence with moderate consequence = Very high risk Potential Hazard to Life: **IOW** Potential Hazard to Property: moderate Preliminary Emergency Protective Measures (2) Clear and maintain culvert (1) Early Warning (3) Deflection structure (4) Signage Text: NA

Description: Evidence of aggraded sediment upstream of crossing. Diverted flows will likely get diverted down road. 6x6 box with trash rack.

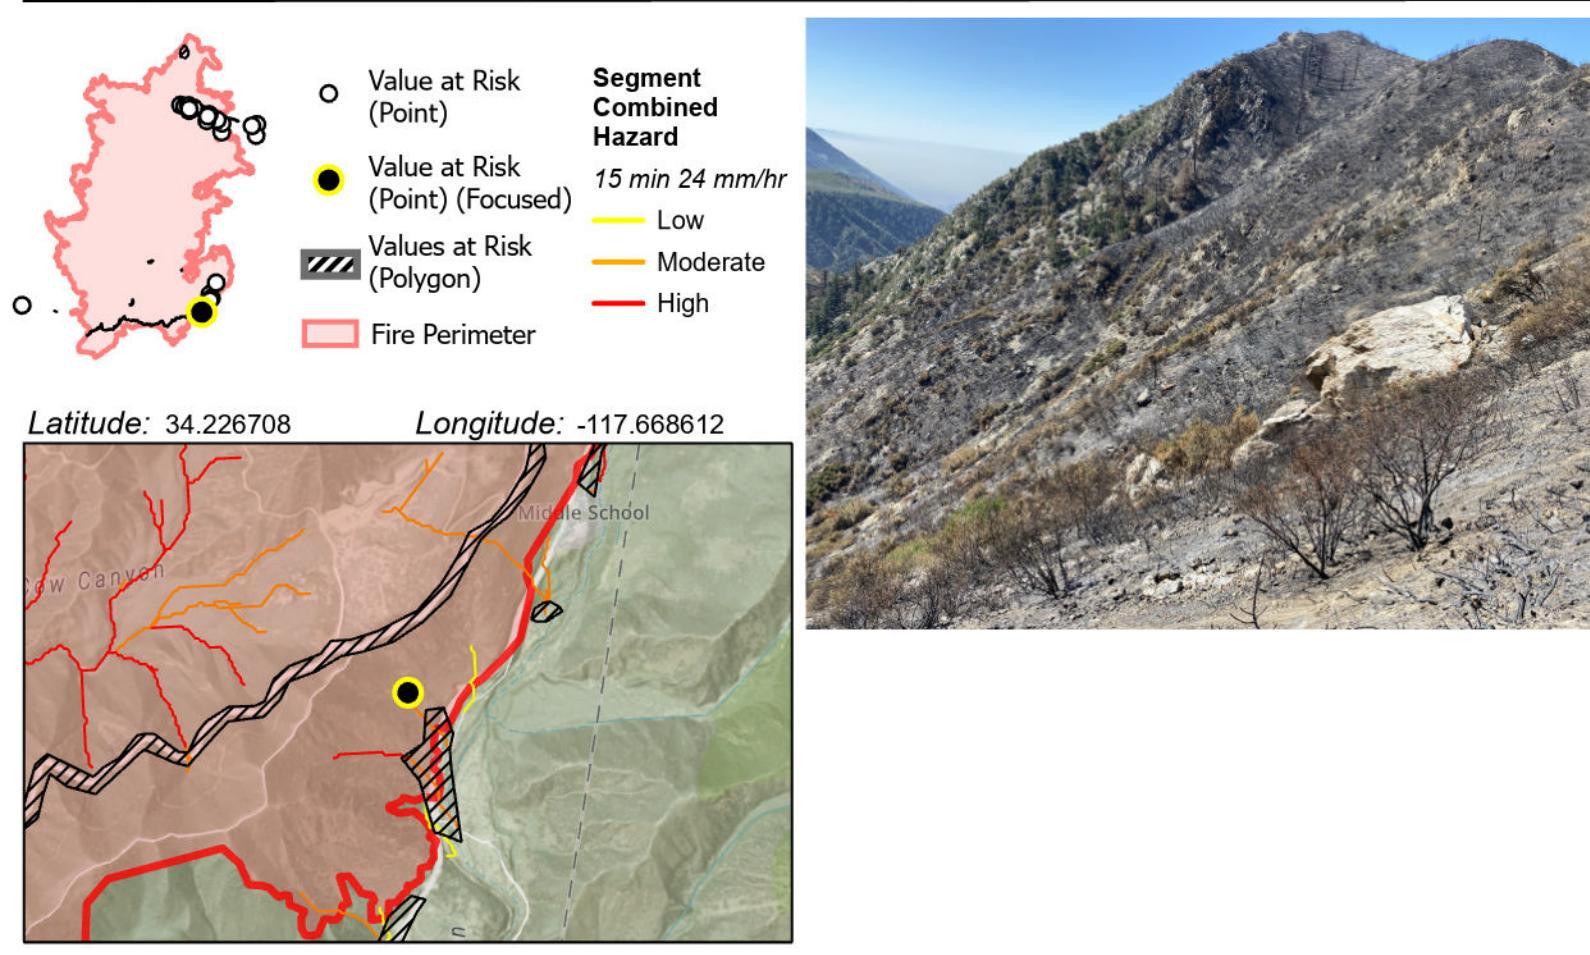
Description: Small structure has a red roof and connecting utility or fence observed from overlying road. Structure located at bottom of potential debris flow/flood source.

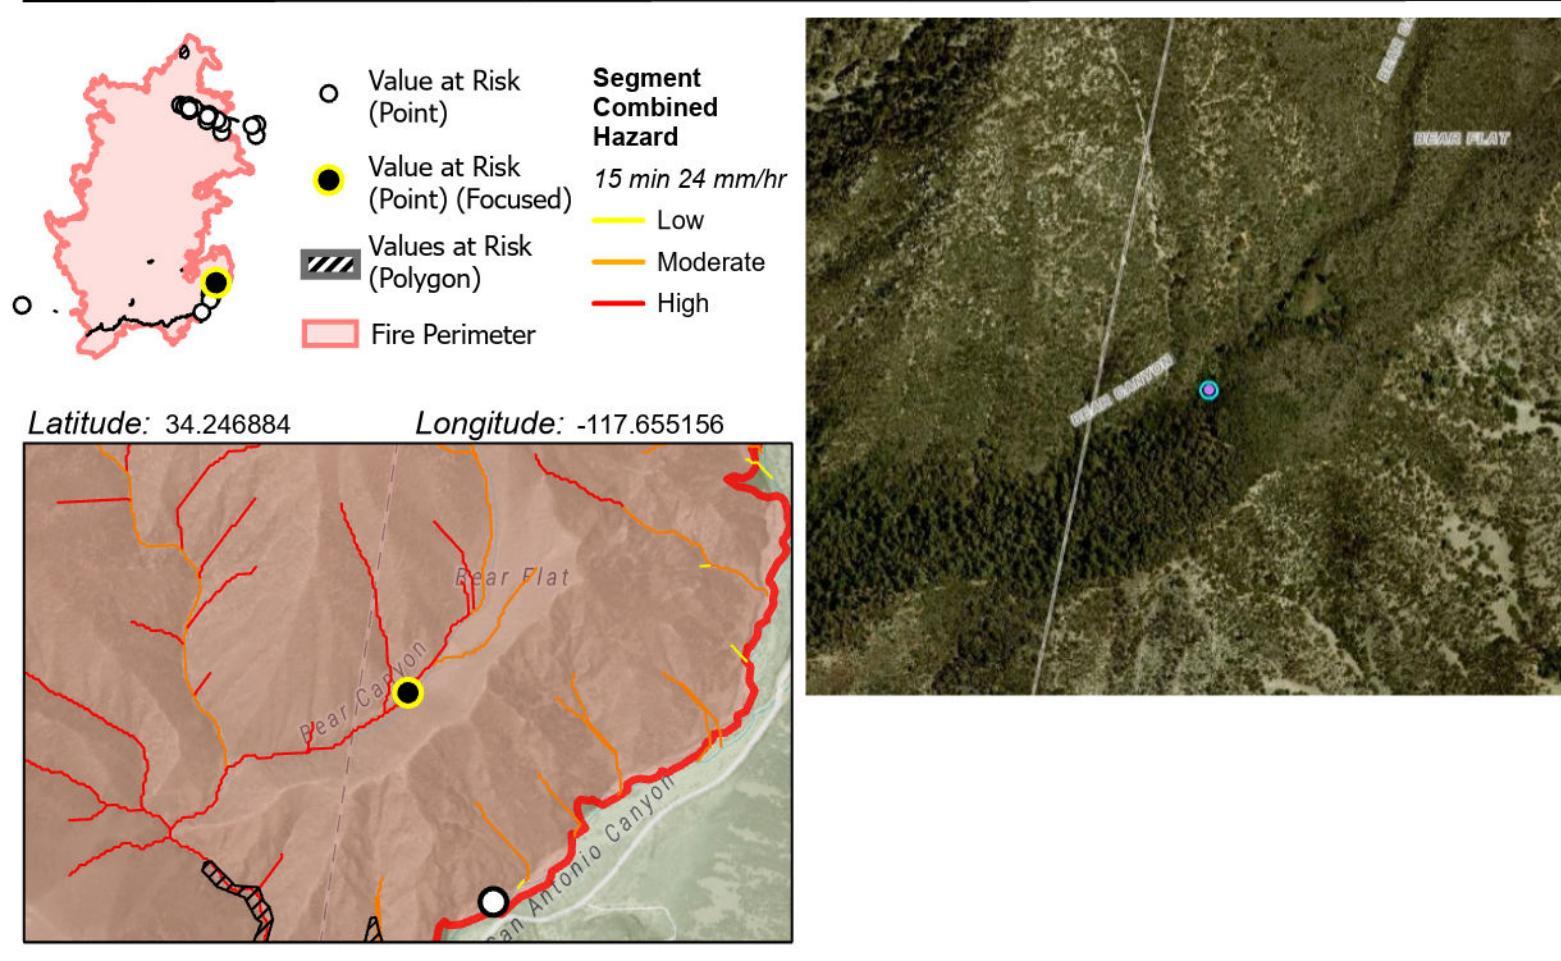
Description: Evaluated remotely. Location of infrastructure is within flow path of a potential debris flow with a high probability of occurrence.

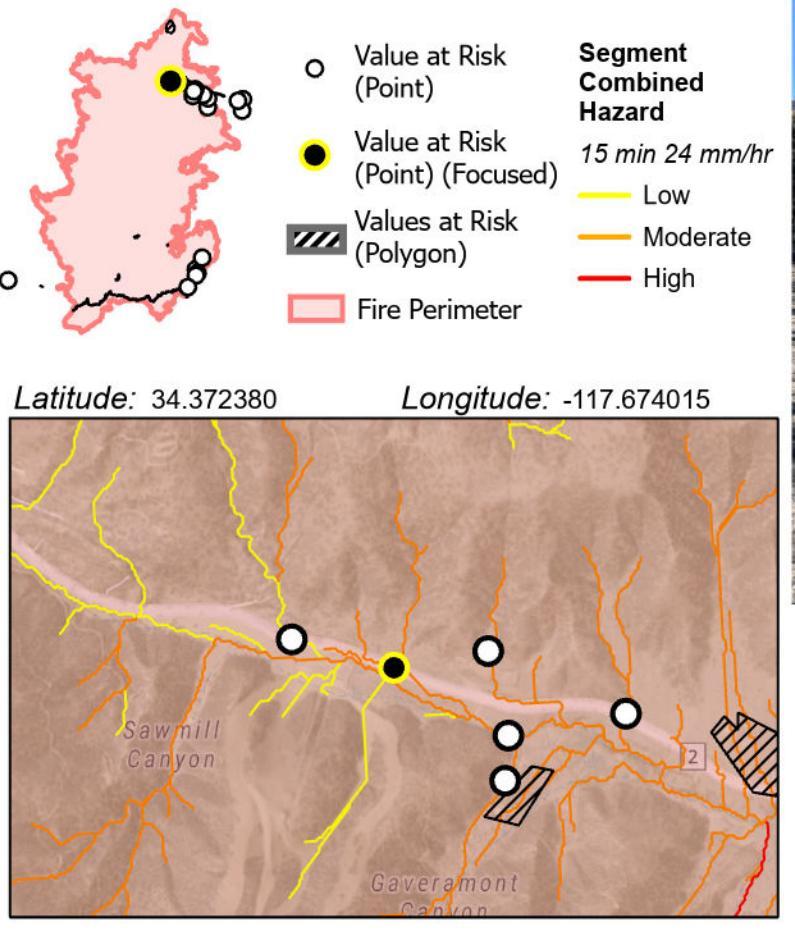
Description: Evidence of aggraded alluvium observed on top of fan surface. Deposits don't appear to extend much past fan apex.

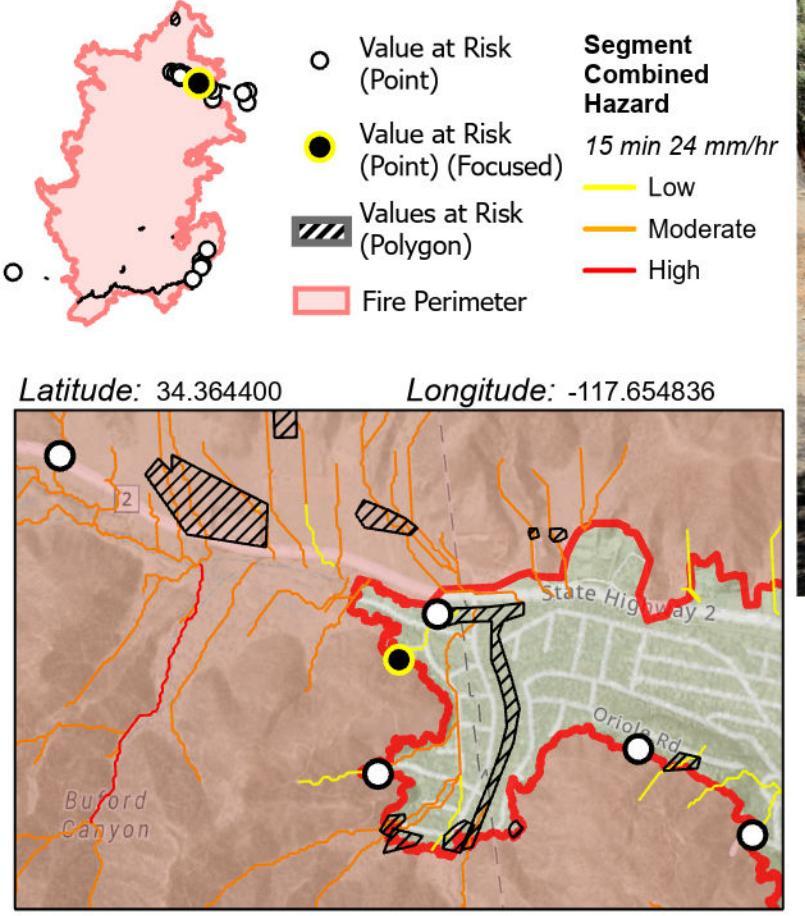
Description: Small rock and fine sediment observed in drainages. Berm constructed at mouth of drainage to divert low flow. Past deposits appear to have caused some level of dry rot in wood siding.

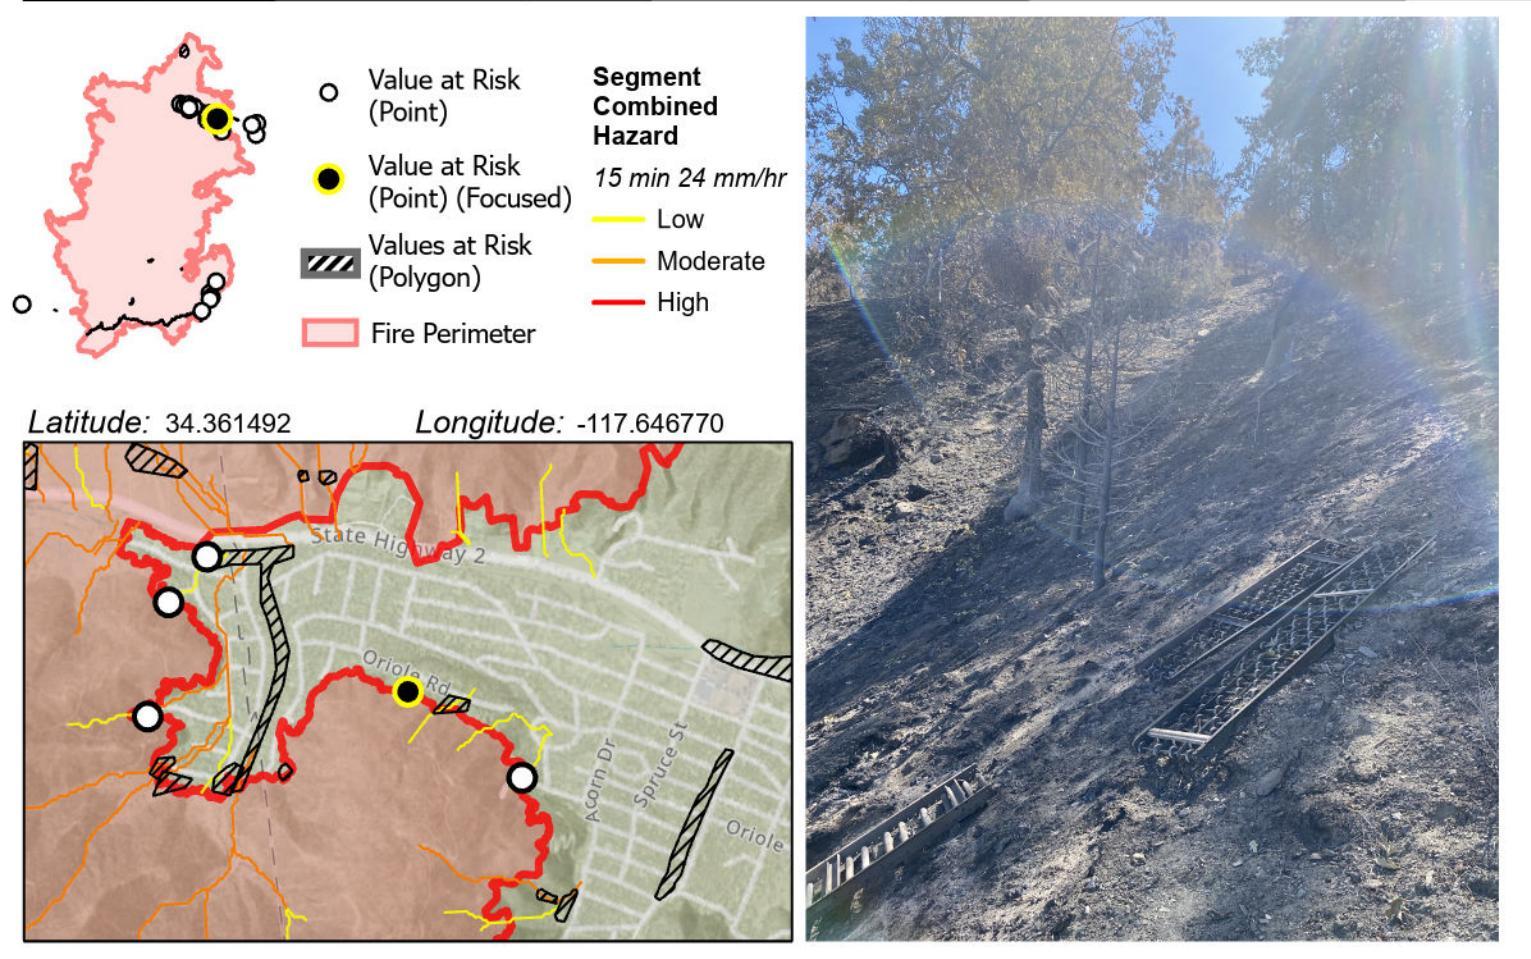
Description: Neighbor reports that home floods in normal years on first floor when drainage around home becomes blocked.

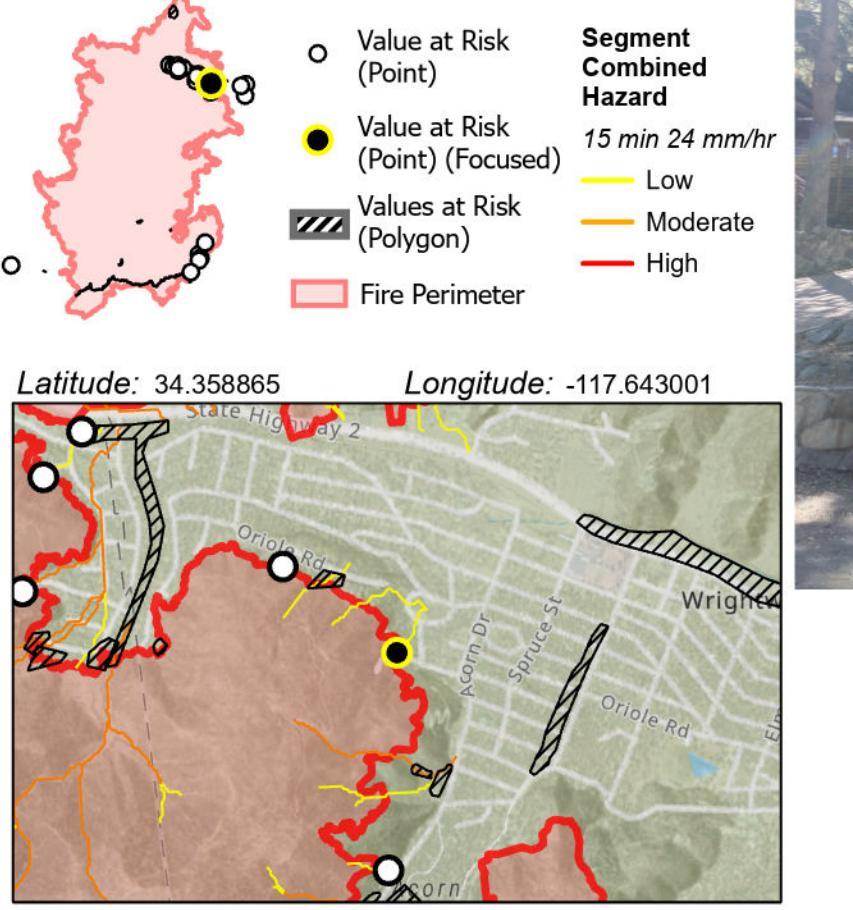
Description: Main home appears mostly out of flow path and therefore not considered a VAR, however landscaping terraces may be in flood path. Observed a minor matrix supported debris flow deposit behind oak in channel above carport.

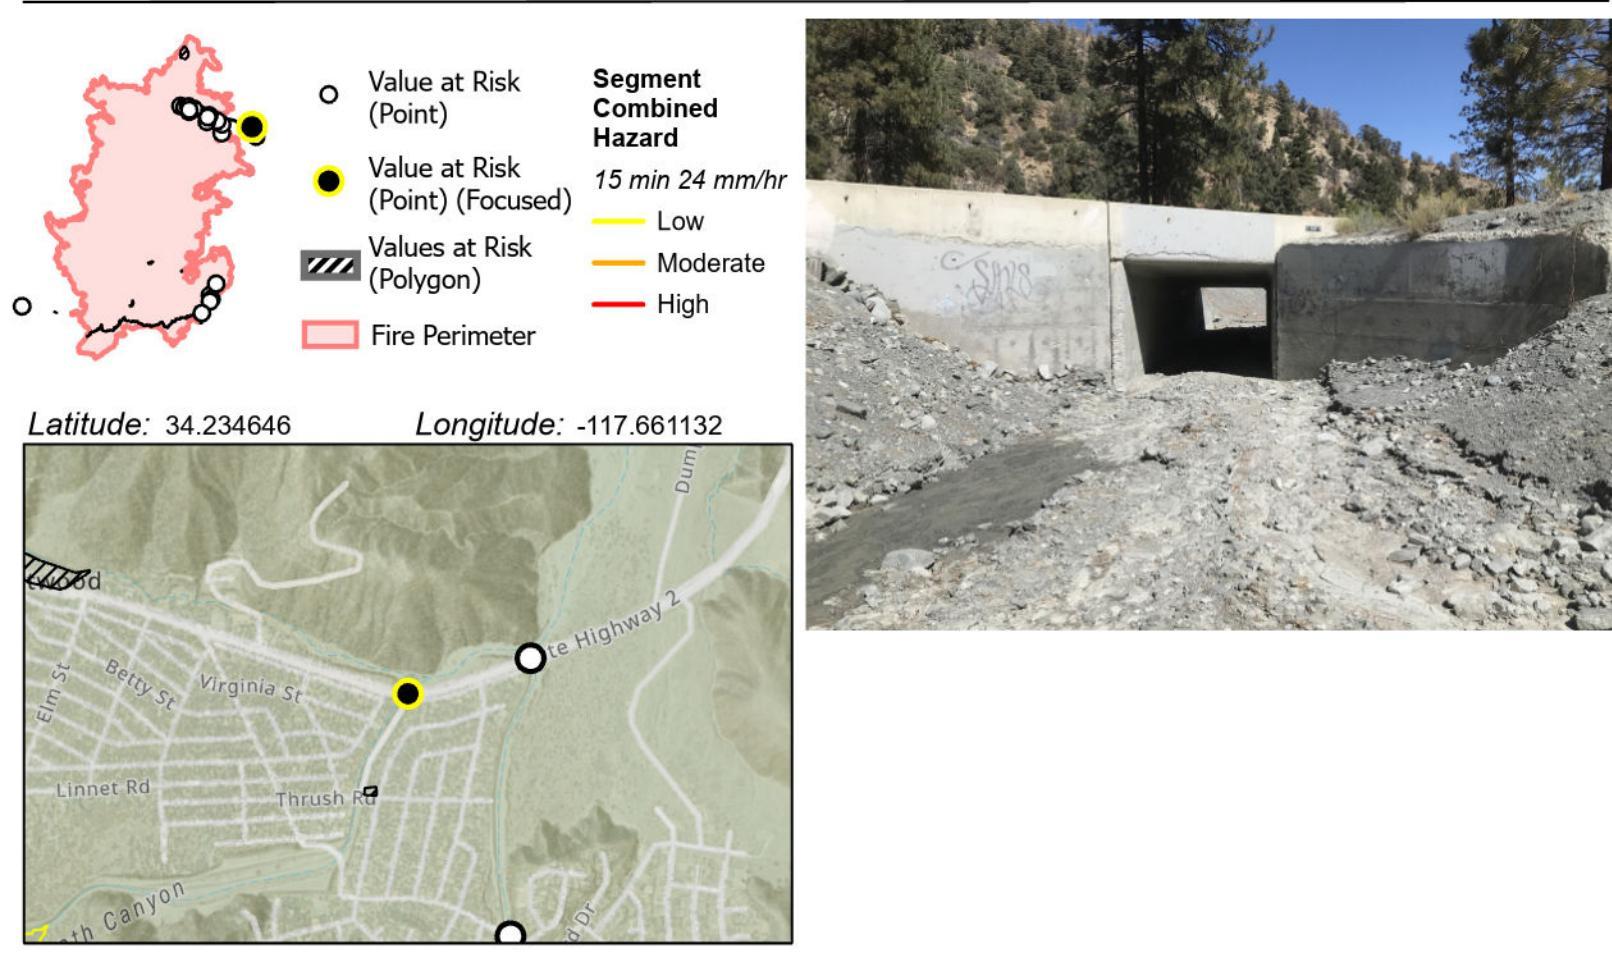
Description: Crossing shows evidence of being damaged by previous debris flows. The potential for plugging and overtopping is likely greatest during large storm events. Post-fire impacts are likely low.

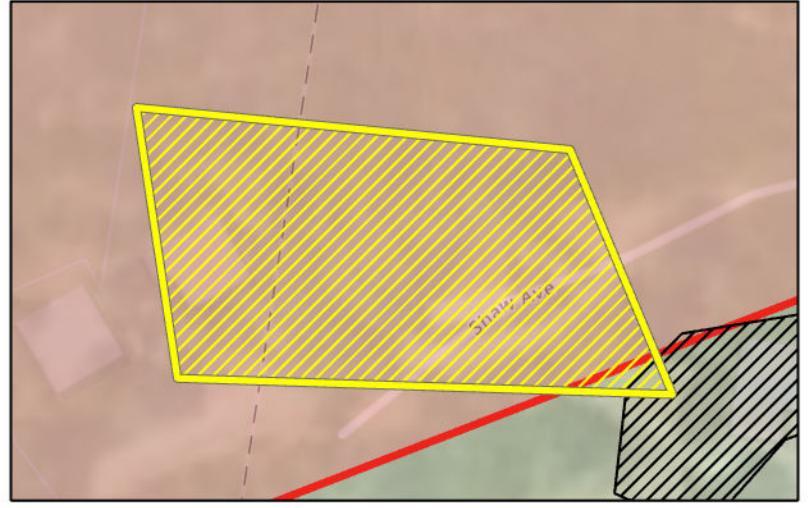
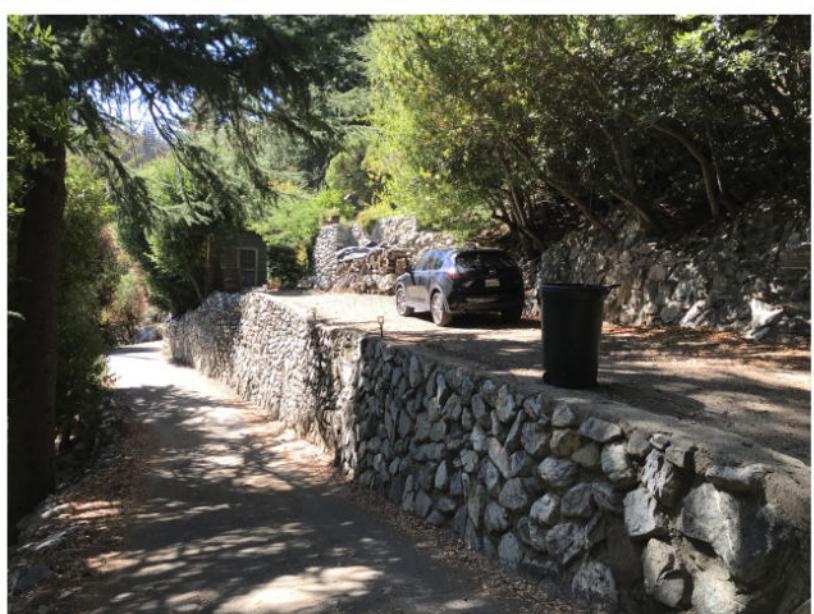
Incident: Bridge Fire	Incident Number: CA-ANF-243334
Community: Mt Baldy	
Site Number: MB_04	
Feature: Residence structures	
Feature Category: home	
Field Observation or Debris flow and rockfall hazard Potential Hazard:	
Potential Hazard to Life: moderate	Potential Hazard to Property: moderate
Preliminary Emergency Protective Measures	
(1) Early Warning	(2) NA
(3) NA	(4) NA
Text: NA

Description: Nearby resident described mudflow inundation of home to depth of 3-4 ft in 2014 rain event. Recently repaired road/retaining wall

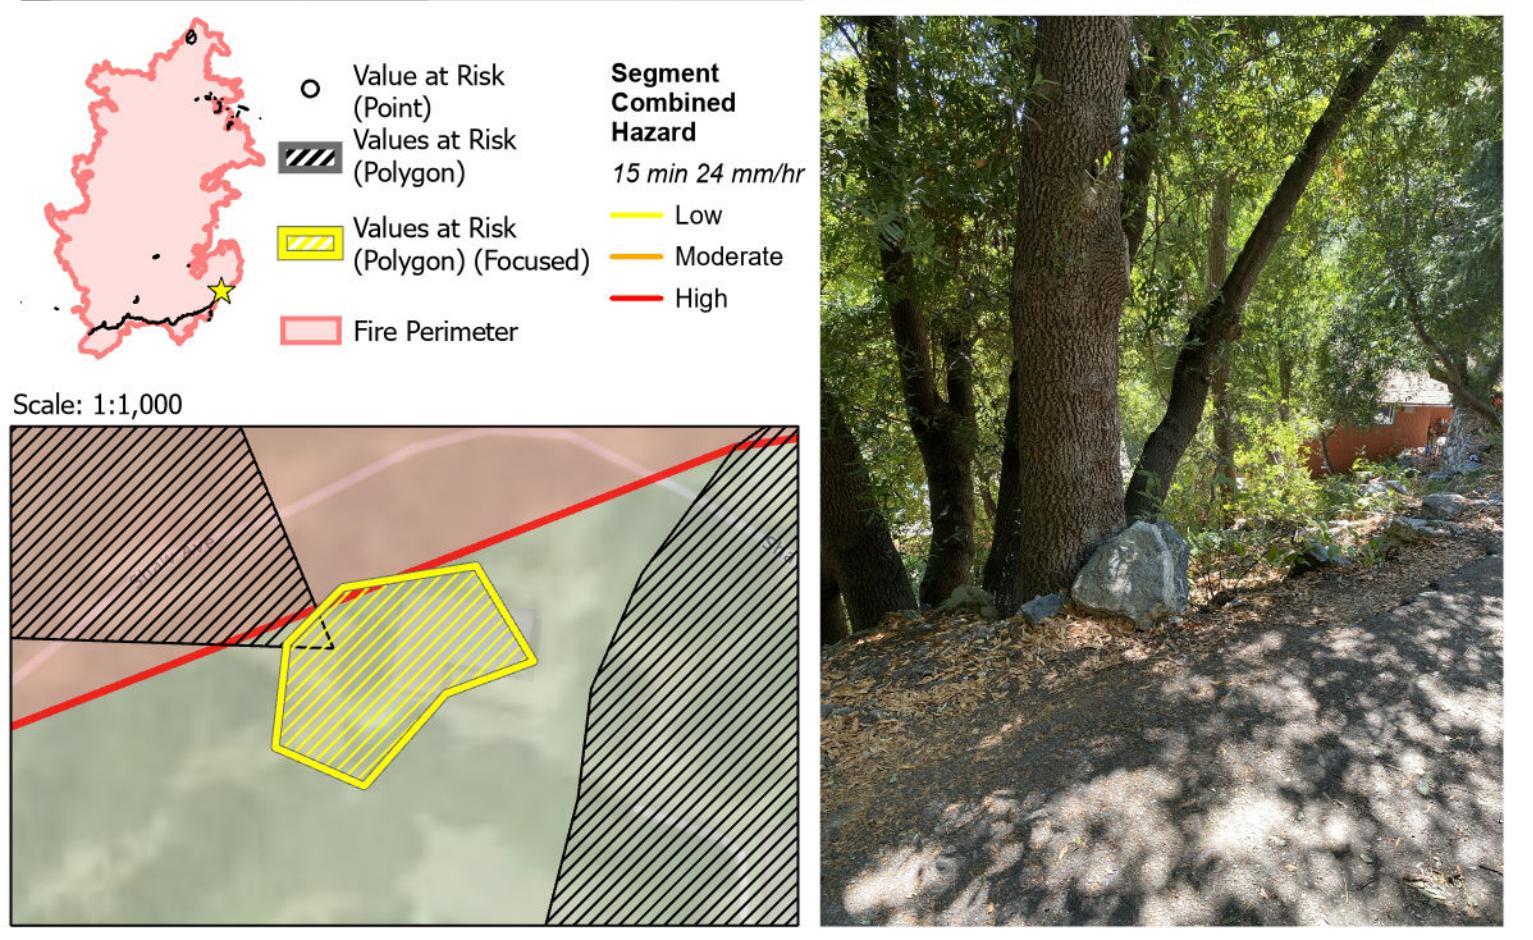
Description: Drainage is choked with sediment, debris, large wood with a large contributing area burned at moderate and high. Concern of debris flood and rockfall hazards that will impact temporary structures or structures under new construction.

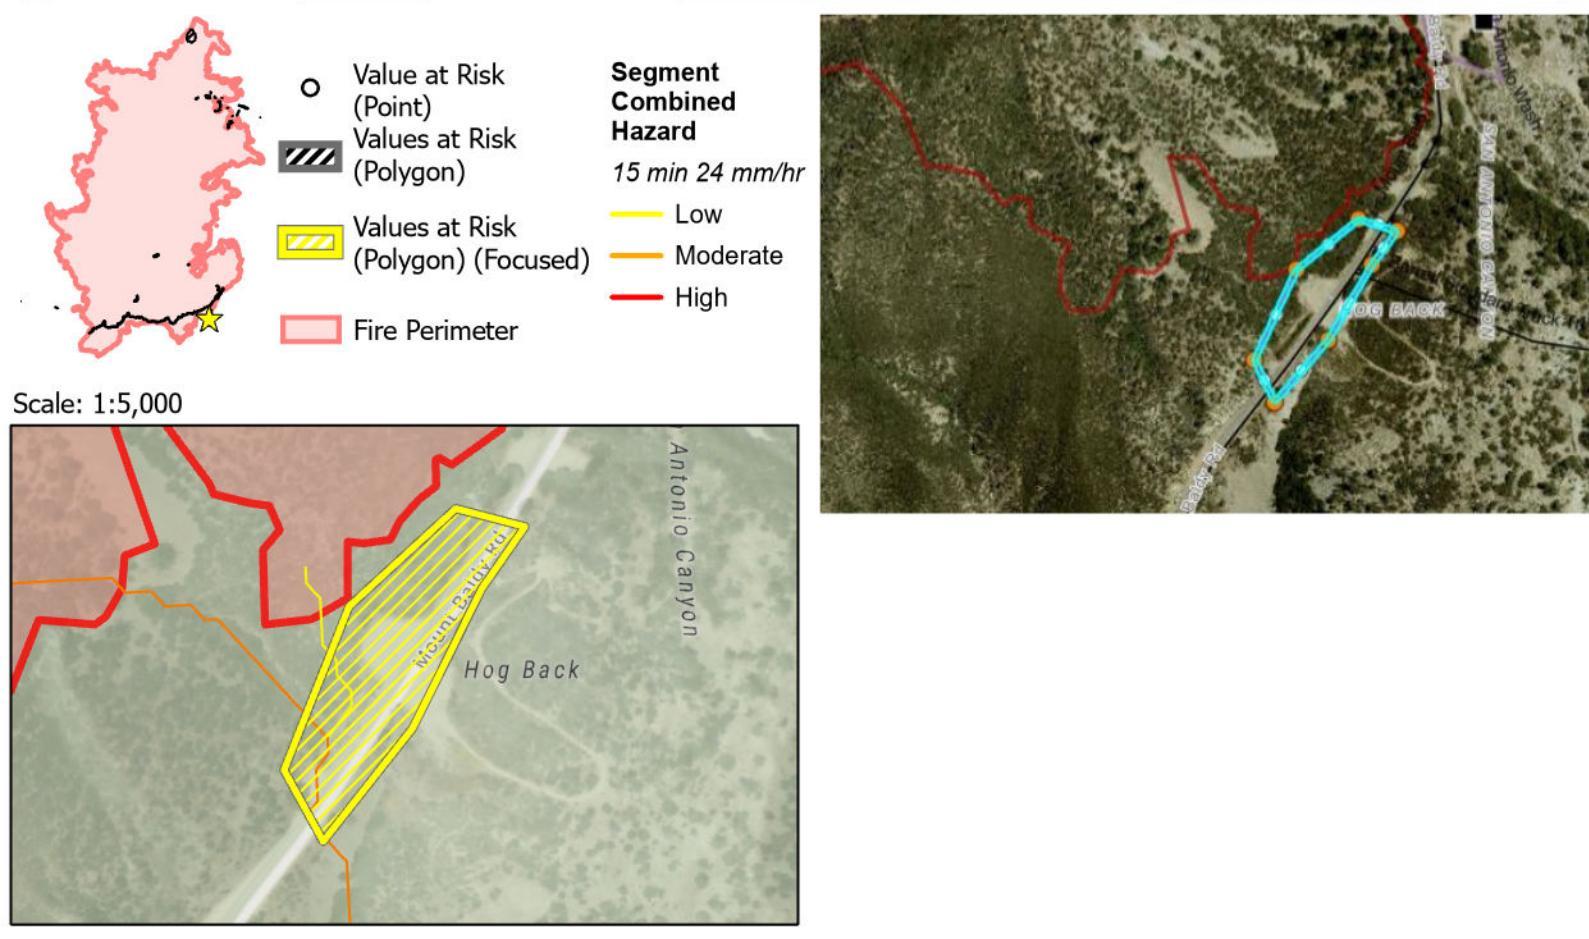
Description: Slopes upgradient are burned at low. Presence of alluvial fans immediately above road. Roadcut has been recessed into fan with no observed failures. Sediment and debris may flow onto road and plug adjacent crossing structure.

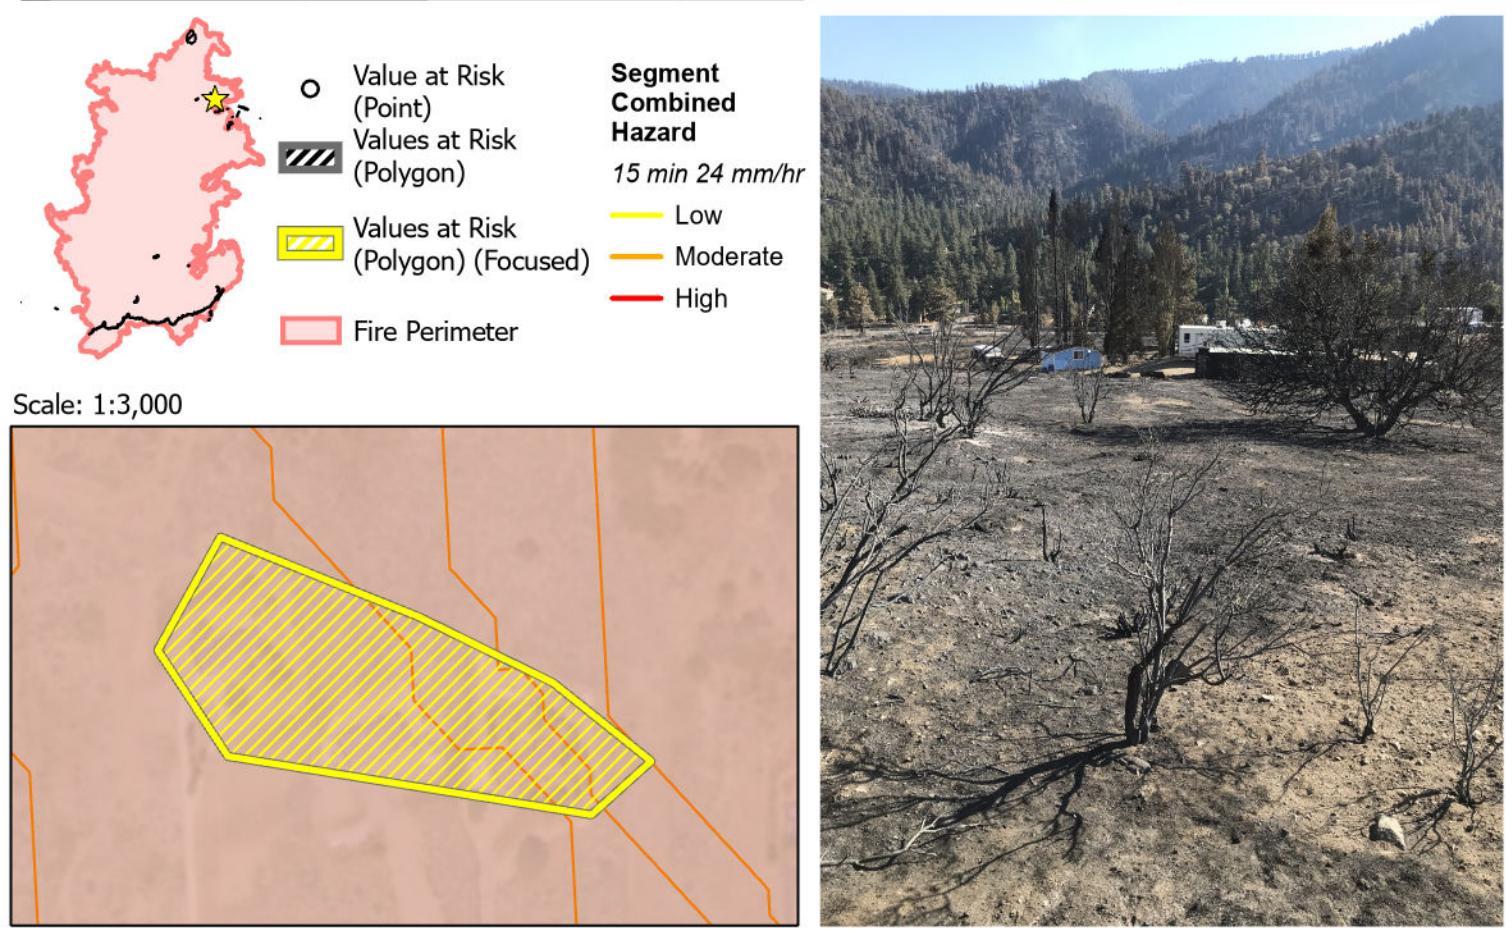
Description: VAR is a structure with green roof. Could not access property and observed this property from road. Overlying slopes have debris slide slope characteristics and are moderate severity burn.

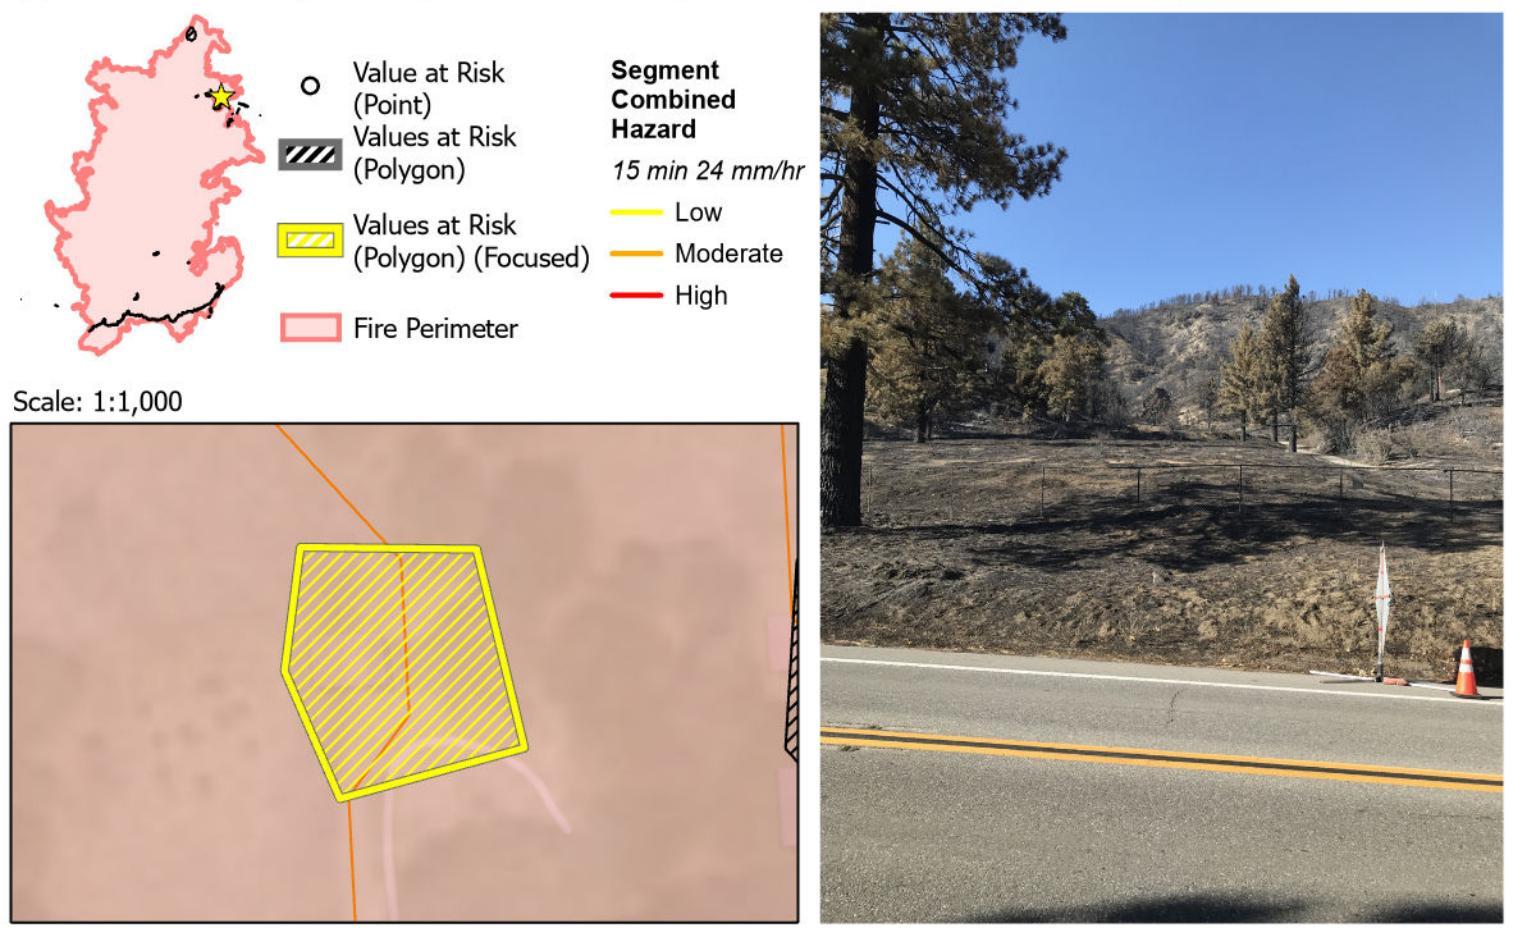
Description: Could not access property to closely observe fan or structure. Overlying basin exhibits debris slide slope characteristics. Several undeveloped pads also within or below alluvial fan.

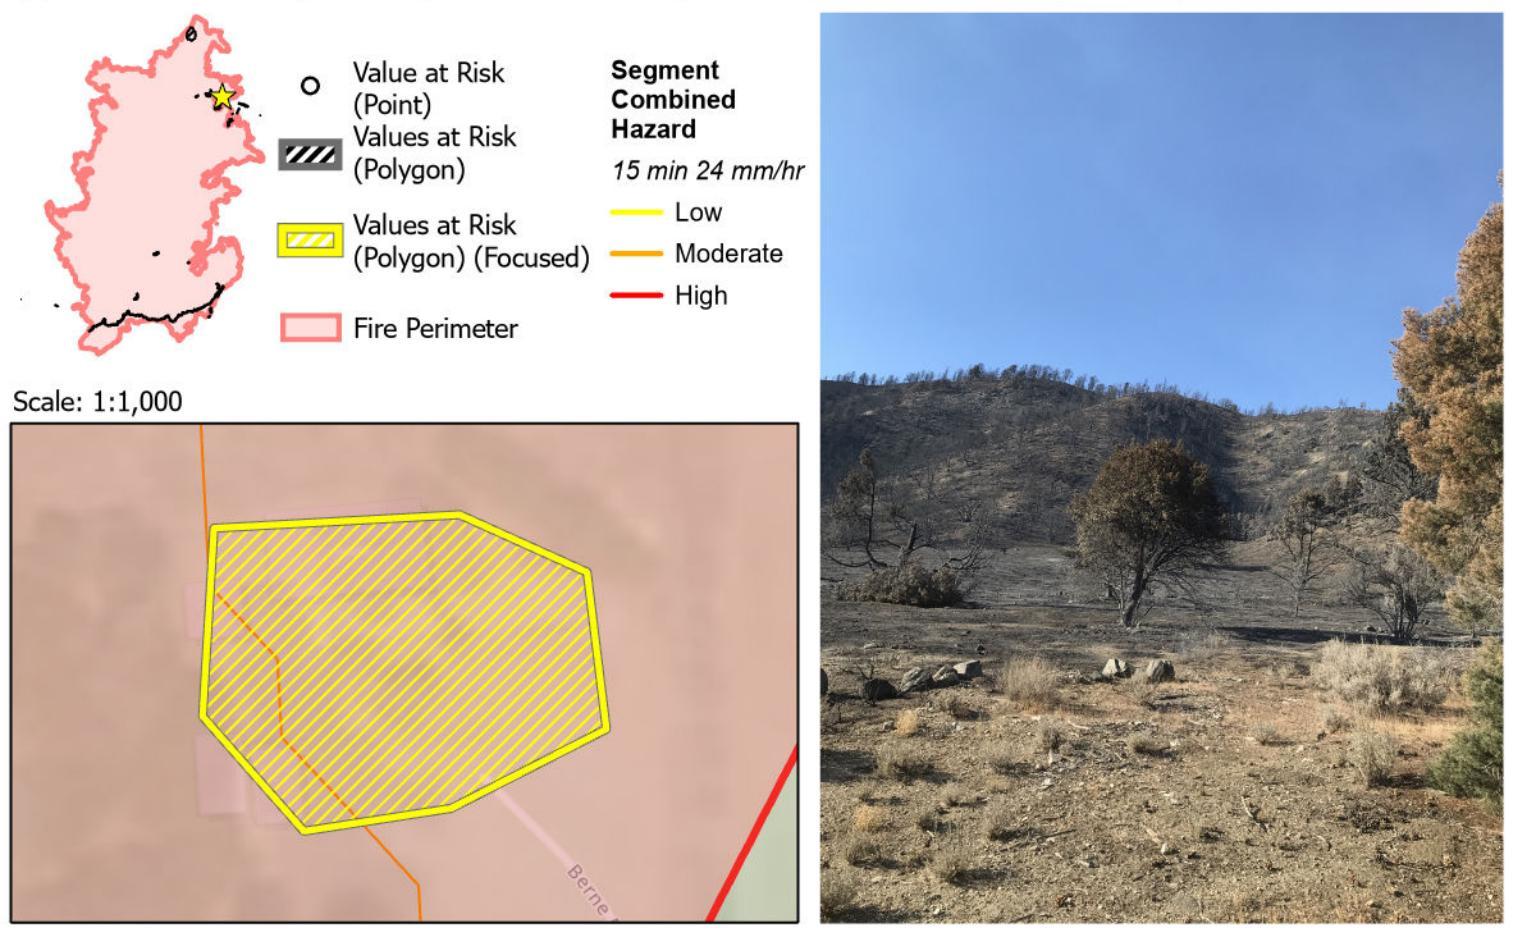
Description: Four houses in drainage, with one of them burned. Much of the sbs within 100-acre drainage is moderate.

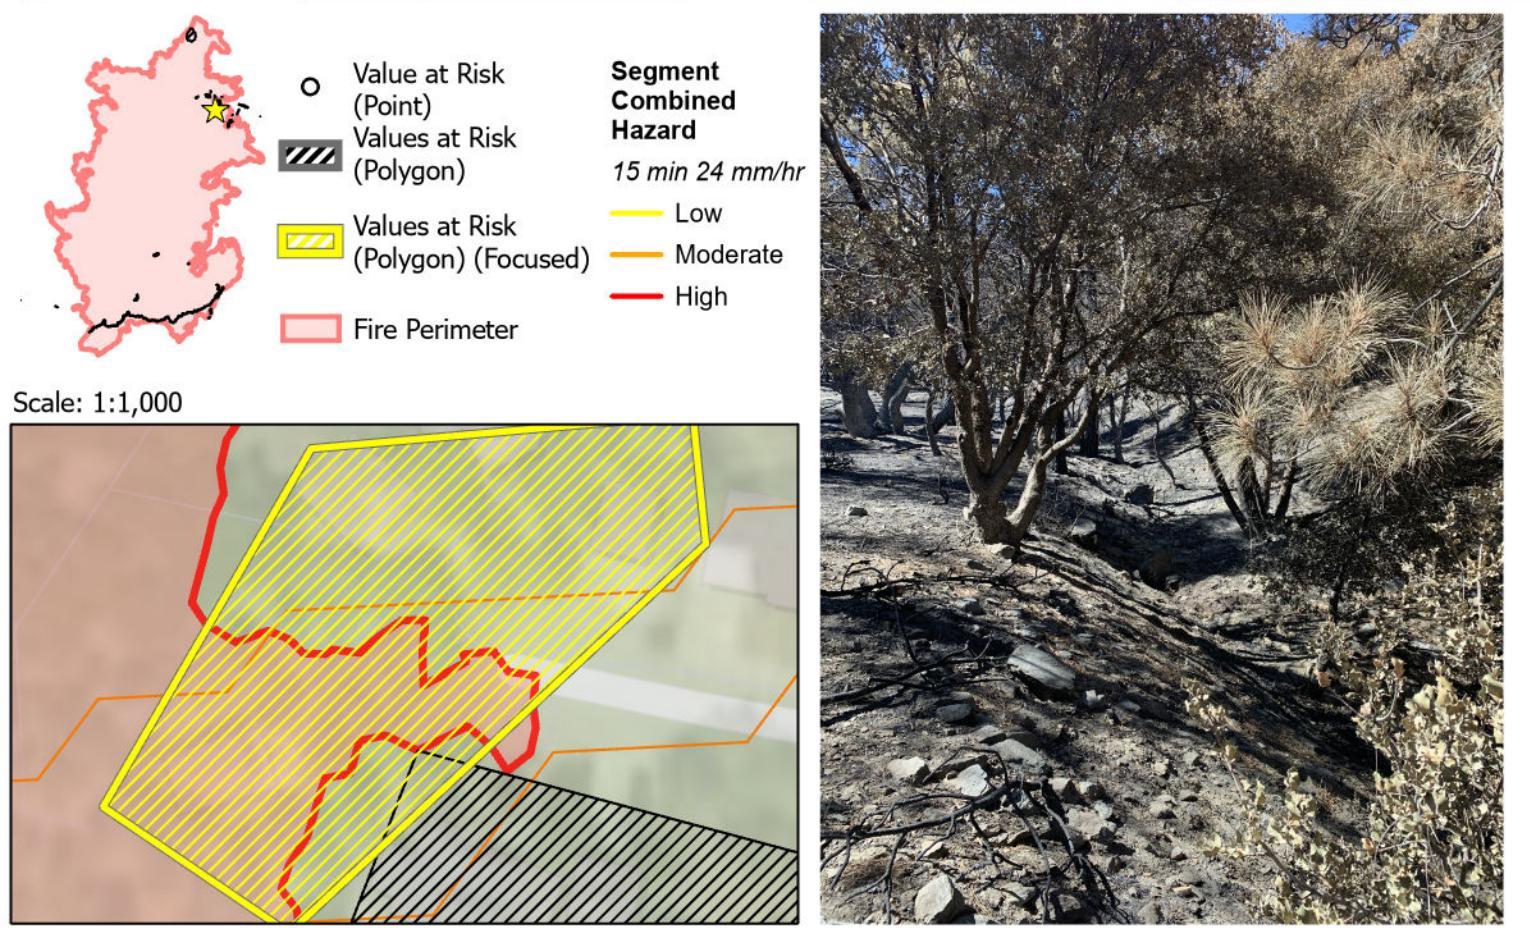
Description: Four houses in drainage, with one of them burned. Much of the sbs within 100-acre drainage is moderate.
