Forest Service
U.S. DEPARTMENT OF AGRICULTURE

Pacific Southwest Region | October 2024

Burned Area Emergency Response Assessment
Technical Report
Bridge Fire (CA-ANF-243334)
October 16, 2024

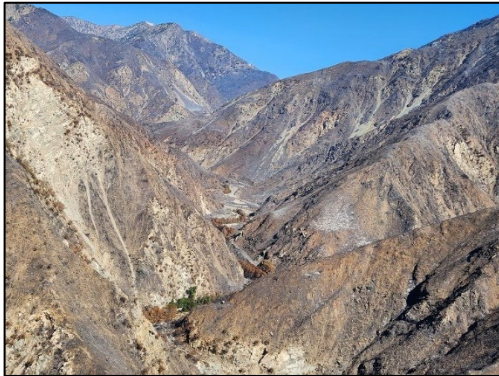
Picture 2. Upper East Fork San Gabriel River watershed (USDA FS)

In the late Cenozoic Era, the metamorphic formations were uplifted and exposed at the surface. Towards the southern section of the burned area, the formations are both metamorphic and granitic. Rocks in this area commonly include coarse-grained, biotite-rich granodiorite, tonalite and gneiss.

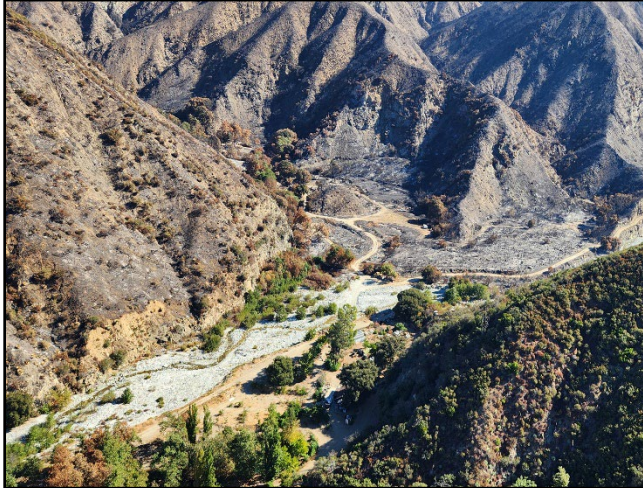
Picture 3. Cattle Canyon floodplain at Coldwater Creek (USDA FS)

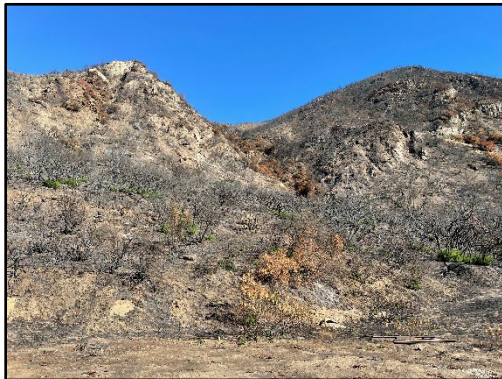
Picture 3. Recovery as seen in chaparral landscapes in the Bridge Fire (USDA FS)

Grasses and sparse shrubs usually experience extremely rapid consumption and spread rates during a wildfire, with very little heat residence time at the soil surface (Picture 4, Picture 7). The result is very little alteration of soil organic matter and little or no change in soil structural stability. Water repellency, occasionally present under shrubs before the fire, may or may not be exacerbated by the fire. Very low and low soil burn severity was classified in areas where the surface organic material was charred or partly consumed. Roots close to the soil surface were usually still pliable, and soil structure was mostly unchanged. Most grassland areas burned at very low to low severity;

however, low severity conditions were found in all vegetation types. Vegetation recovery is anticipated to be rapid in these areas and sprouting was observed in some grasslands during the assessment. Post-fire erosion response in areas of low soil burn severity will be somewhat variable. Some low-severity areas under forest vegetation will have litter and organic material additions before the wet season; however, some of the grass and shrublands have little or no surface cover remaining except rock.

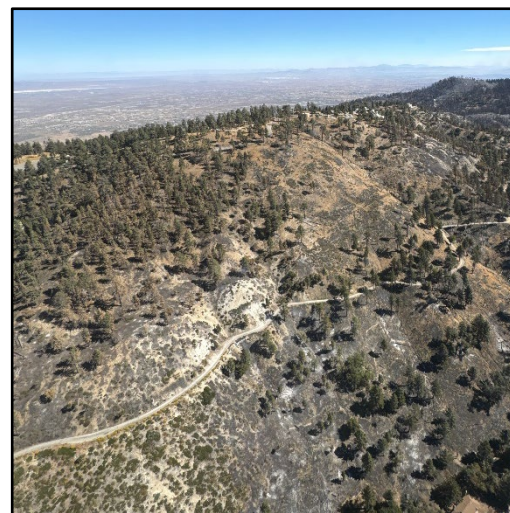
Picture 4. Low soil burn severity areas of the Bridge Fire (USDA FS)

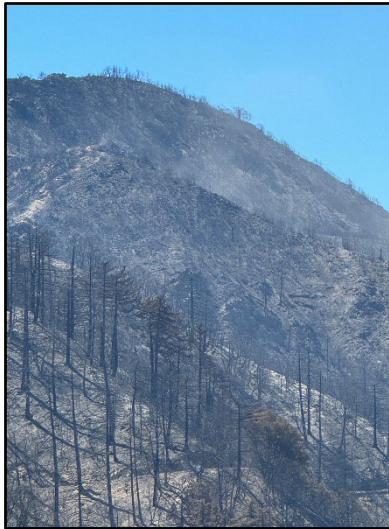
Picture 6. Post-fire wind erosion on the Bridge Fire (USDA FS)

Significant areas of moderate and high SBS had signs of wind erosion. This was observed as exposed tan subsurface soil and by exposed roots that were not consistently charred. This was likely caused by strong fire-induced inflow/outflow winds as well as the strong wind events occurring during the burn. The wind erosion removed much of the ash layer and the loose surface soil once the structure was lost (Picture 6). The loss of these materials could reduce the ash loads being deposited in the drainages during the initial rain events, but also reduces the soils water holding capacity. This reduction in water holding capacity will expedite runoff during the onset of precipitation events. This loss of the surface “A” horizon will also significantly reduce the soil productivity in these areas. Before the fire, the A horizon would have varied from chaparral to timbered ground, however it would have held rich organic matter that supported the vegetation vs the weakly developed horizons below.

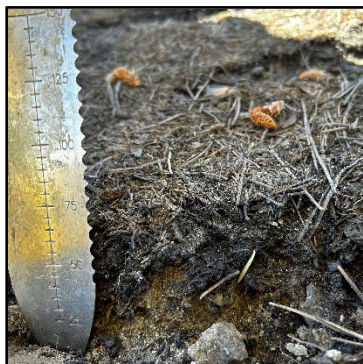
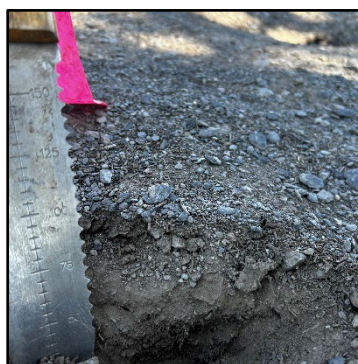
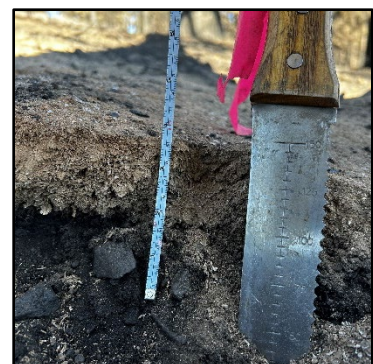
The moderate class of soil burn severity is far more diverse in observed soil conditions and can include various vegetation types, ranging from forests to shrub communities. In forested areas the litter layer may be largely consumed, but scorched needles and leaves remain in the canopy and will rapidly become mulch. This is important in re-establishing protective ground cover and soil organic matter. Generally, there will be less destruction of soil organic matter, roots, and structure in an area mapped as moderate compared to an area mapped as high SBS. In a shrub ecosystem, even where pre-fire canopy density was high, the litter layer is generally thin, and while the shrub canopy may have been completely consumed by the fire, the soil structure, roots, and litter layer may remain intact beneath a thin ash layer. On the Bridge Fire, moderate soil burn severity was found in areas where the surface organic material was completely consumed by the fire, fine roots close to the soil surface were charred up to 3 cm deep, and the soil structure was often altered at the surface. Moderate severity occurred under forest canopy or under chaparral. Some areas have potential for inputs of litter to increase ground cover, but more commonly no surface organic matter remains, which can increase post-fire erosion.

Picture 7. Photos of the three classes of soil burn severity. On the left, low soil burn severity. In the center, moderate soil burn severity. On the right, high soil burn severity. (USDA FS)

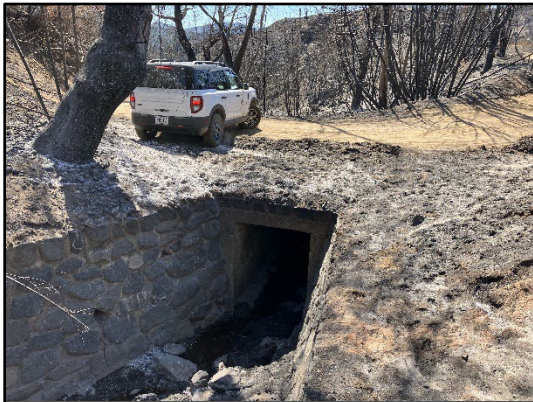
Picture 8. Box culvert at Hummingbird Creek on San Dimas Experimental Forest (USDA FS)

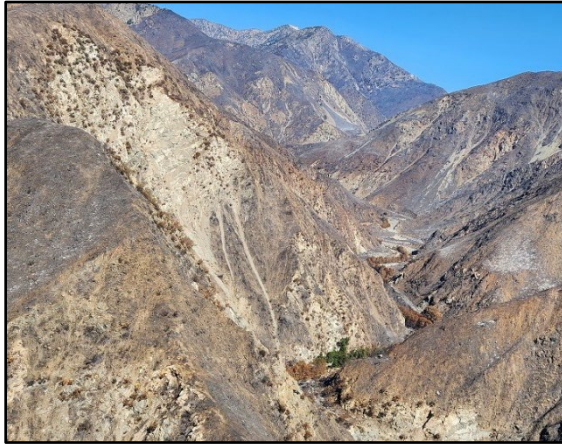
Picture 9. Steep chutes above East Fork San Gabriel River loaded with sediment (USDA FS)

From ground surveys and an aerial reconnaissance flight, it is evident that pre-fire mass wasting as rock-fall, shallow landslides, and some old debris flow deposits exists throughout major portions of the burned area. Throughout the Bridge Fire burn scar most slopes and drainages are loaded with unsorted, unconsolidated materials comprised of rocks of all sizes including boulders, cobbles, gravels, and fine sediments, available to be transported. This is related to the type of parent materials, the steep slopes and continues gravitational and hydrological mobilization of rocks and sediments down slopes and drainages. Scanning the burn scar from south to north, some of the drainages in the burn scar that present large amounts of unsorted, unconsolidated materials available to be transported included: Tanbark Creek, Hummingbird Creek, Bear Creek, Cow Canyon, Cattle Canyon, Coldwater Canyon, East Fork San Gabriel River, Fish Fork, Vincent Gulch, Prairie Fork, Sheep Canyon, Heath Canyon, Flume Canyon, Government Canyon, and Sawmill Canyon. In most of these watersheds, in addition to the fact that large amounts of sediments are present and available to be transported, major portions of these watersheds experienced moderate to high soil burn severity. From ground surveys and aerial reconnaissance, it is evident that many of the steep chutes flowing into the major creeks in the burn scar are loaded with sediments (Picture 9).

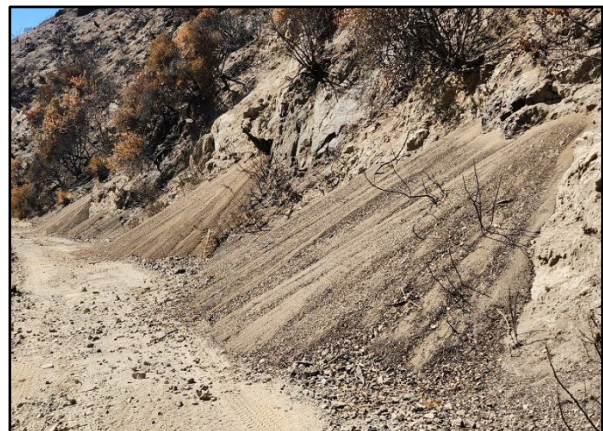
As a result of the fire and the removal of supportive vegetation, post-fire dry ravel and rockfall was observed on slopes, impacting roads, and further loading channels with fine sediments and rocks (Picture 10). In addition to the fact that many of these drainages impacted by the fire experienced a moderate to high soil burn severity, many of the slopes in the burn area are steep (40-60%) or very steep (60+%) slopes.

Picture 10. Post-fire dry ravel and rockfall impacting roads and loading channels (USDA FS)

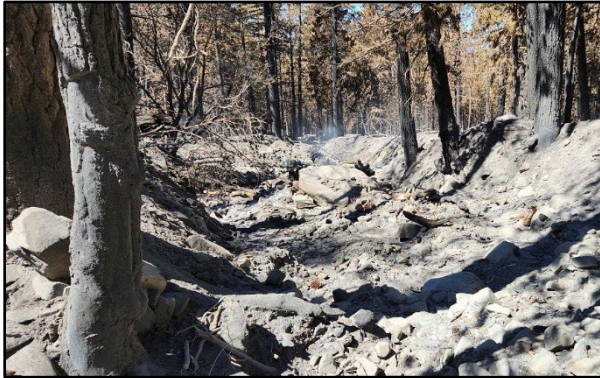
Within the Bridge Fire burn scar, widespread evidence of debris flow deposits was identified in many watersheds, and creek bottoms (Picture 11). For the most case, these debris flow deposits were mobilized during storms under pre-fire conditions. Now that the Bridge Fire burned such a high

Picture 11. Debris flow levees and deposit – Prairie Fork (USDA FS)

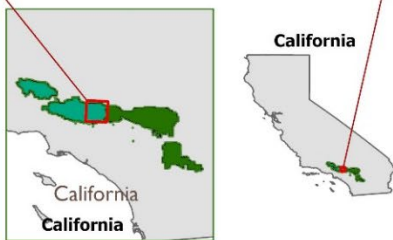
Soil Burn Severity is a measure of the fire's effects on the ground surface and soil condition. This map identifies the fire-induced changes in soil and ground surface properties that may affect infiltration, runoff, and erosion potential. The BAER Team uses this map to identify areas of unacceptable risk to a critical value and where mitigating treatments may be most effective. This product is appropriate for wildland landscapes and does not represent fire effects in developed areas.

Soil Burn Severity	Acres	% Burned
High	3,743	7%
Moderate	27,806	51%
Low	17,140	31%
Unburned	5,970	11%
Assessment Boundary	54,659 acres
