Watershed Emergency Response Team (WERT) 2024 Bridge Fire

CA-ANF-243334 October 24, 2024

REPORT TITLE: Watershed Emergency Response Team (WERT) Evaluation – 2024 Bridge Fire

Bridge Fire – WERT REPORT EXECUTIVE SUMMARY

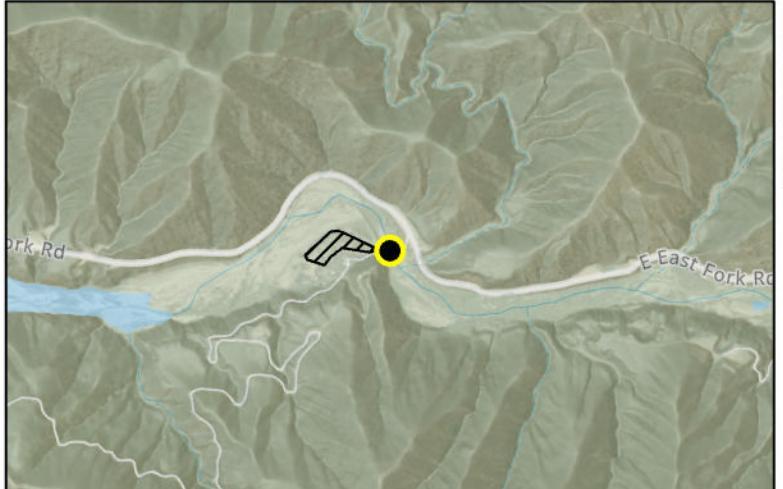
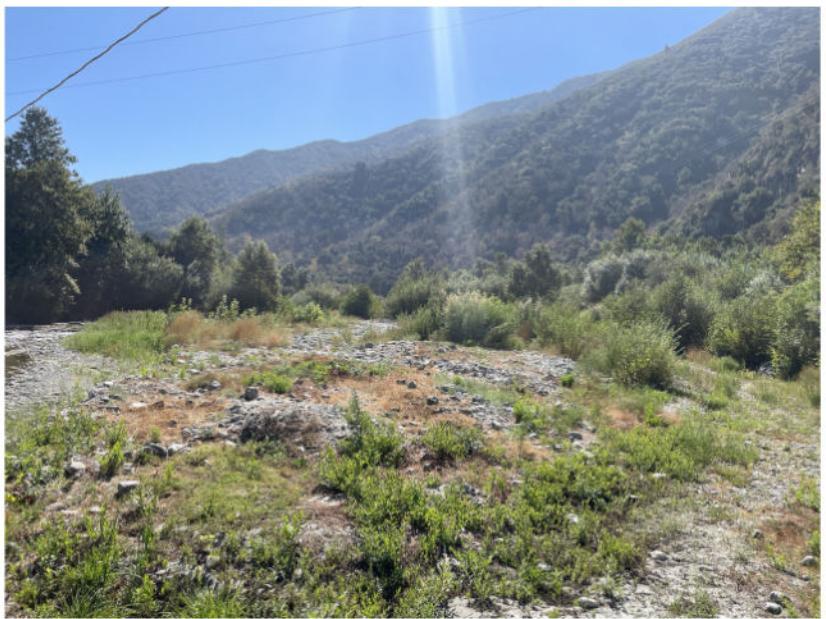
Field Observation or Bridge accessing camp 19. Limited flow capacity. Risk of debris and large flows relieving around approaches. Potential Hazard: Skew angle of bridge relative to channel will likely force flows to the west, placing pressure on the camp.

Potential Hazard to Life: moderate

Potential Hazard to Property: high

Text: Access to camp will likely be cutoff. Recommend evacuating camp during large storms. Install deflection structure to protect diverted flow from impacting camp. Prepare right bank abutment to function as a critical relief. Consider removing the railings.

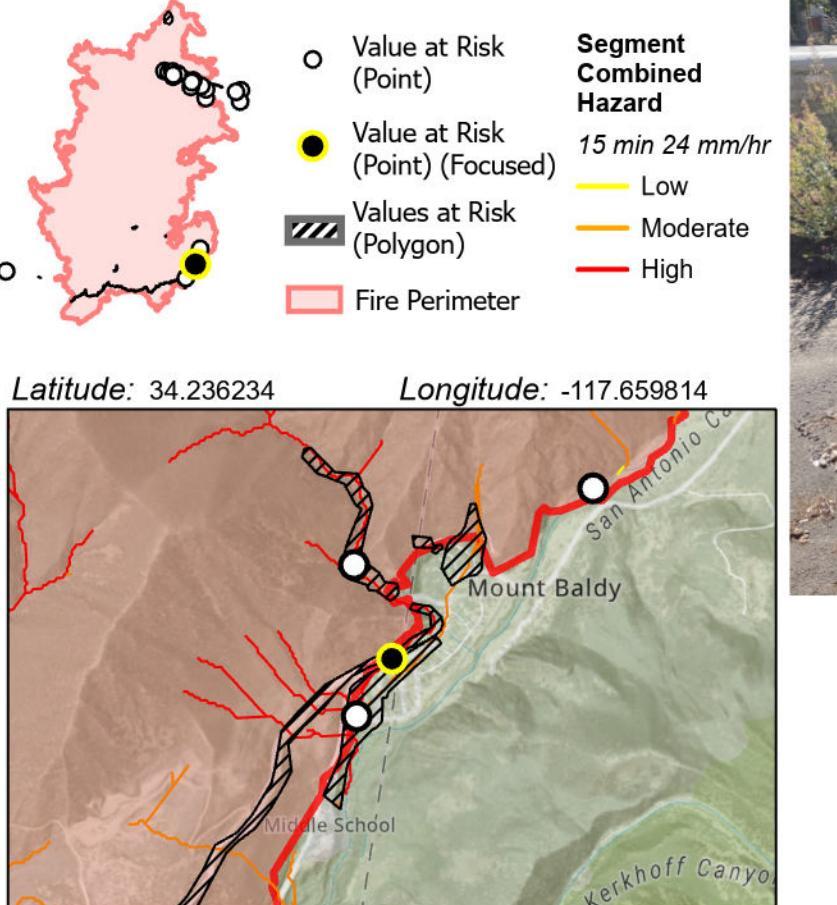
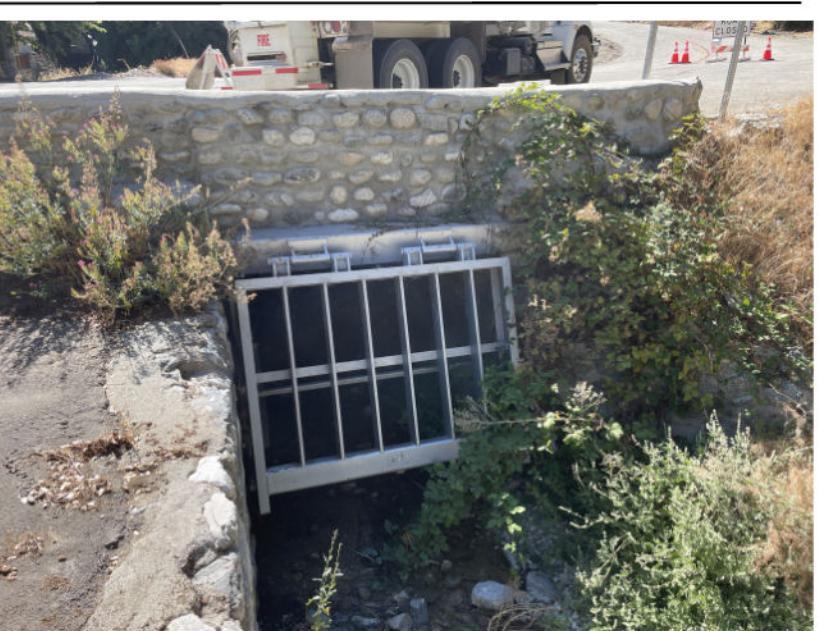
Incident: Bridge Fire Community: Mt Baldy Site Number: MB 07 Feature: Crossing structure. Feature Category: drainage structure Field Observation or Debris blocking culvert forcing overtopping flows. Potential Hazard: Very likely occurrence with moderate consequence = Very high risk Potential Hazard to Life: **IOW** Potential Hazard to Property: moderate Preliminary Emergency Protective Measures (2) Clear and maintain culvert (1) Early Warning (3) Deflection structure (4) Signage Text: NA

Description: Evidence of aggraded sediment upstream of crossing. Diverted flows will likely get diverted down road. 6x6 box with trash rack.

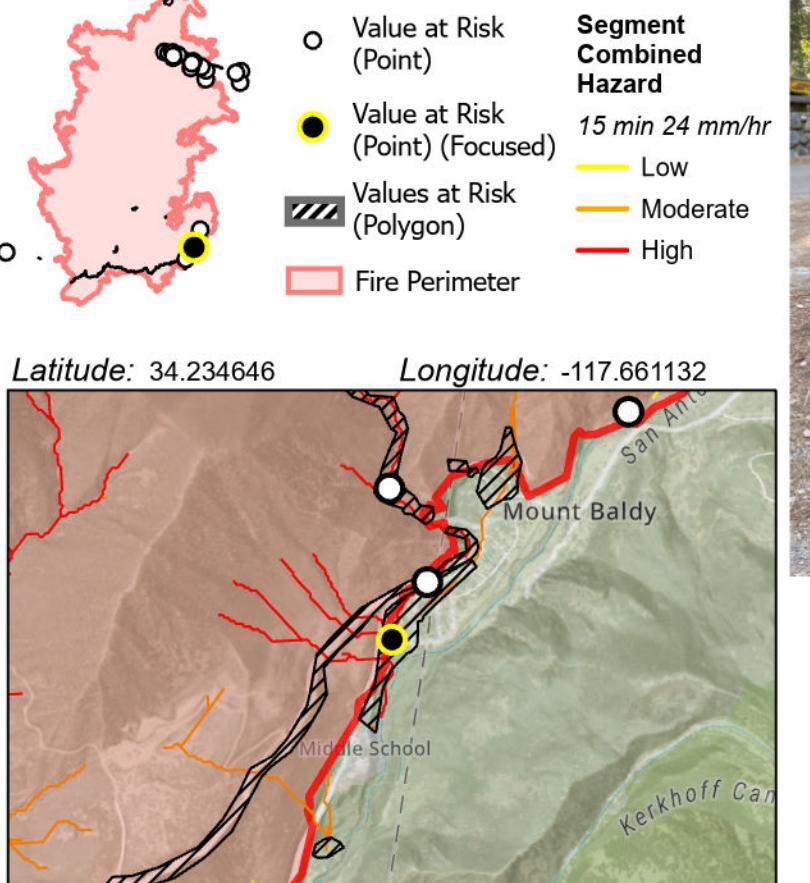
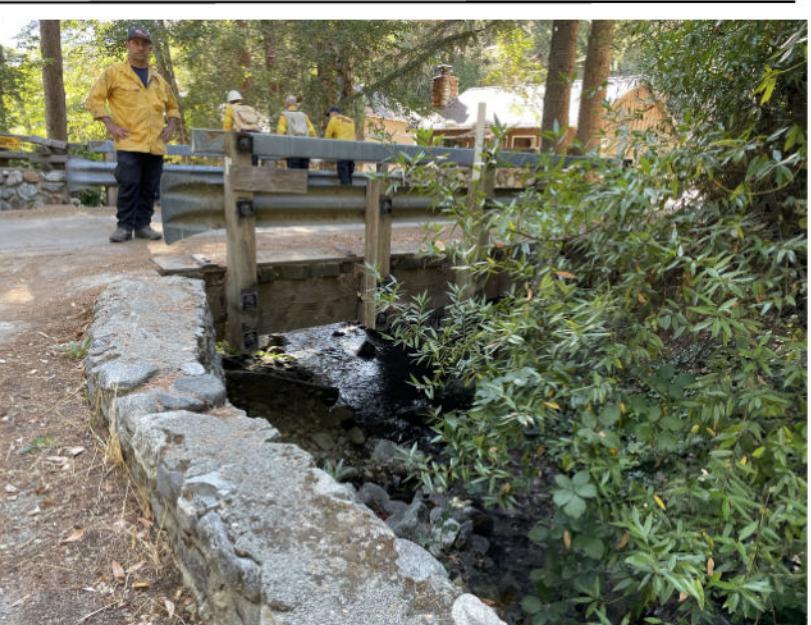
Field Observation or Debris flood hazard potentially plugging bridge crossing and lead to backwater and overtopping flows. Reports Potential Hazard: of flooding in the area in 2014.

Potential Hazard to Life: moderate

Potential Hazard to Property: high

Description: 5x17 opening under bridge. Bridge appears to have limited capacity to convey increased flows and debris.

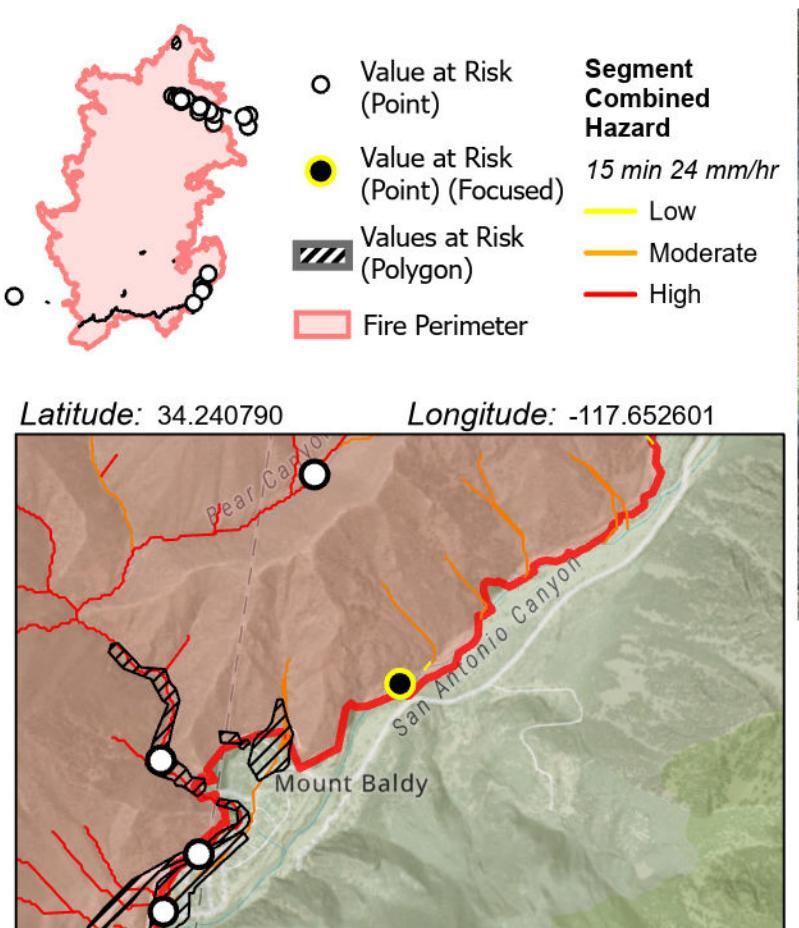
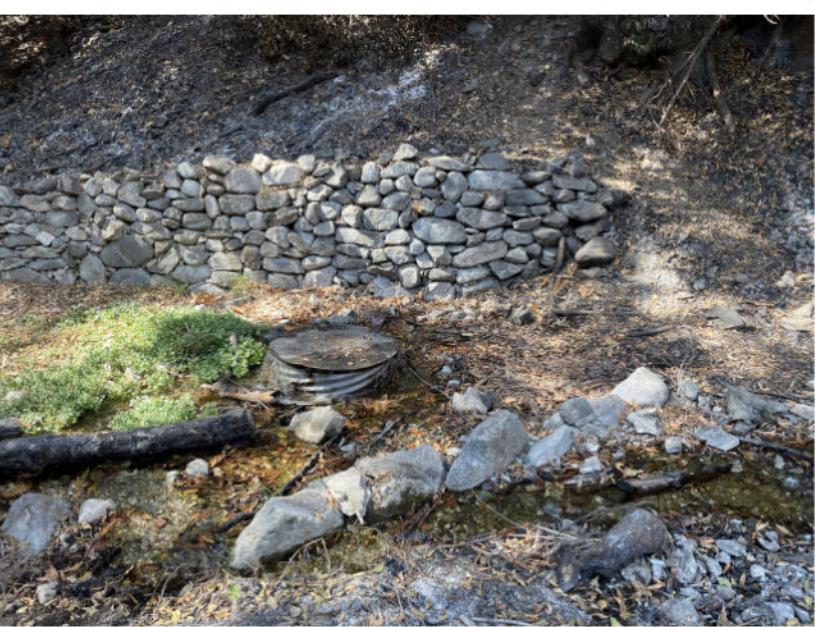
Field Observation or Rockfall and sediment impacting structure. Positive pressures may keep it he inlet free of debris. *Potential Hazard:*

Potential Hazard to Life: low

Potential Hazard to Property: moderate

Description: Current retaining wall at foot of slope is being overtopped by scree.

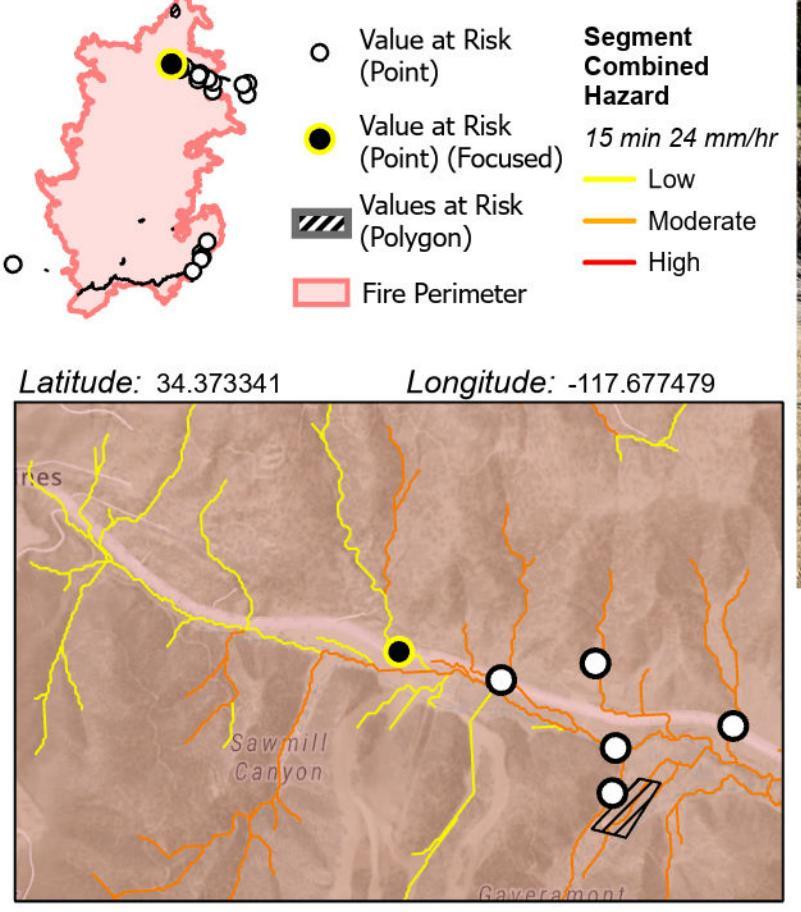
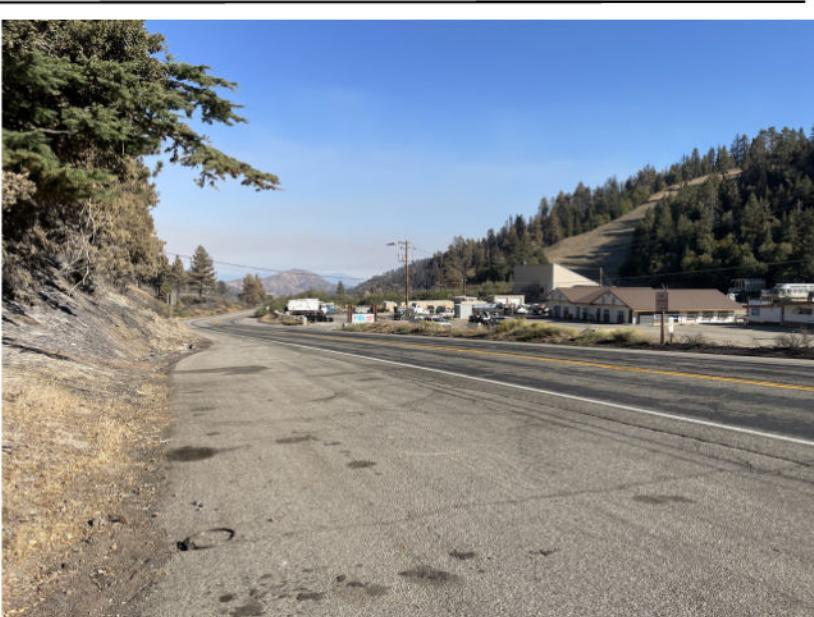
Field Observation or Debris flood spilling onto Hwy 2 from a channel that is burned at moderate and low. Flows will travel down and Potential Hazard: across road where they may impact parking area of Mtn High Ski Resort.

Potential Hazard to Life: low

Potential Hazard to Property: moderate

Description: Minimal evidence of pre-fire flow within channel. Increases in post-fire flow are anticipated that may overwhelm cross-drain culvert.

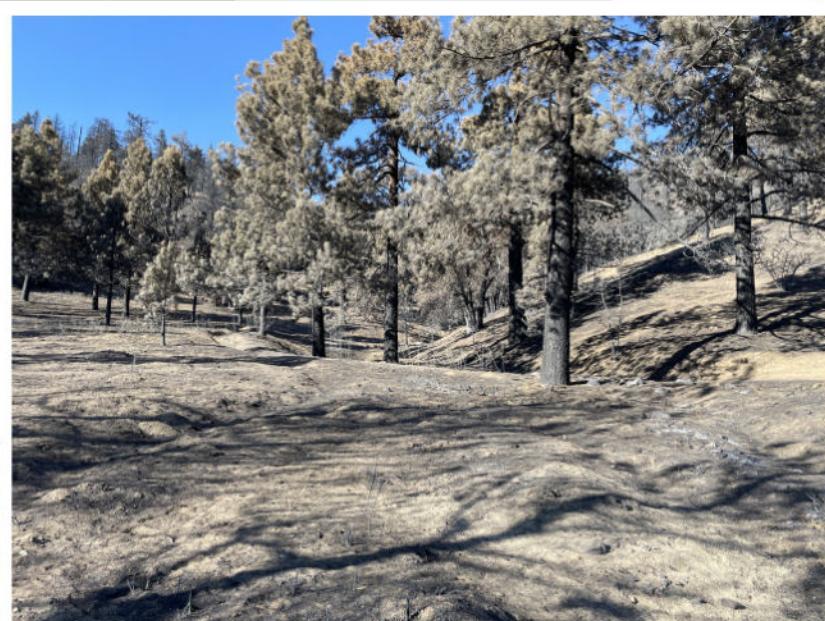
Field Observation or Channel with alluvial fan at outlet that exhibits signs of deposits extending onto fan surface. Catchment above Potential Hazard: is burned at moderate and high. Debris floods may exit the channel, extend across the fan, and spill out onto Hwy 2.

Potential Hazard to Life: low

Potential Hazard to Property: low

Description: Evidence of aggraded alluvium observed on top of fan surface. Deposits don't appear to extend much past fan apex.

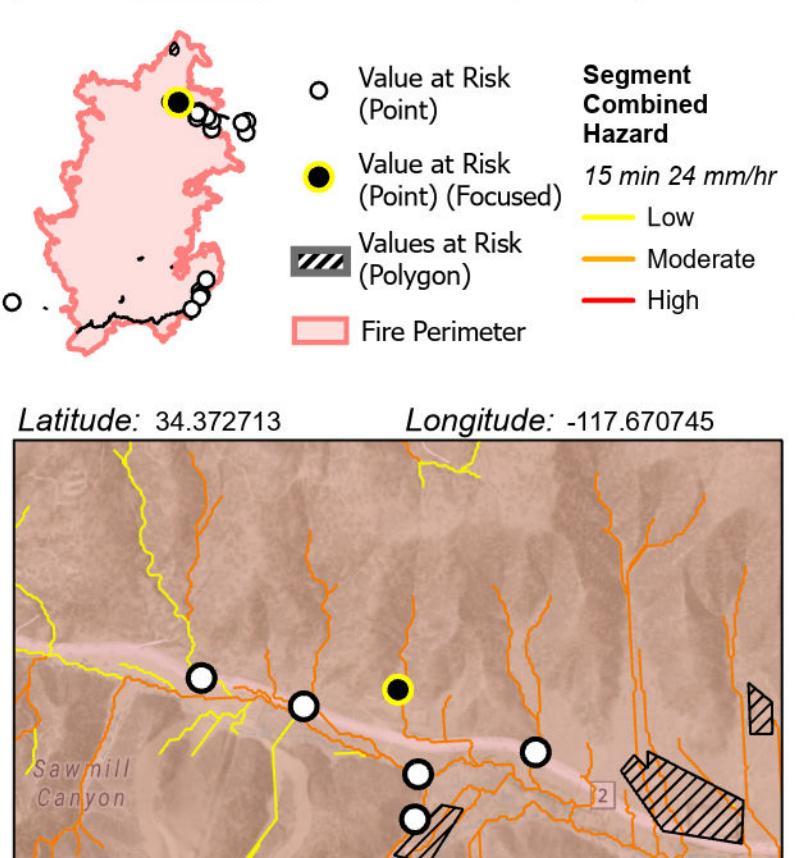
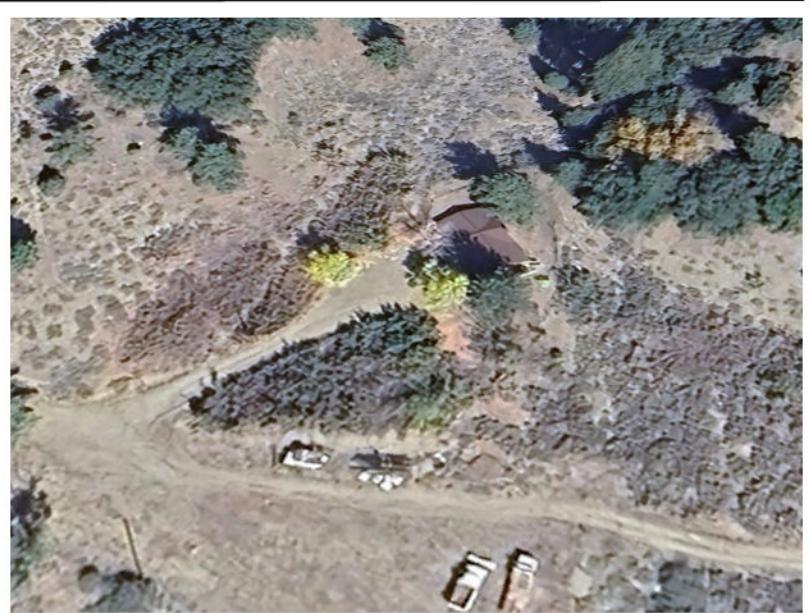
Field Observation or Burned residential structure within mouth of 22-acre drainage burned at moderate to high sbs. Drainage Potential Hazard: appears directed to the east side of structure. Potential hazard is flood that could mobilize burnt debris and impact future structure.

Potential Hazard to Life: moderate

Potential Hazard to Property: high

Description: Hazard to property is based on reconstruction.

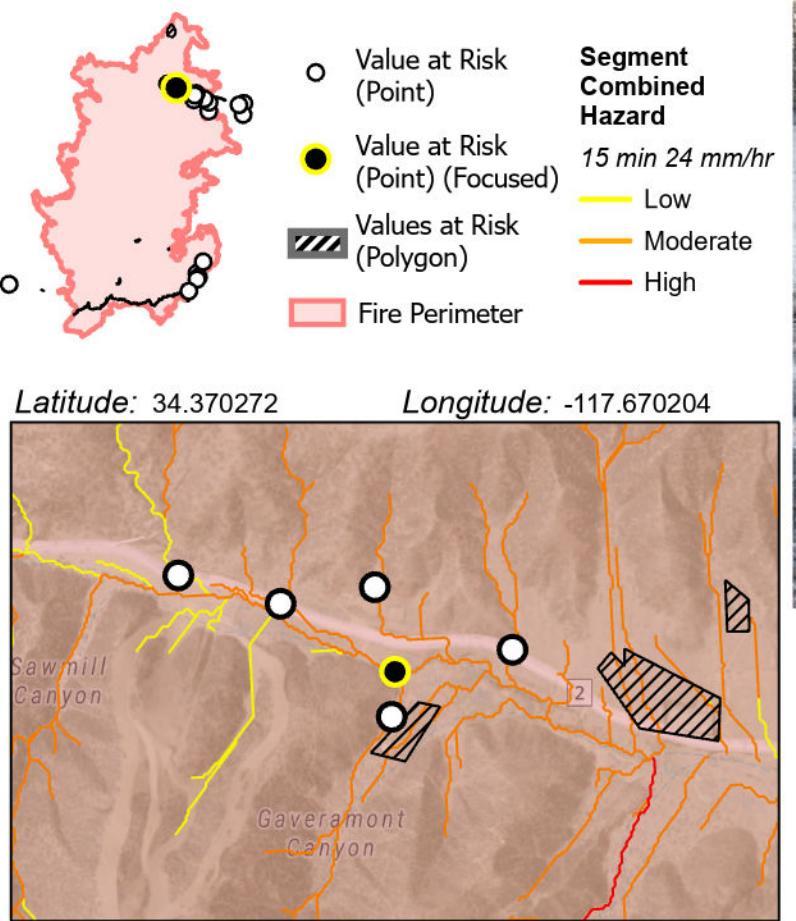
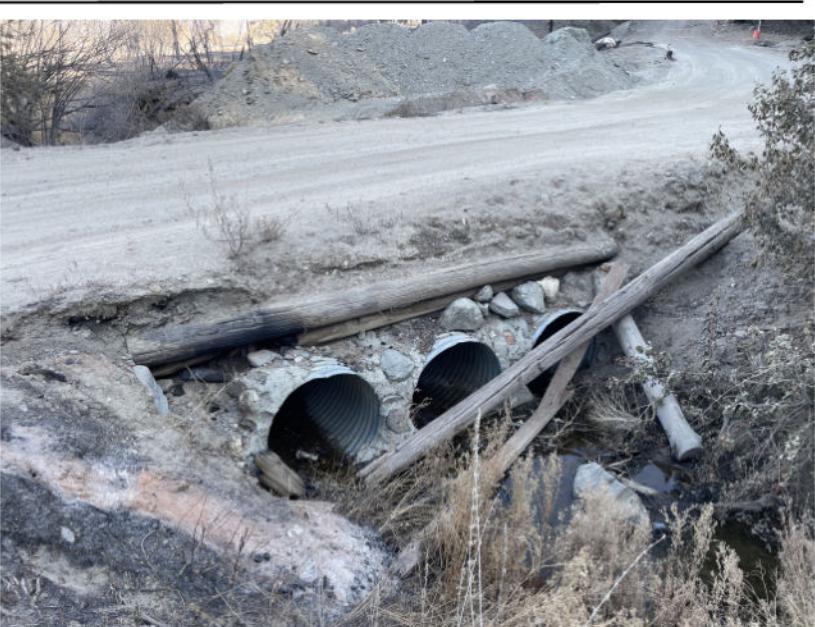
Field Observation or Flood and debris will block crossing, causing overtopping flows and possible washout. Access to structures and Potential Hazard: water tank will be lost in the event of a washout.

Potential Hazard to Property: moderate

Description: Crossing consists of three 36" diameter CMPs and forms a nick point in channel. Channel may head cut through meadow above may occur if crossing is washed out.

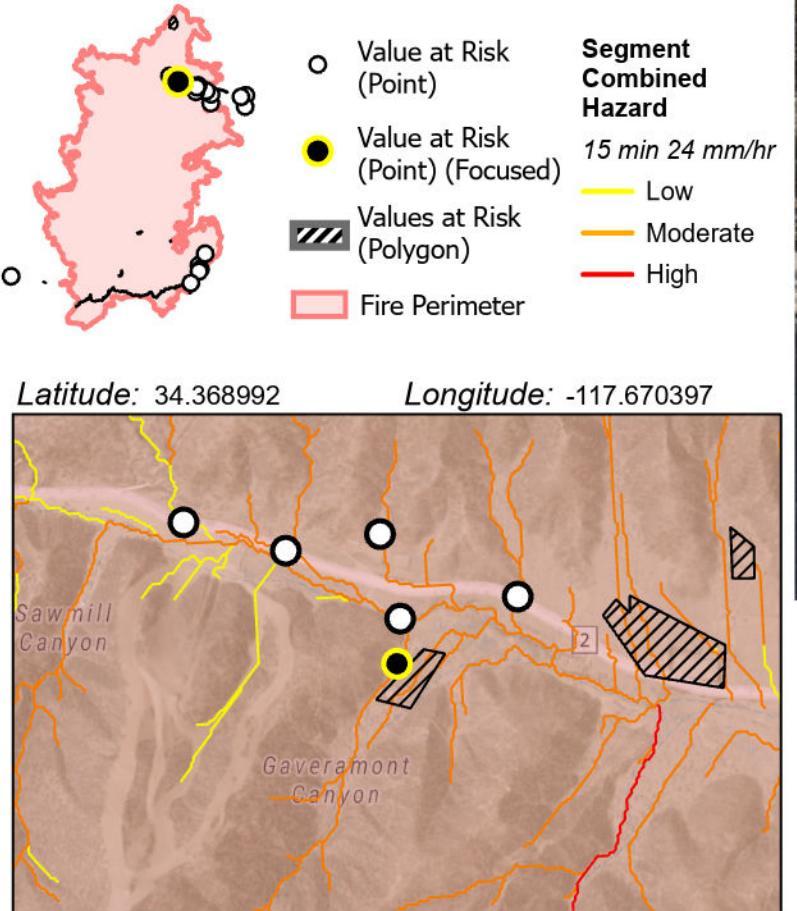
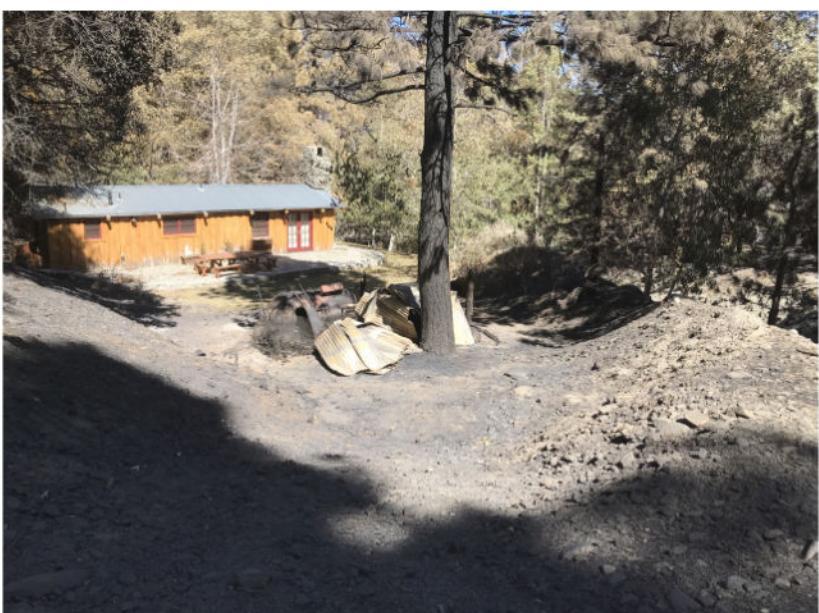
Field Observation or Recreational ranch structure at the edge of alluvial fan. What appears to be the active drainage is directly Potential Hazard: adjacent. A 6' earthen berm was observed between drainage and ranch structure.

Potential hazard is flood that could mobilize burnt debris and impact the commercial structure. Flood/debris flow. Likely occurrence with moderate consequence = high risk

Potential Hazard to Life: low

Potential Hazard to Property: high

Description: Low life hazard because no obvious permanent residents.

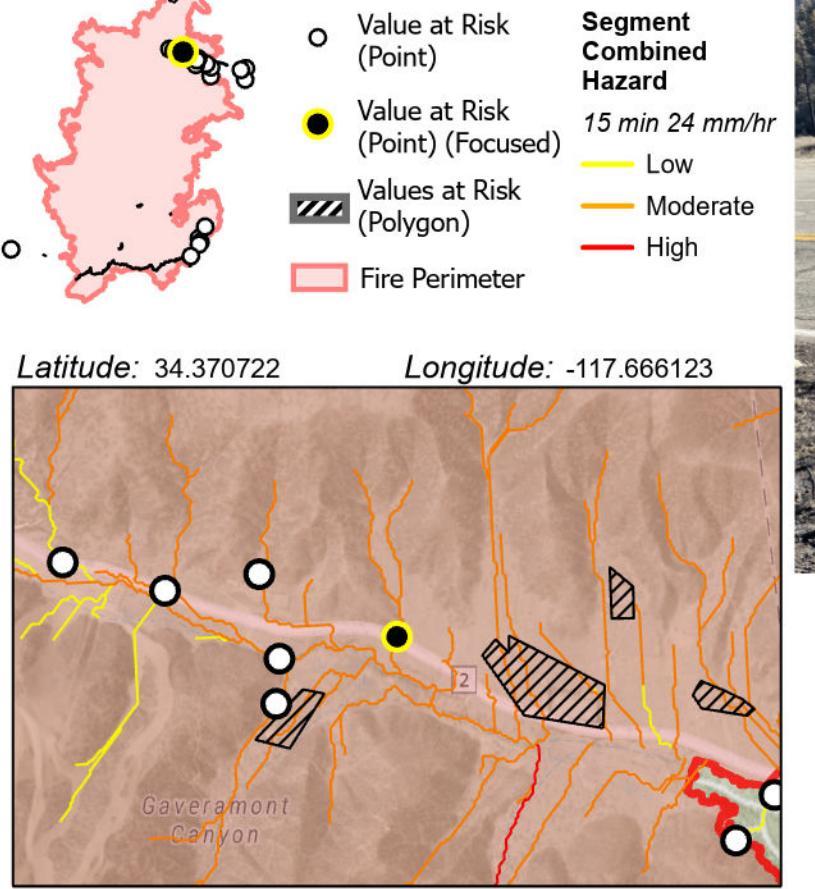
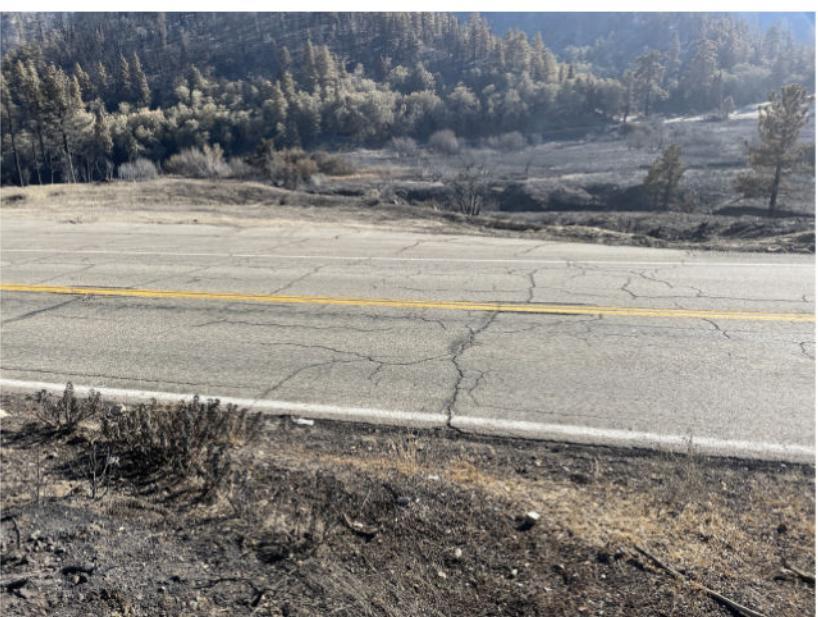
Field Observation or Flows impacting Hwy 2. Drainage from burned slopes enters a ditch along the western edge of alluvial fan and Potential Hazard: discharges directly onto road.

Description: There is an opportunity to improve drainage by directing ditch into adjacent culvert inlet. Culvert inlet is currently blocked and may need to be upsized.

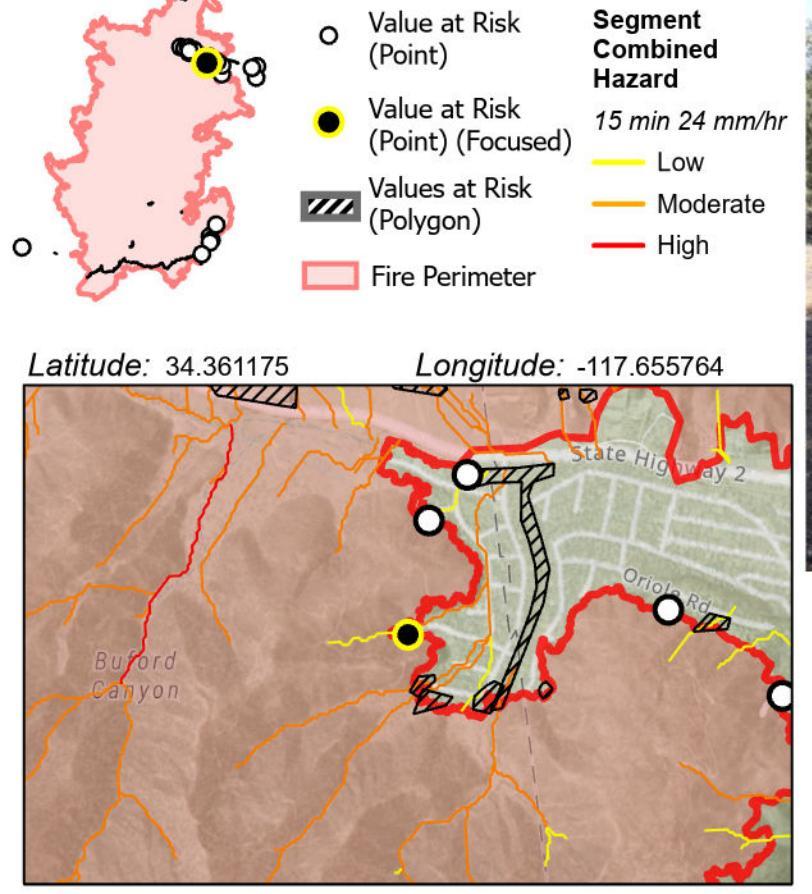
Description: SBS is generally low with moderate along ridgelne. Mostly small rocks, possibility of flood or small hyperconcentrated flow

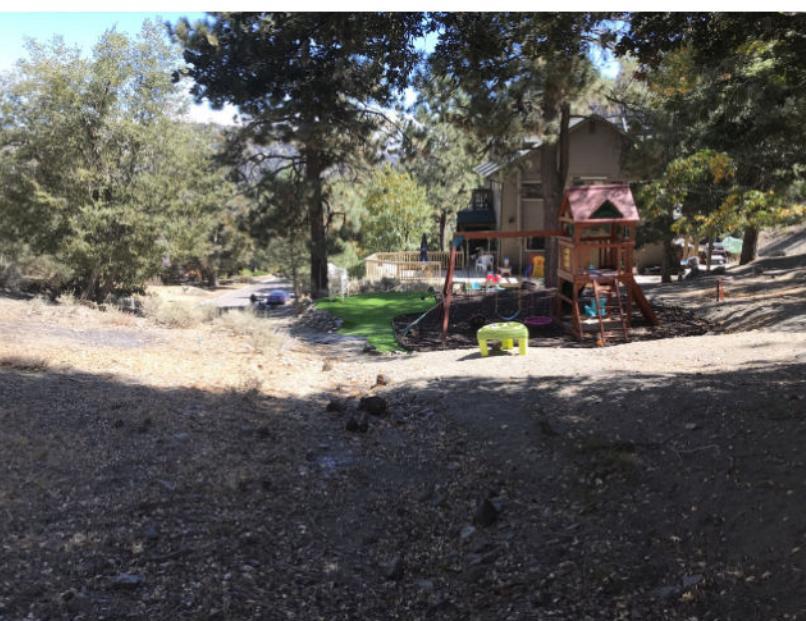
Field Observation or 1 home centered on bottom of steep drainage swale. Potential hazard is flood mobilizing burnt debris and soil Potential Hazard: and impacting structures. Possible probability of occurrence with minor consequences = low risk.

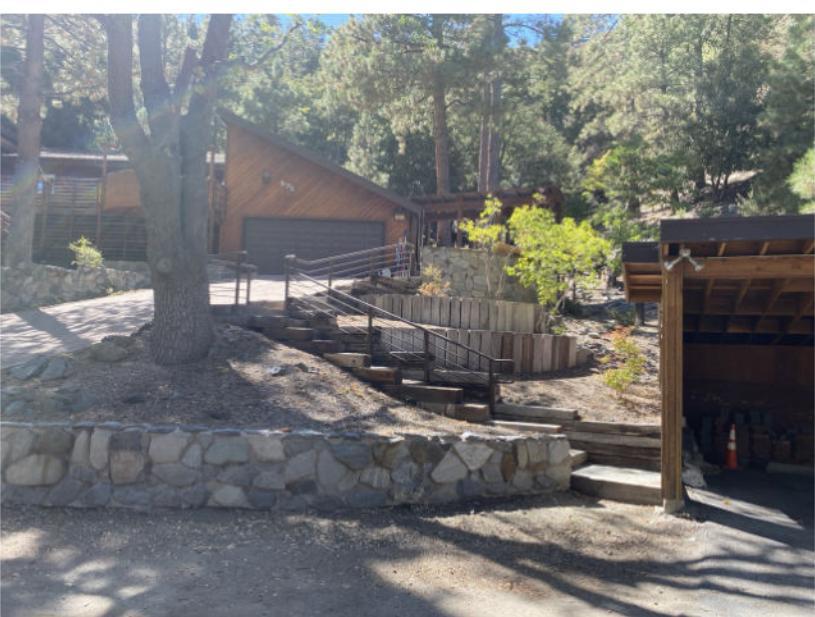
Field Observation or 1 home on margin of flow path. Minimal fan here. Potential hazard is flood mobilizing burnt debris and soil and Potential Hazard: impacting structure. Possible to likely probability of occurrence with minor consequence=low risk.

Description: There is a shallow bowl shaped steep swale above home with hydrophilic vegetation. Above the swale the low severity burn was in thick oak forest with much remaining canopy and the burn may not significantly impact hydrologic characteristics. However if flows in this basin increase, the home may experience more water flow than in the past and be slightly impacted by water and burnt debris. We observed unpinned home north of this home and it appears unlikely to receive flood flow.

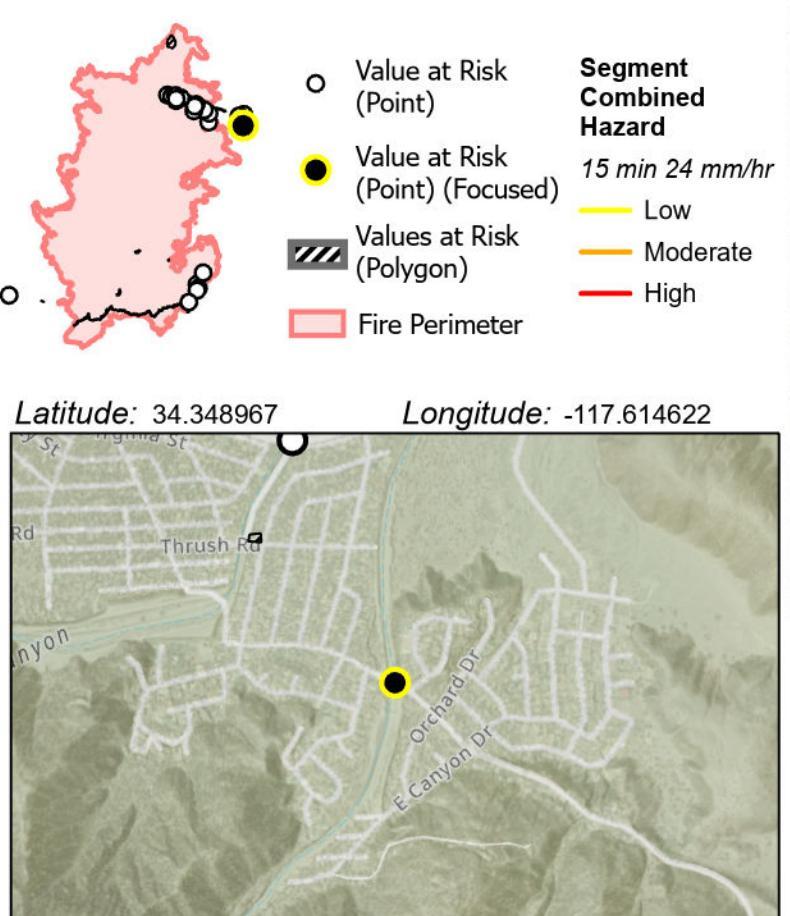
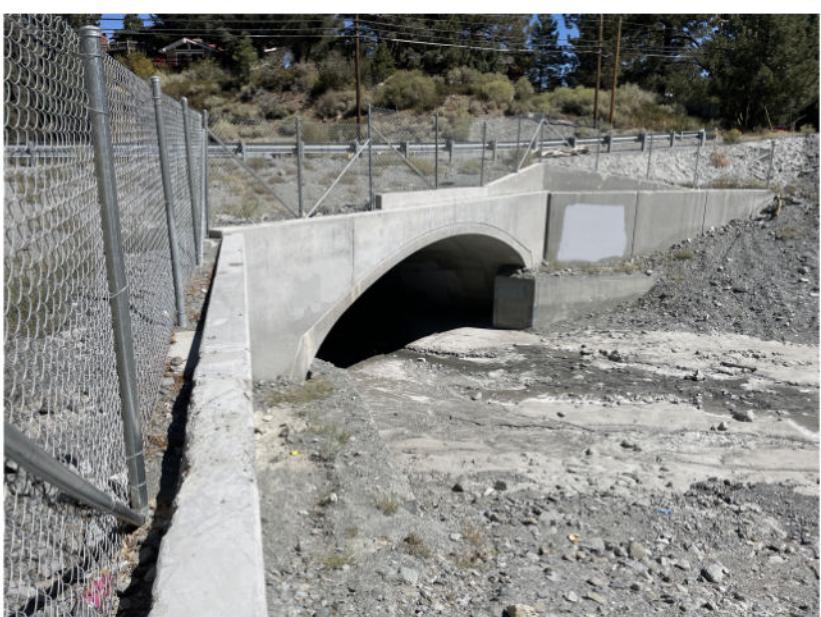
Field Observation or Bridge crossing. Appears adequately sized and should only become an issue under very large flows. If Potential Hazard: plugged, flows will be diverted down the highway. Potential for aggradation at downstream confluence which may impact bridge capacity.

Description: Bridge appears to have experienced overtopping flows in 2023.

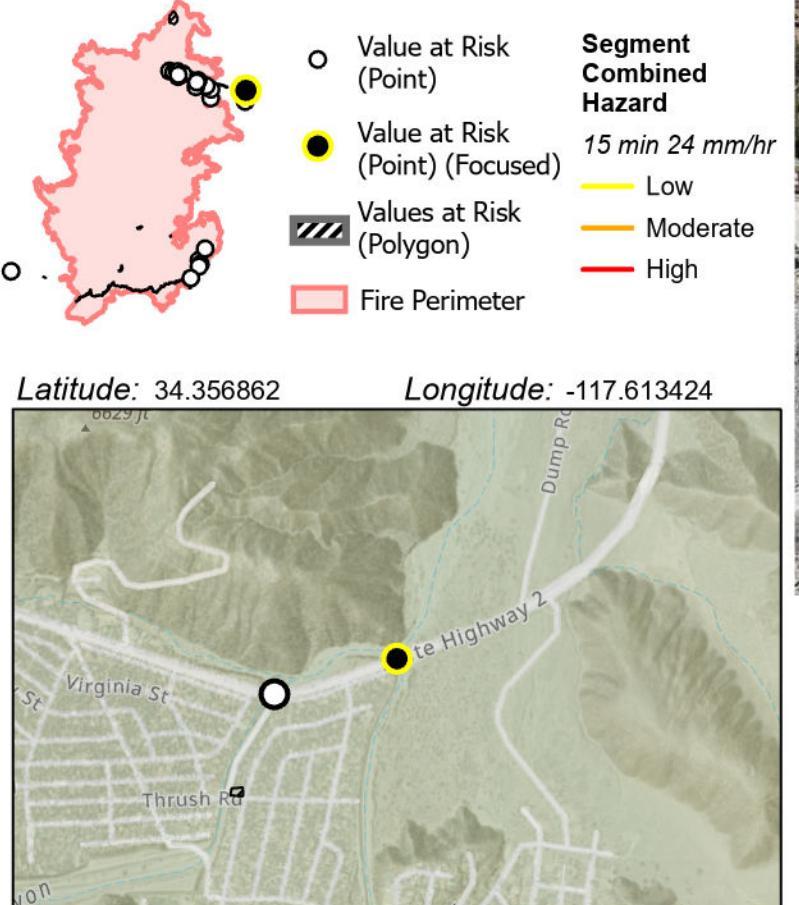
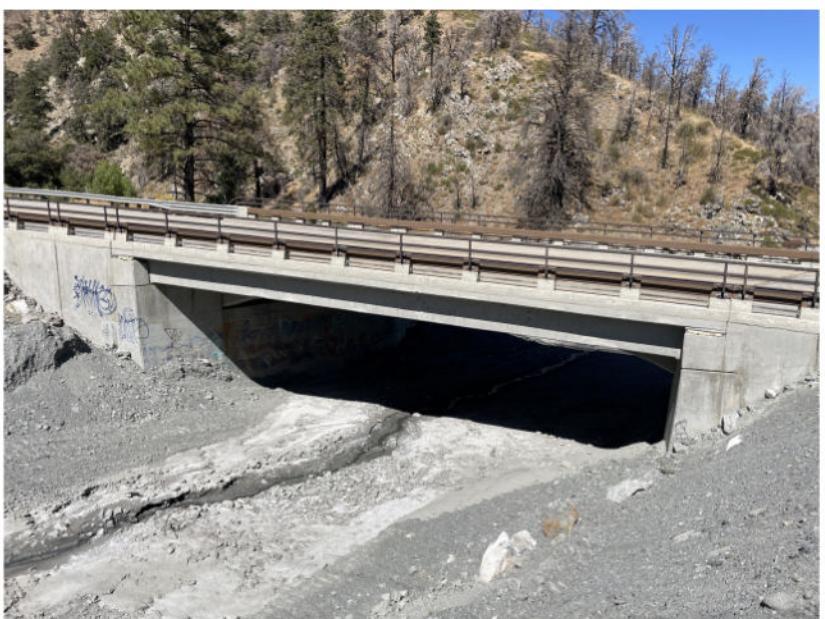
Field Observation or Surface flooding of inmate Camp 19. Flows diverted from San Gabriel River and Upper Monroe Rd could *Potential Hazard:* impact structures and block access to the inmate camp.

Description: Moderate and high flood hazards upstream will generate runoff and debris that can overtop the bridge and direct flows into the inmate camp.

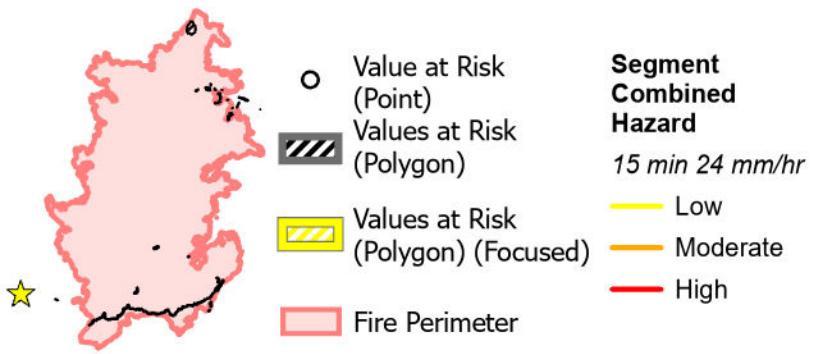
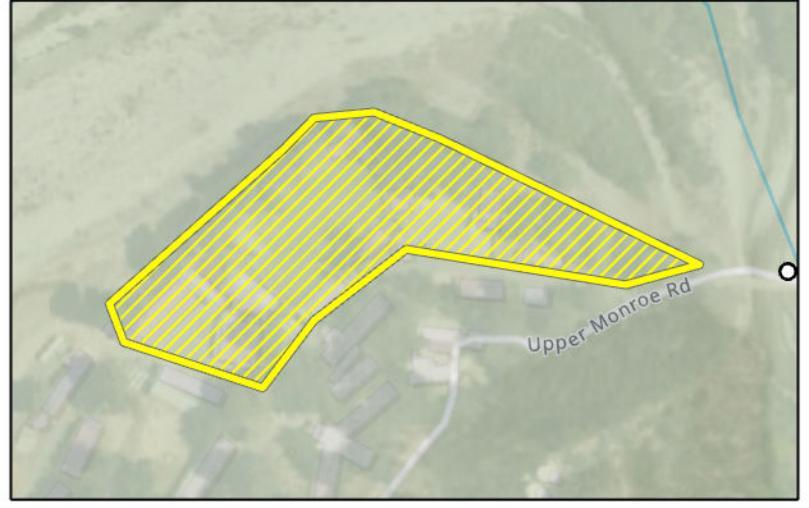
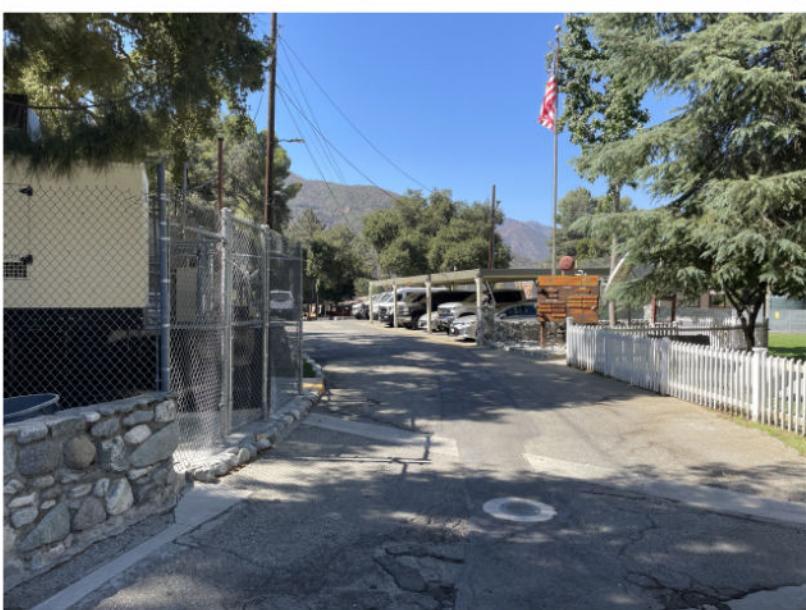
Field Observation or Residential structures along river that are accessed by a bridge. Structures appear to be positioned on terrace Potential Hazard: above river. Risk of debris and flood flow may impact bridge and cutoff access. An extreme event may impact structures. Evaluated remotely

Description: Access may be lost during flooding. Behind locked gate, evaluated remotely.

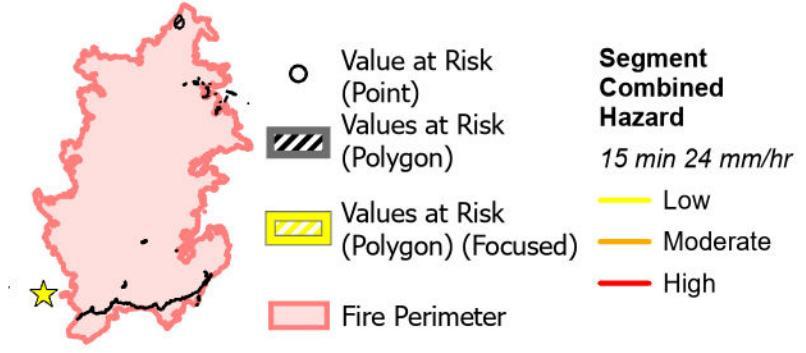
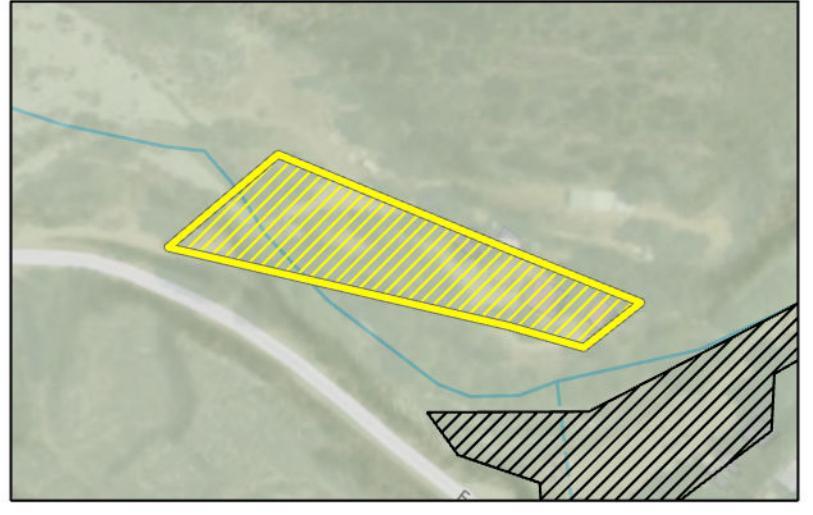
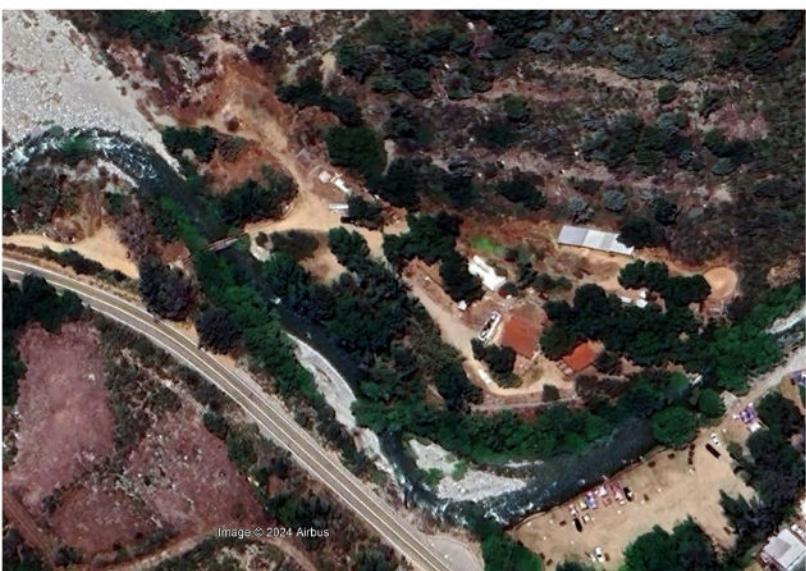
Field Observation or Campground, cabin, and restroom structure on river terrace. Potential hazard is flood mobilizing burnt debris Potential Hazard: and soil and impacting structures or campers.

Description: Area has a restroom on grade, raised grade cabin, shed, and ~20 campsites.

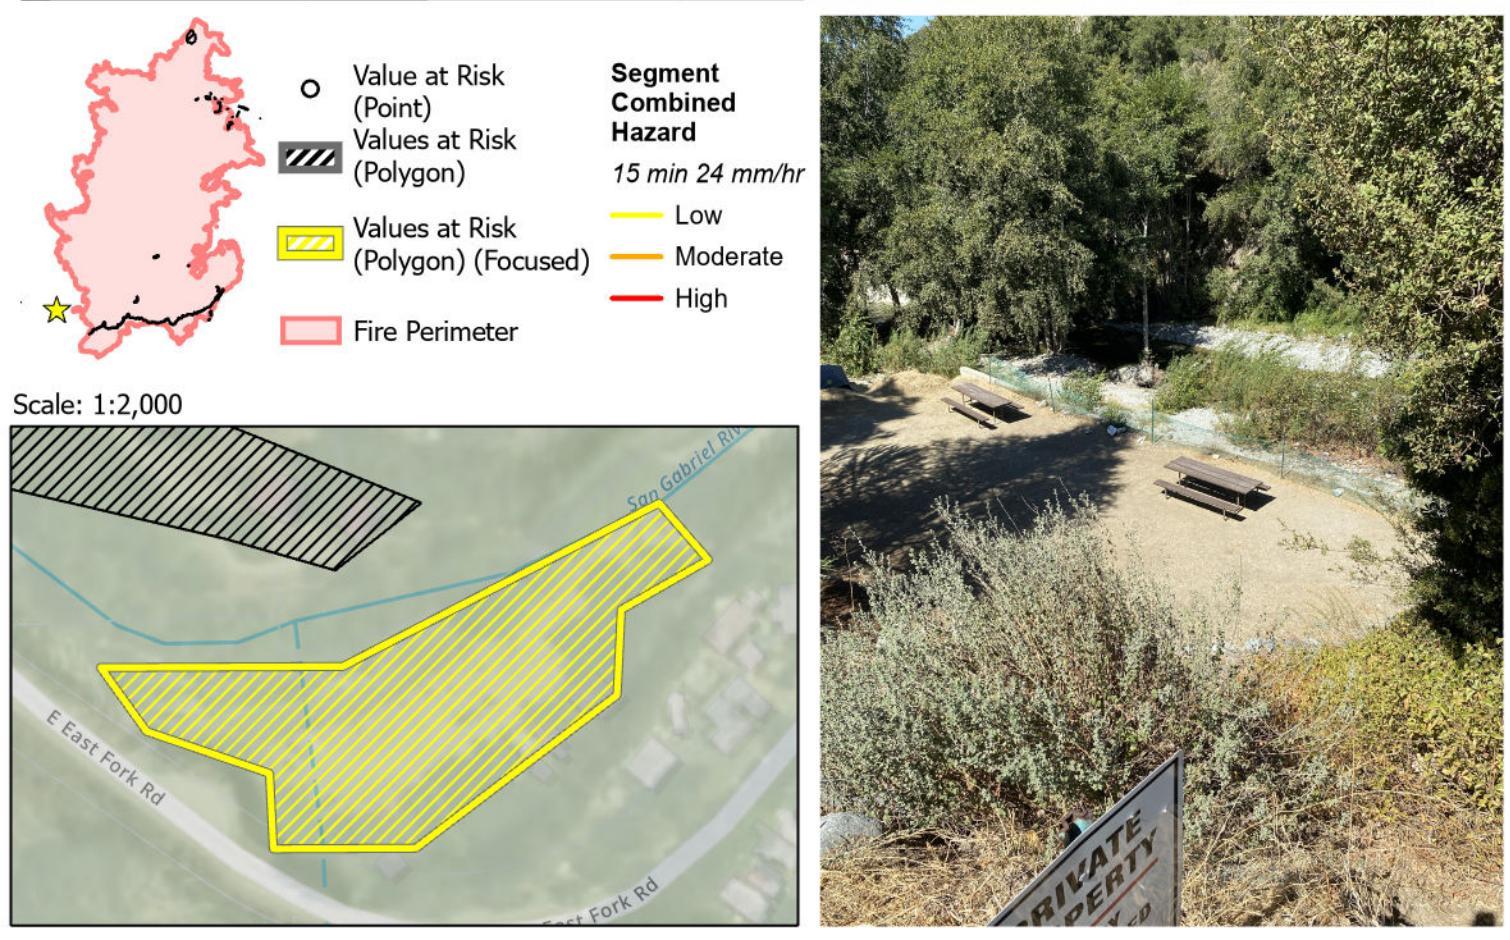
Field Observation or Potential flood and debris flow hazards that may impact structures. Access to structures will be cut off due to Potential Hazard: flooding, rockfall, and debris flows.

Description: Emergency access will likely be cut off due to damaged roads during and after storm events.

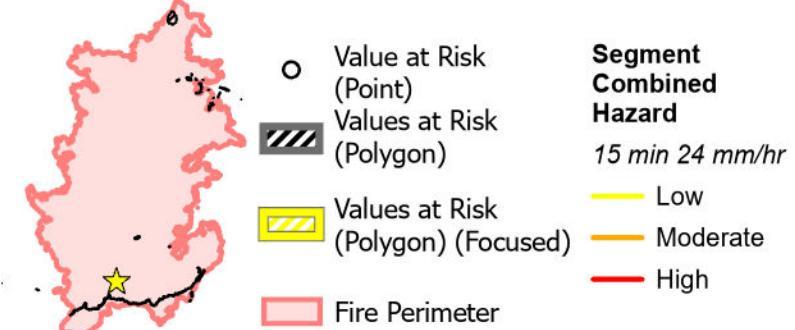
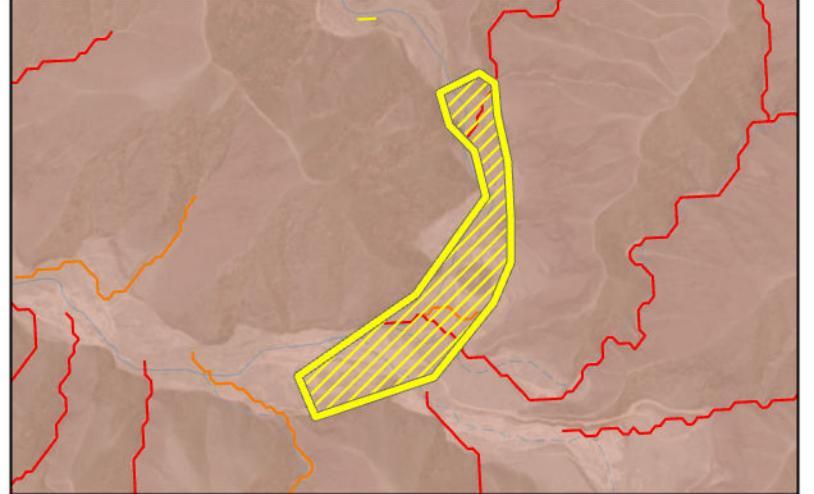
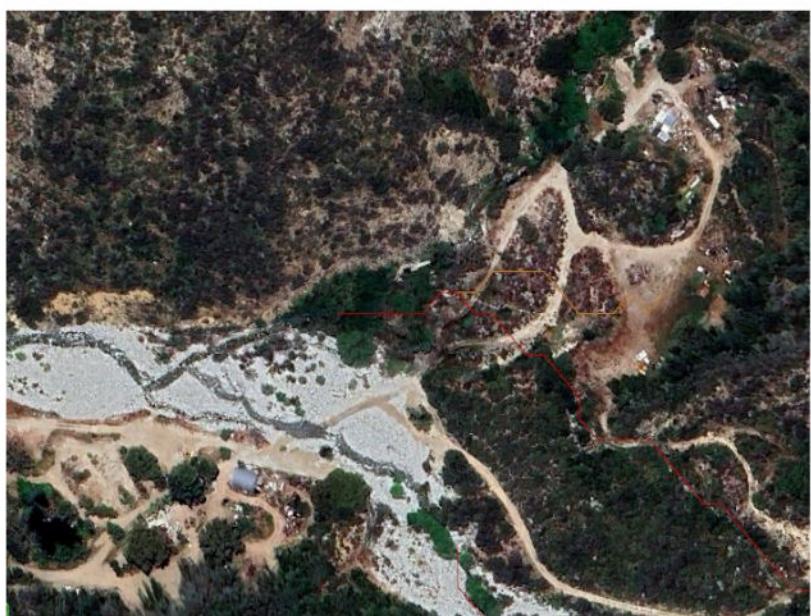
Field Observation or Flood and debris flows may impact structures. Access will likely be cutoff. Reviewed remotely. *Potential Hazard:*

Description: Evaluated remotely due to locked gates.
