Watershed Emergency Response Team (WERT) 2024 Bridge Fire

CA-ANF-243334 October 24, 2024

REPORT TITLE: Watershed Emergency Response Team (WERT) Evaluation – 2024 Bridge Fire

Bridge Fire – WERT REPORT EXECUTIVE SUMMARY

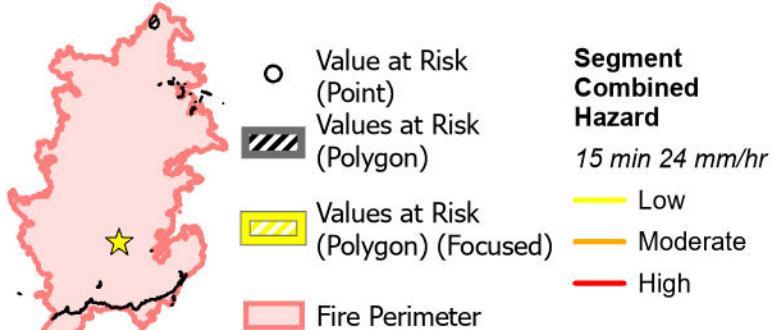
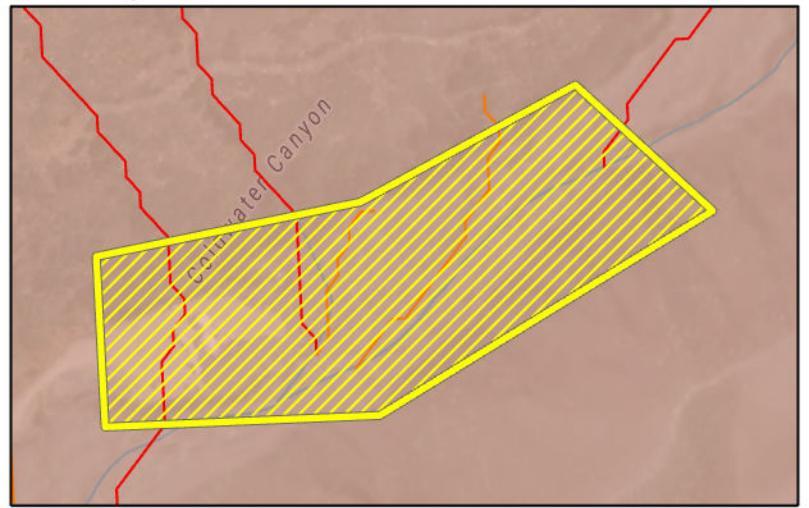
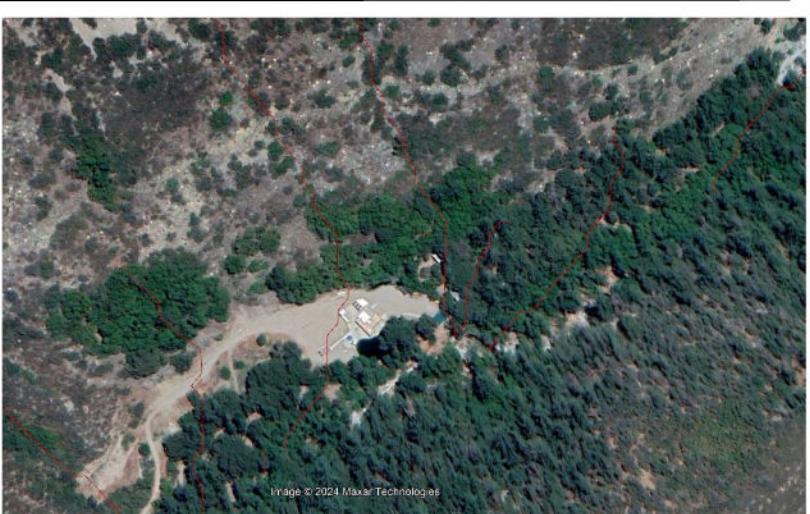
Field Observation or Potential flood and debris flow hazards that can impact remote mining area. Due to remote location and Potential Hazard: inaccessibility, evaluated site remotely.

Description: Had to evaluate this site remotely due to access limitations. Site is adjacent to active channel and backs against steep slopes that show evidence of slope instability and debris flow activity.

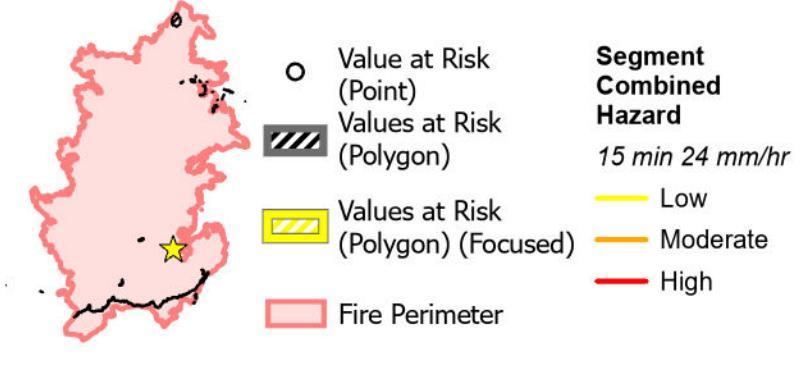
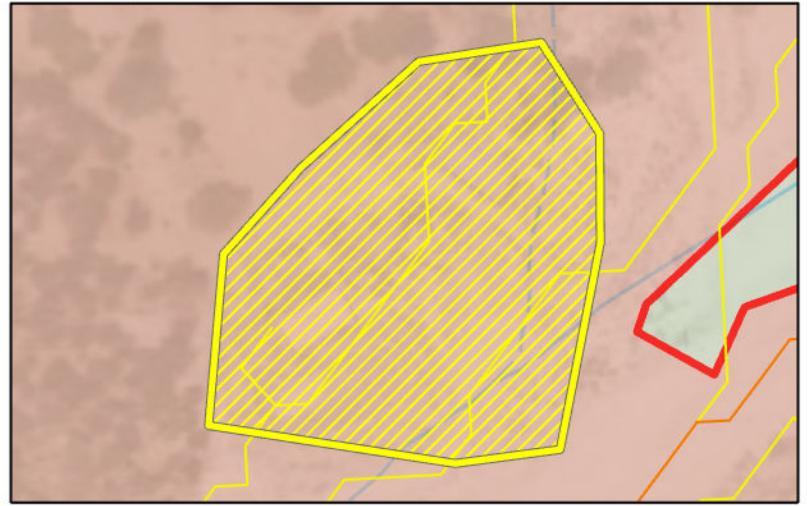
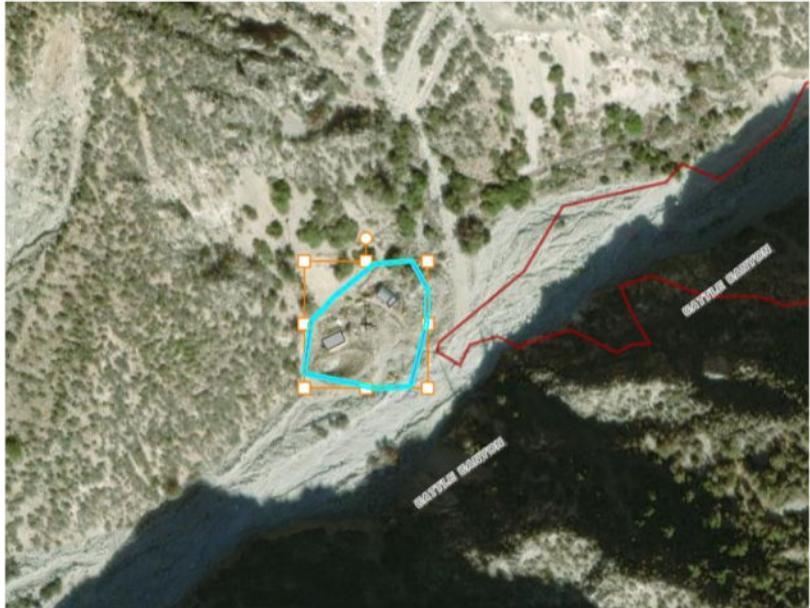
Field Observation or Debris flow, rockfall, flood flow damage to Glendora Ridge Road that can limit access. *Potential Hazard:*

Description: Access along Glendora Ridge road will likely be cut off and reduce emergency services to Mount Baldy.

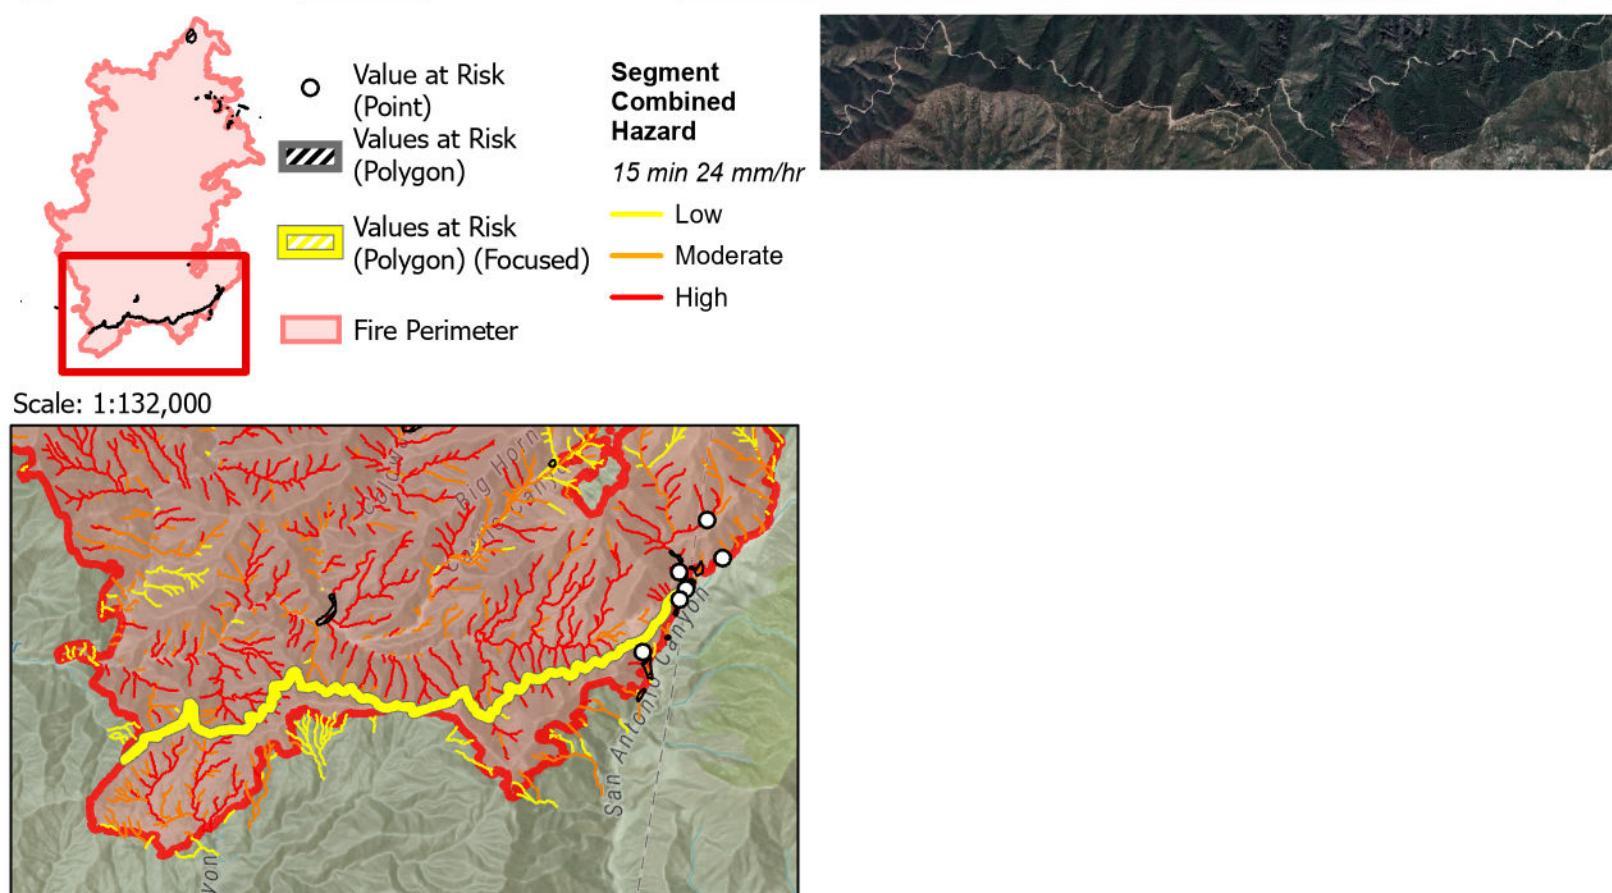
Field Observation or Debris flood/flow that may overtop banks and impact improvements associated with a boy scout camp. *Potential Hazard:* Assessed remotely due to locked gates.

Description: Threat to life only exists if the camp is occupied. Most of the camping area appears to be out of direct flow paths. Access may be cut off along Panorama Mtwy.

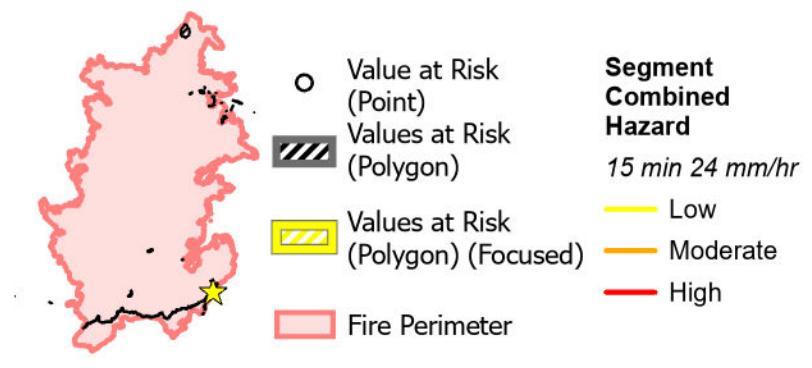
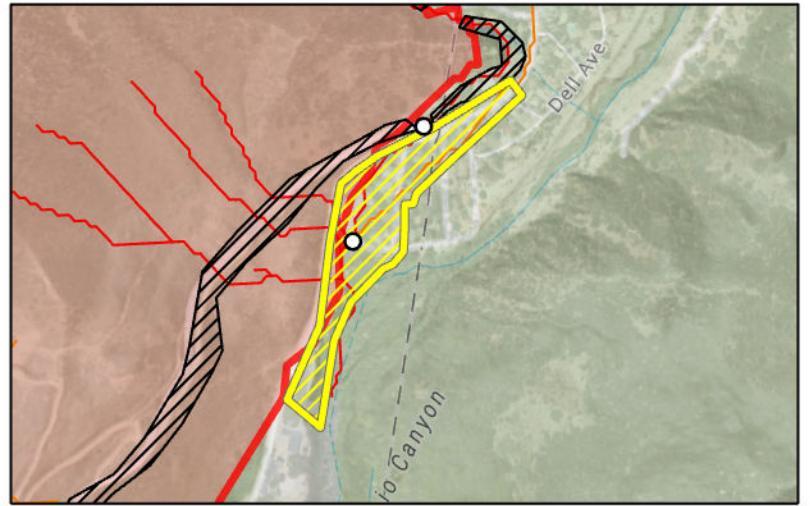
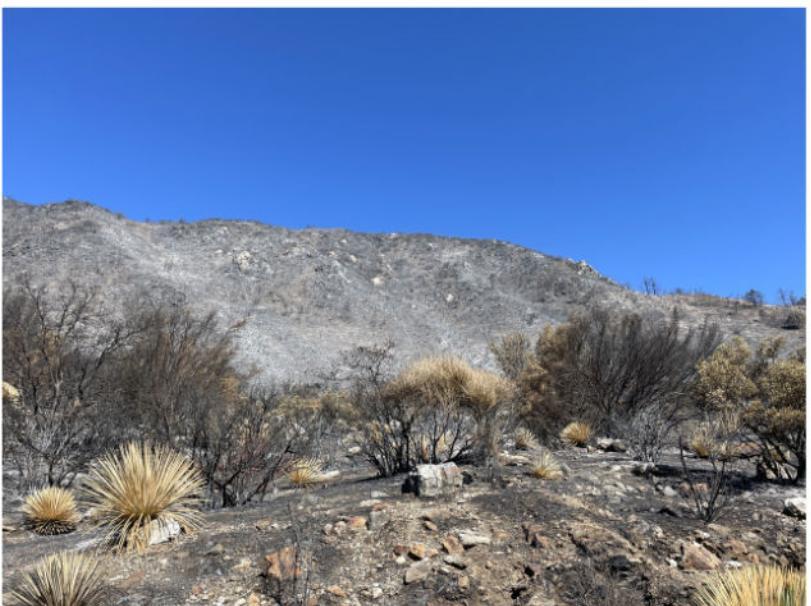
Description: Observed colluvial rock/boulders are generally sub-rounded and angular.

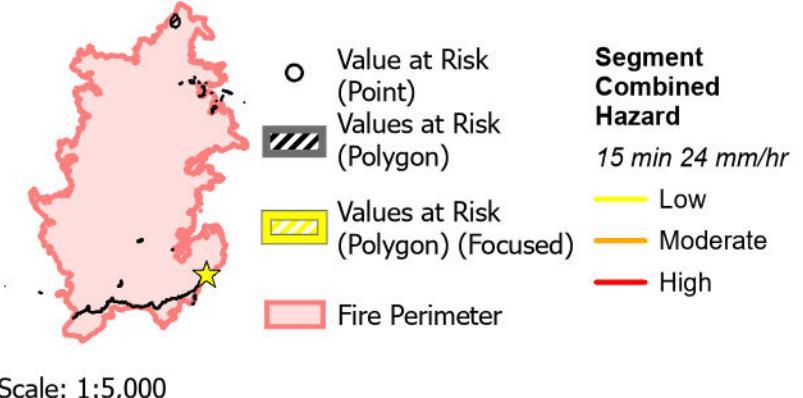
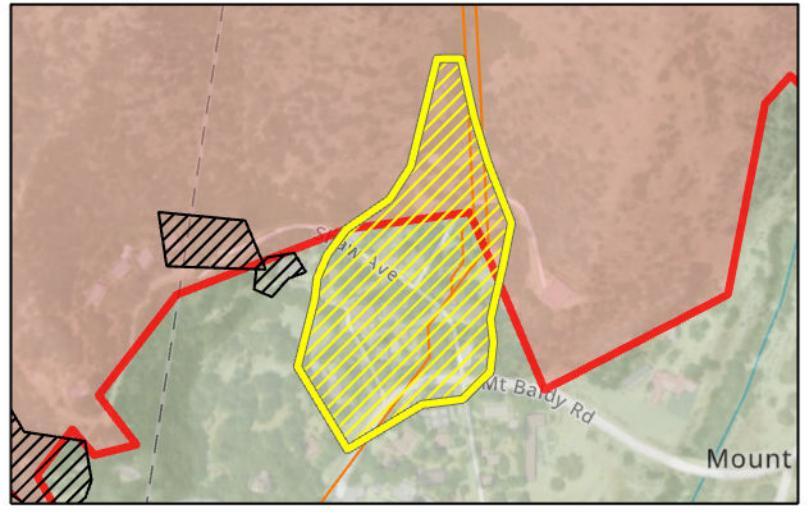
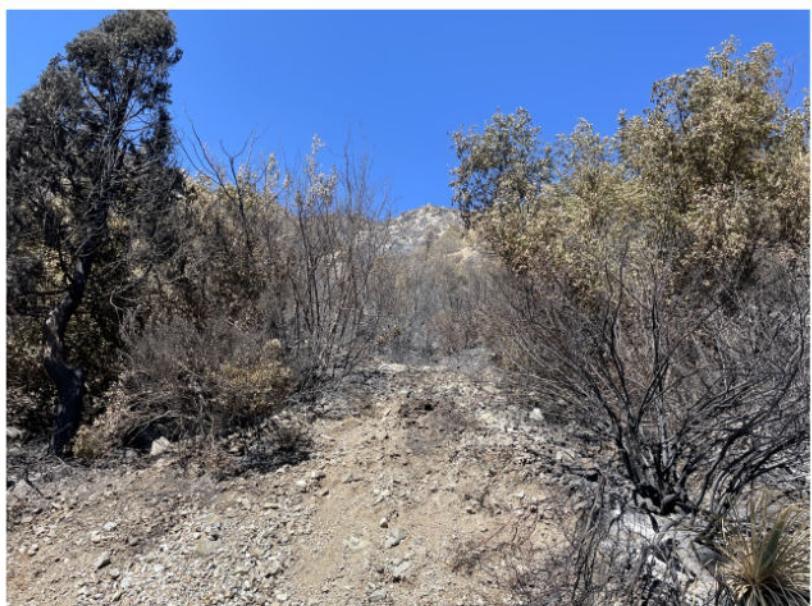
Description: Steep headwall burned at moderate plus with fan deposit above road.

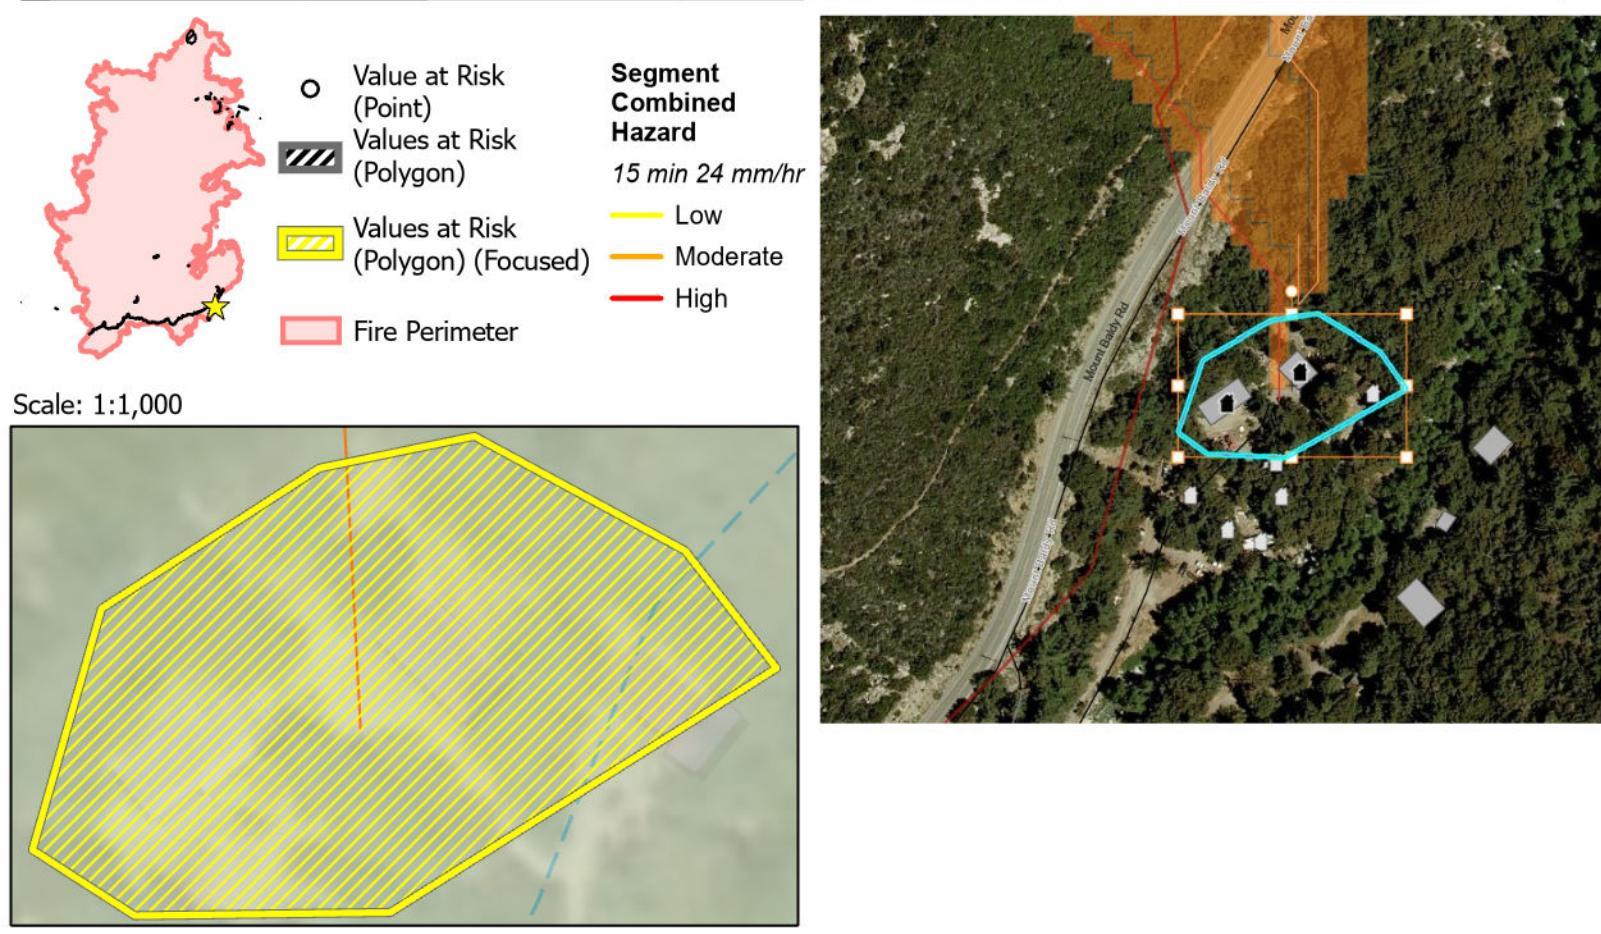
Field Observation or Utility structures on fan below burned drainage. Potential hazard is flood that could mobilize burnt debris and Potential Hazard: impact structures/infrastructure

Potential Hazard to Property: moderate

Description: Utilities located below mouth on fan. Much of 250-acre catchment is moderate or high sbs.

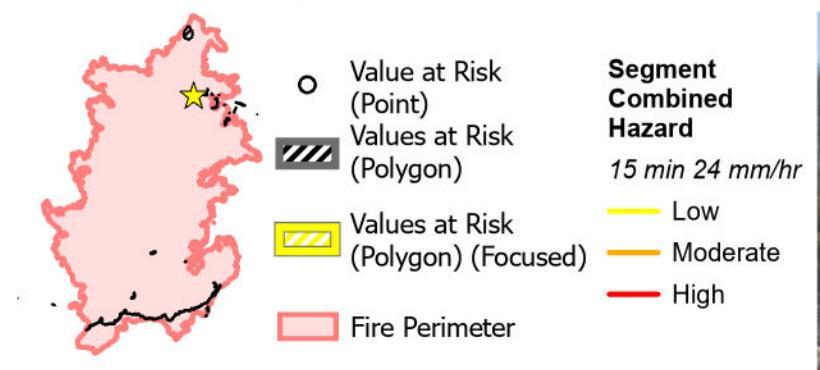
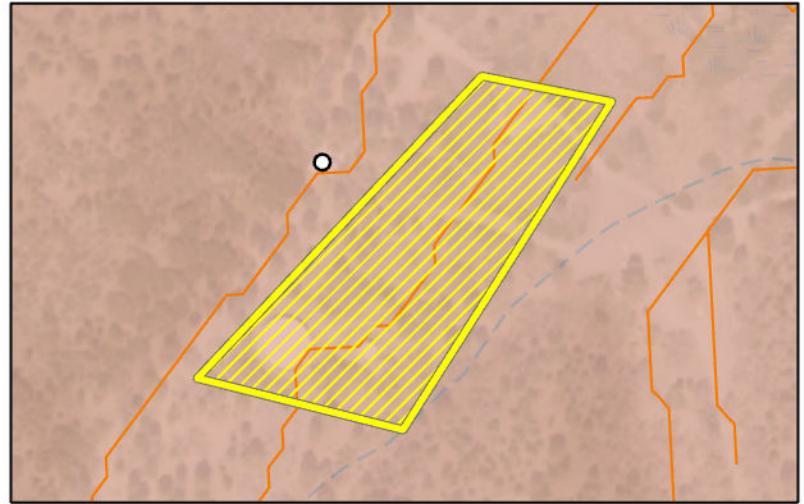
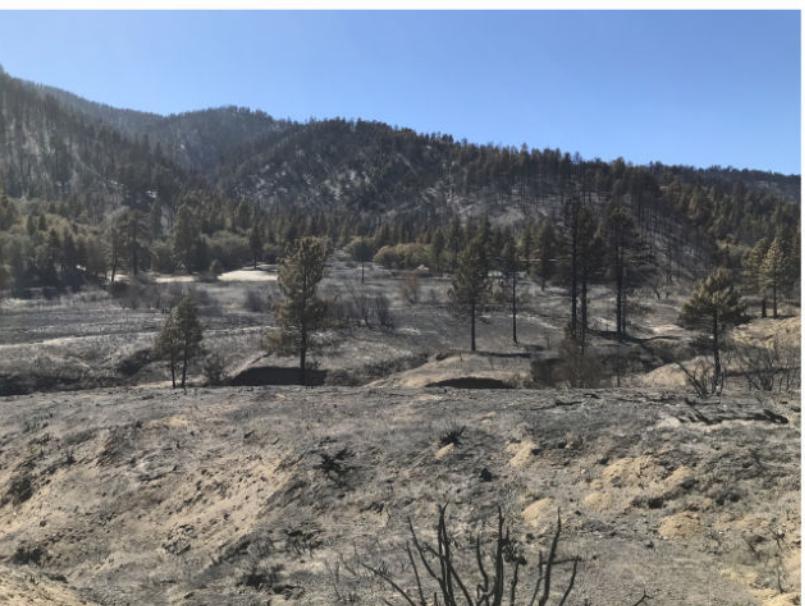
Field Observation or Several houses and LA Sheriff training facility on fan. Two structures appear burned. Numerous flow paths *Potential Hazard:* make it difficult to determine where flow concentrates. Potential hazard is flood that could mobilize fine sediment/debris and impact structures.

Potential Hazard to Life: moderate

Potential Hazard to Property: moderate

Description: Observed berm in channel appears to stop drainage upslope of houses with no diversion. Most of 90-acre drainage is burned at moderate and high sbs.

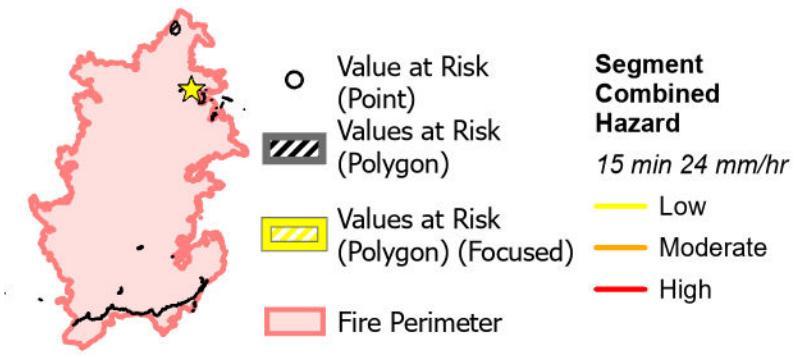
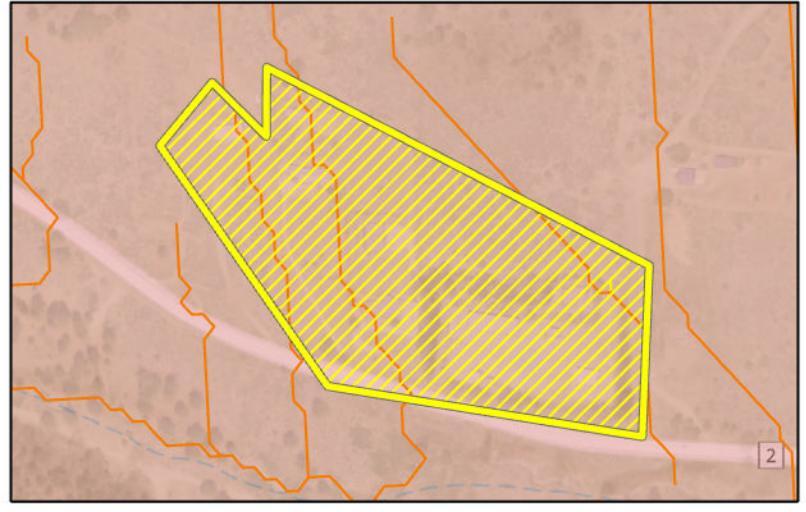
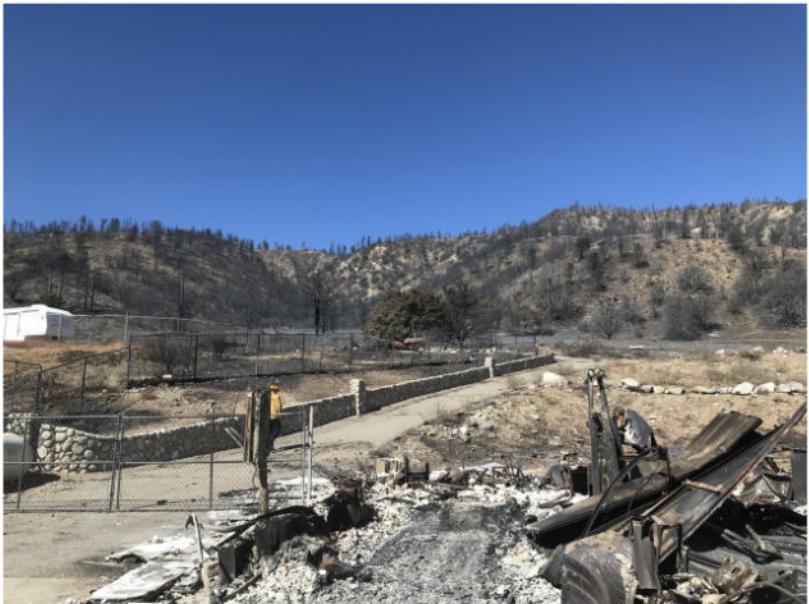
Field Observation or House at apex of fan. Drainage has been diverted to west of house. Potential hazard is flood that could mobilize Potential Hazard; fine sediment/rocks and impact structure.

Potential Hazard to Property: moderate

Description: Homeowner was aware of flood potential. He asked that I not photograph structure or property. Most of 35-acre catchment is burned at moderate and high sbs.

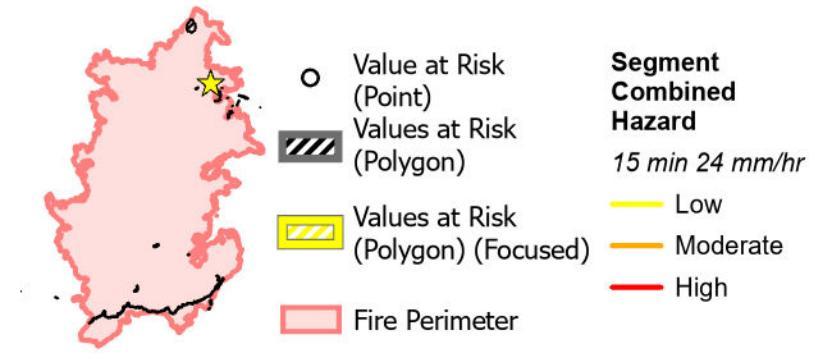
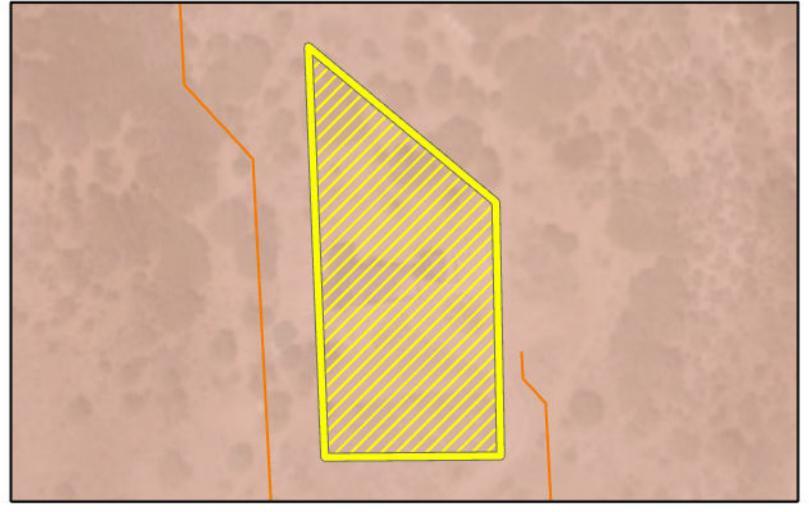
Field Observation or 3 homes within fan with evidence of debris flows. Potential hazard is flood mobilizing burnt debris, soil, and rock Potential Hazard: and impacting structures.

Potential Hazard to Life: moderate

Potential Hazard to Property: moderate

Description: Debris flow and debris flood hazard to homes on fans. Western basin has more drainage area and rockier fan deposit with debris flow evidence. Eastern basin has less drainage area and more planar fan deposit without channel on fan. Westernmost home has several foot tall berm above it. Overlying slopes exhibit debris slide slope and landslide characteristics. Protective berms are a feasible here with available room and access

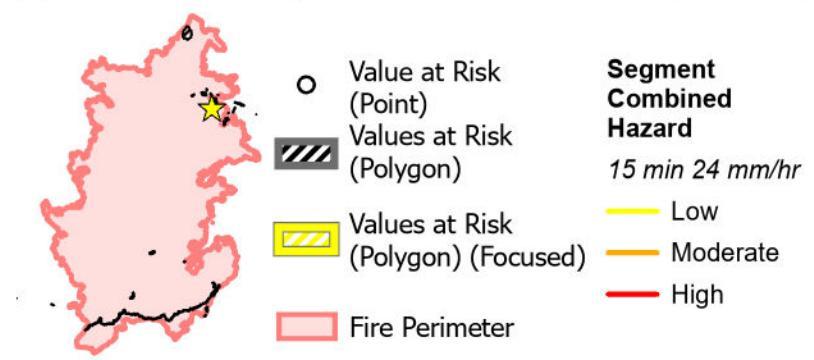
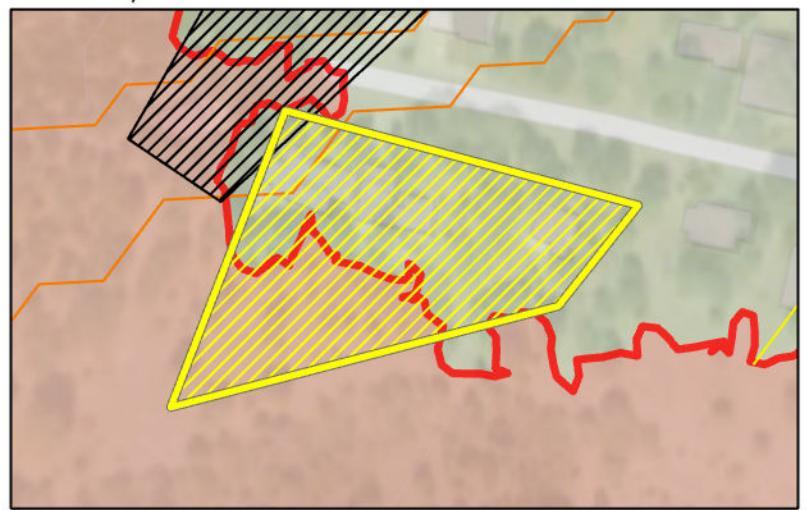
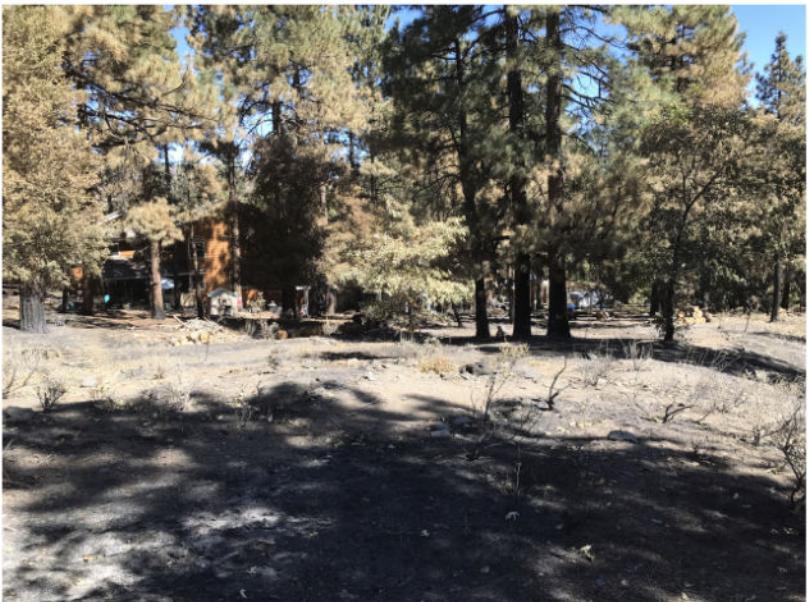
Field Observation or Houses located on low terrace at outlet of fan. Drainage channel appears to ramp onto terrace. Potential hazard Potential Hazard: is debris flow/flood that could mobilize burnt debris and impact structures.

Potential Hazard to Life: high

Potential Hazard to Property: high

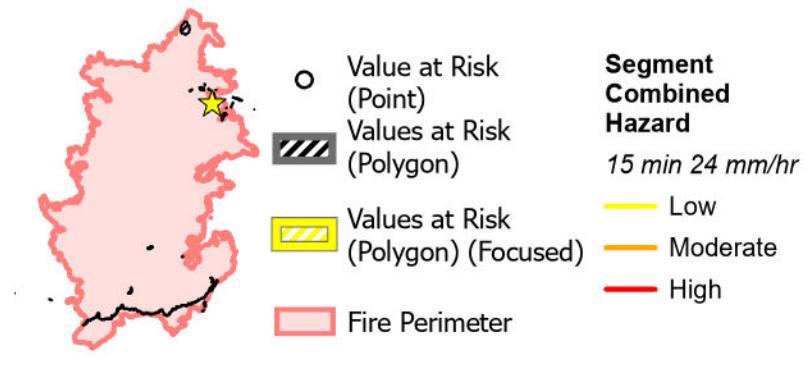
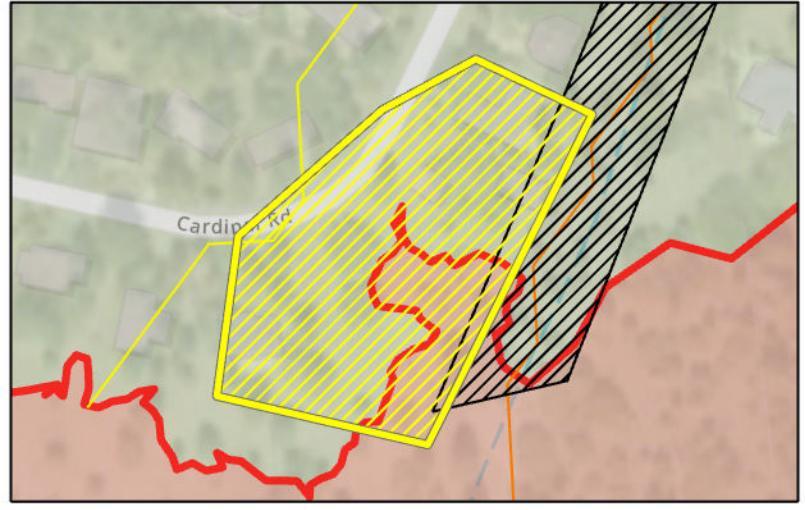
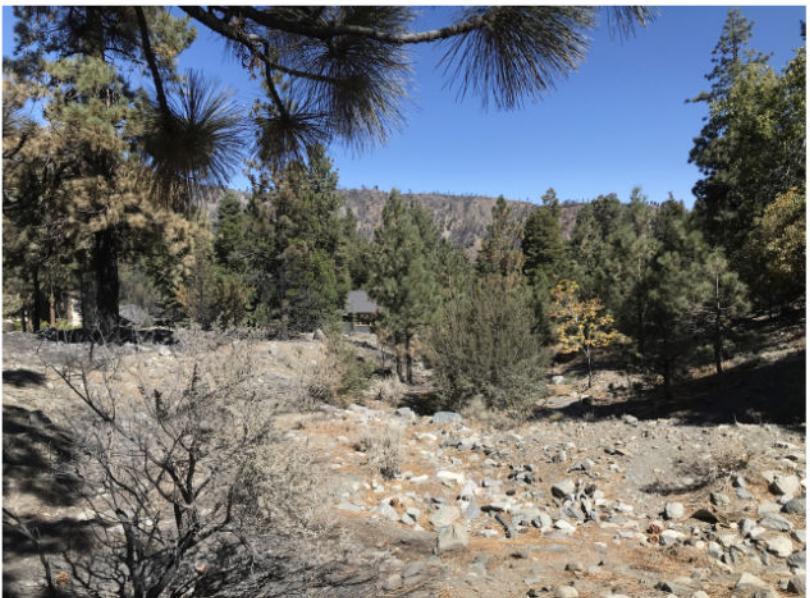
Field Observation or Debris Flow/Flood mobilizing sediment and debris that may cause localized debris jams that can force flows *Potential Hazard:* over channel banks.

Potential Hazard to Life: moderate

Potential Hazard to Property: moderate

Description: This hazard will be analyzed in more detail after performing hydrologic and hydraulic modeling.

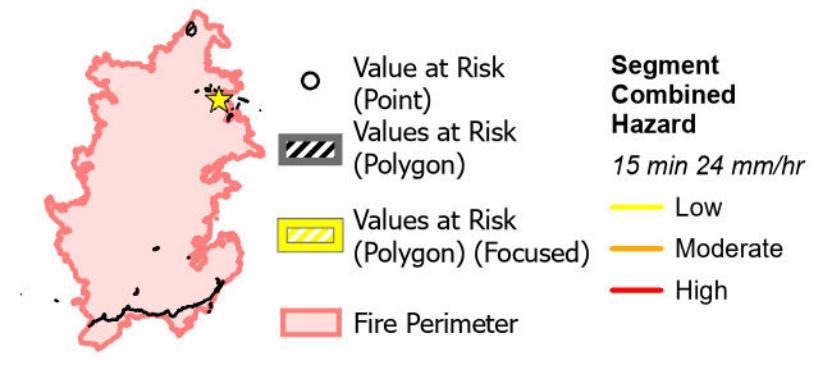
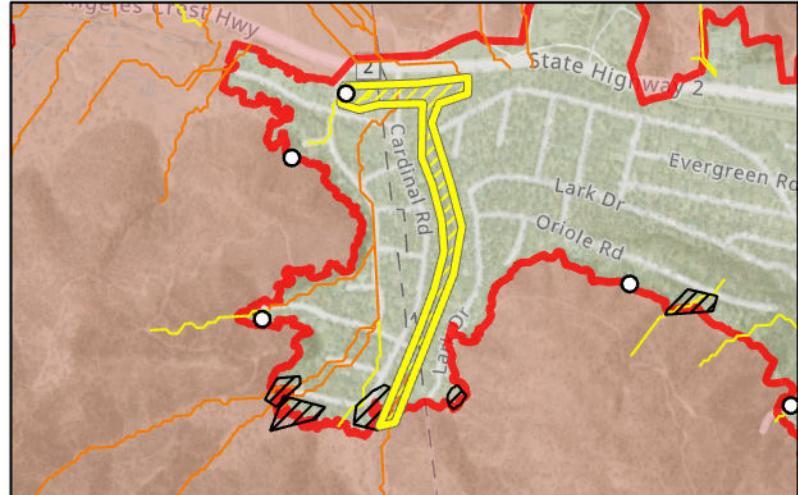
Field Observation or 2 homes within fan. Potential hazard is flood mobilizing burnt debris and soil and impacting structures. *Potential Hazard:*

Description: Overlying slopes exhibit old debris slide slope characteristics. Minimal evidence of geologically recent debris flow deposits near homes. Low overlying burn severity, however high mortality of white fir likely. Boulders several feet wide are deposited in overlying gullies

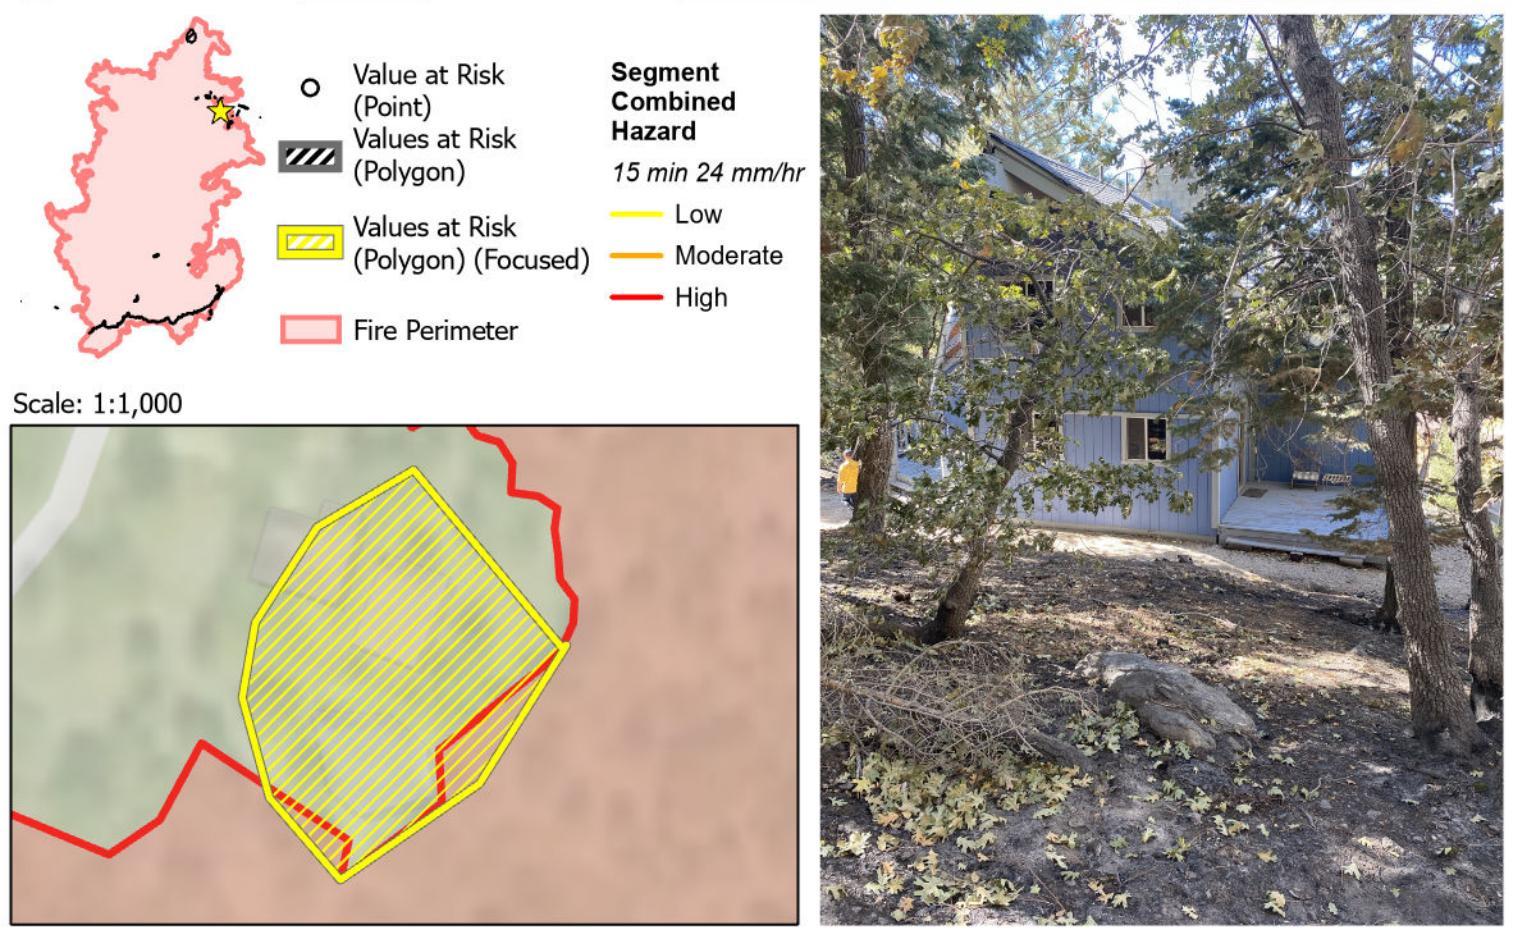
Field Observation or Houses within mouth of burned drainages. Earthern berm along upslope house directs flow to lower house. Potential Hazard: Potential hazard is flood that could mobilize fine sediment/small rocks and impact structures.

Description: Earthen berm is approximately 3' high. Generally low sbs within the 15-acre catchment above.

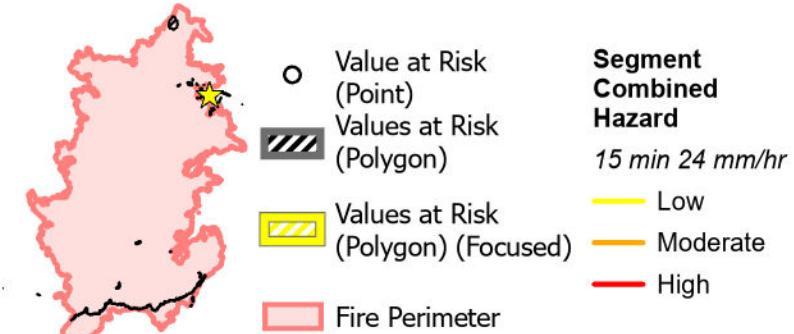
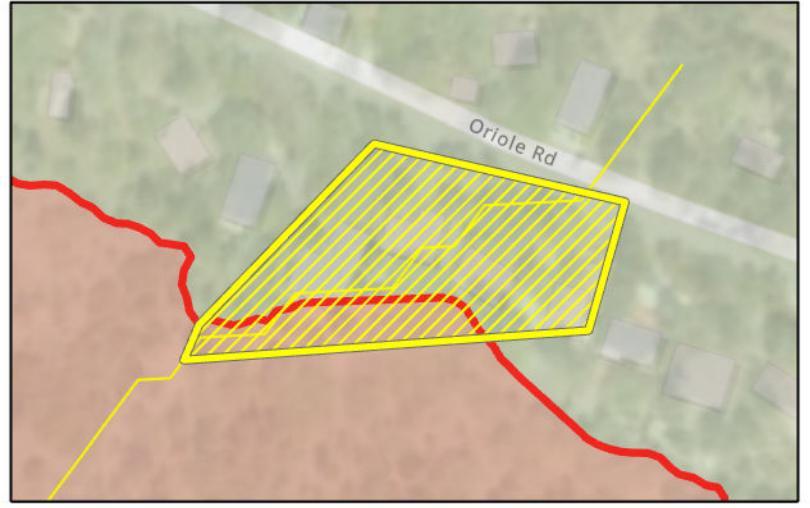
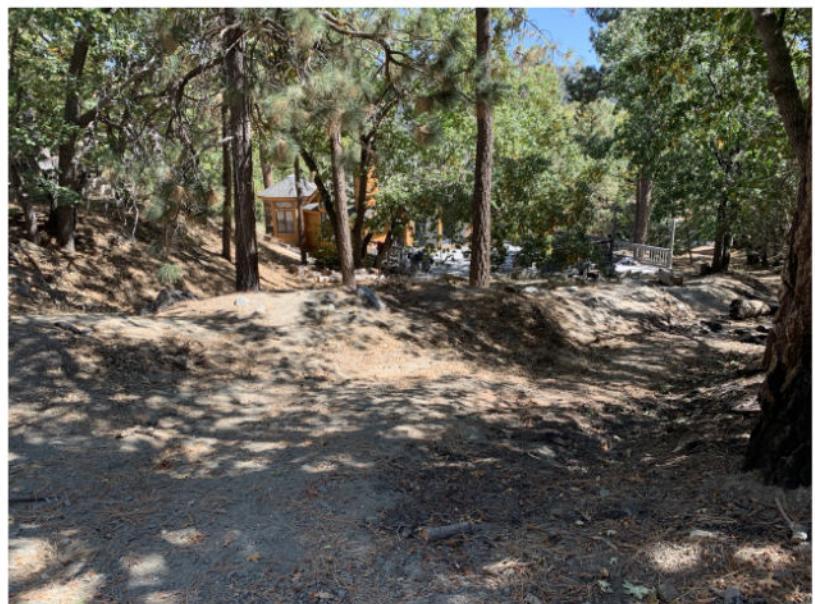
Field Observation or 1 home and 1 garage within fan. Potential hazard is flood mobilizing burnt debris and soil and impacting Potential Hazard: structures.

Potential Hazard to Property: moderate

Description: Fan exhibits minimal evidence of past debris flow, consisting of only one older matrix supported debris deposit above old oak. These structures are at moderate risk rather than low due to moderate severity burn. Channel at fan apex does not clearly continue to home and has been filled in during grading. Drainage alignment continues to house in below bar polygon and the next two homes below included in other adjacent low/low VAR.

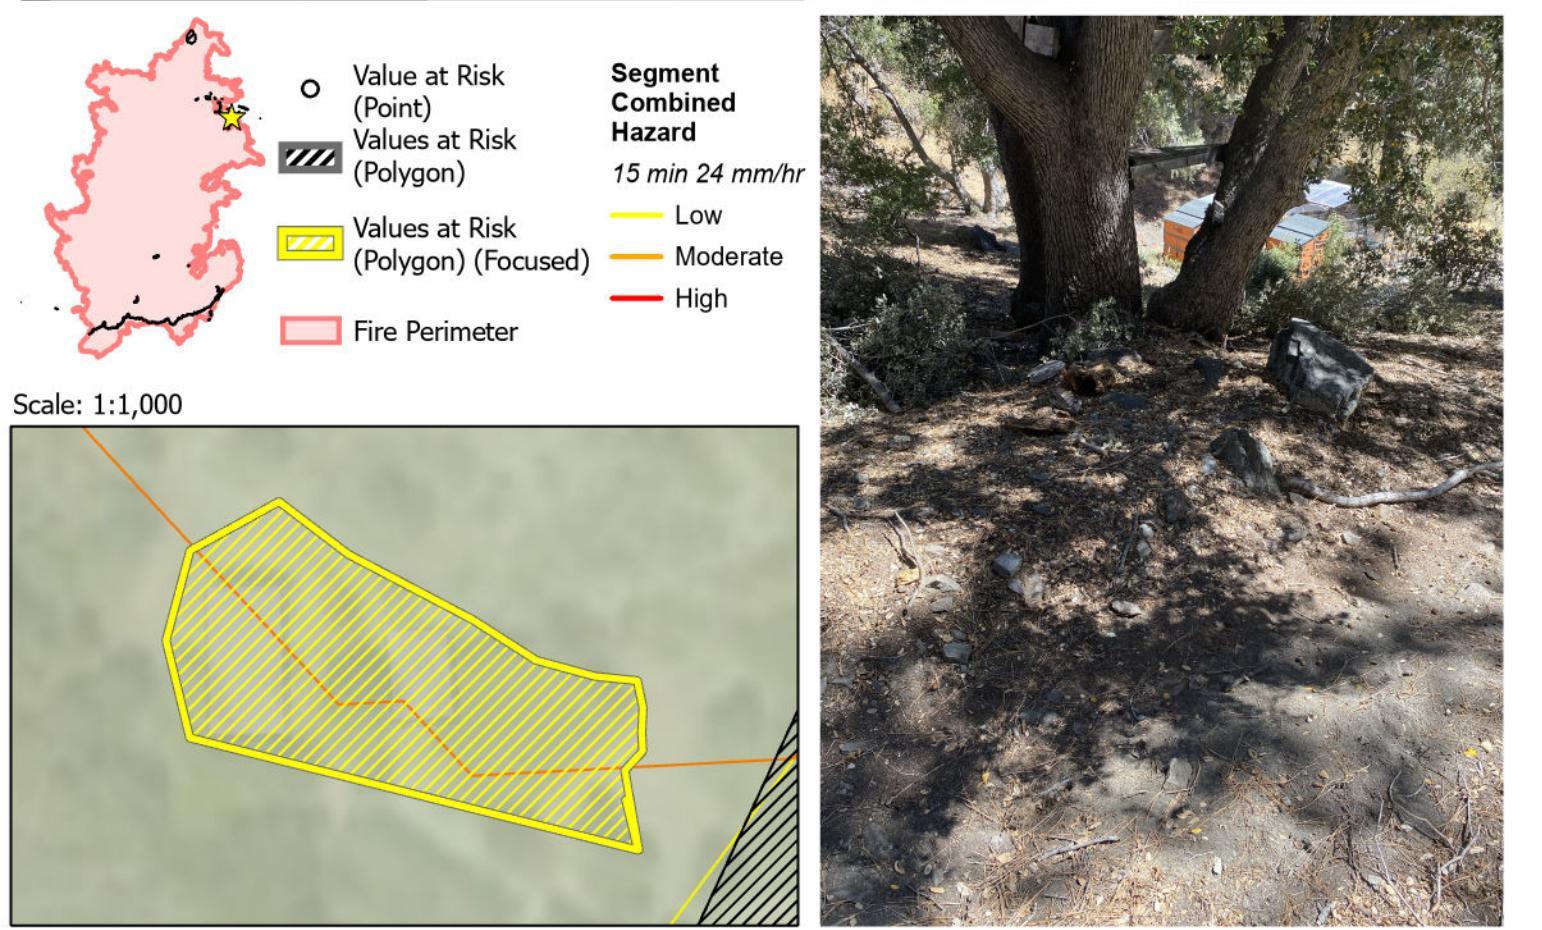
Field Observation or 3 homes within or below fans. Potential hazard is flood mobilizing burnt debris and soil and impacting Potential Hazard: structures.

Description: Apex of fan above southernmost home has angular matrix supported deposits and 4 ft boulders, lower part of fan has more subdued topography, so geologically recent debris flows have not traveled to home locations. Flooding appears to route around southernmost home and onto driveway. Northernmost home more likely to receive flood flow from northern (other) drainage but has similar low risk to both homes to the south.

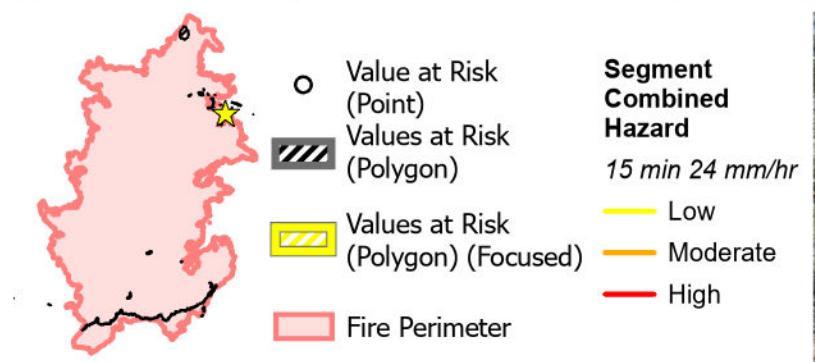
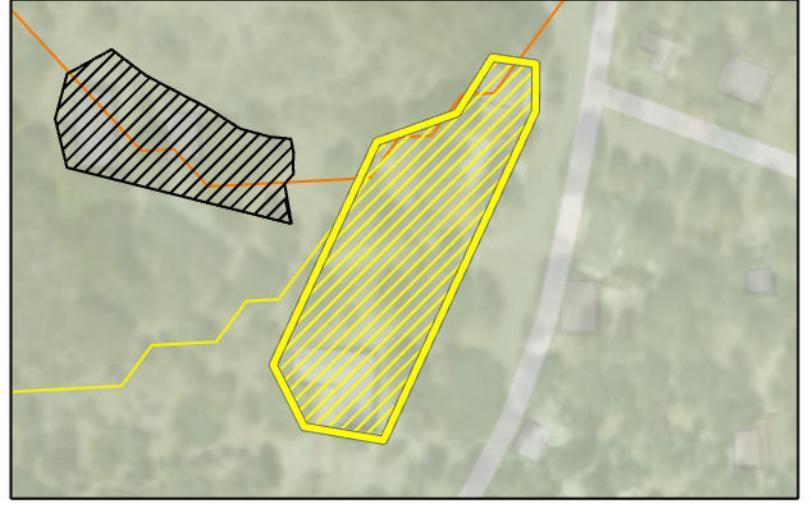
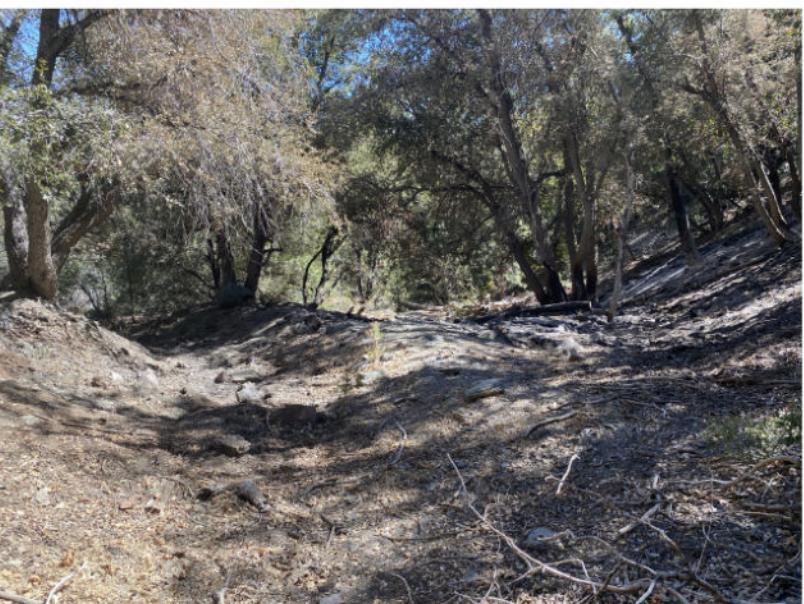
Description: The 2 northernmost homes are lower in elevation from drainage and could receive flows even though not centered in fan. The home south of polygon not included due to higher position above drainage.

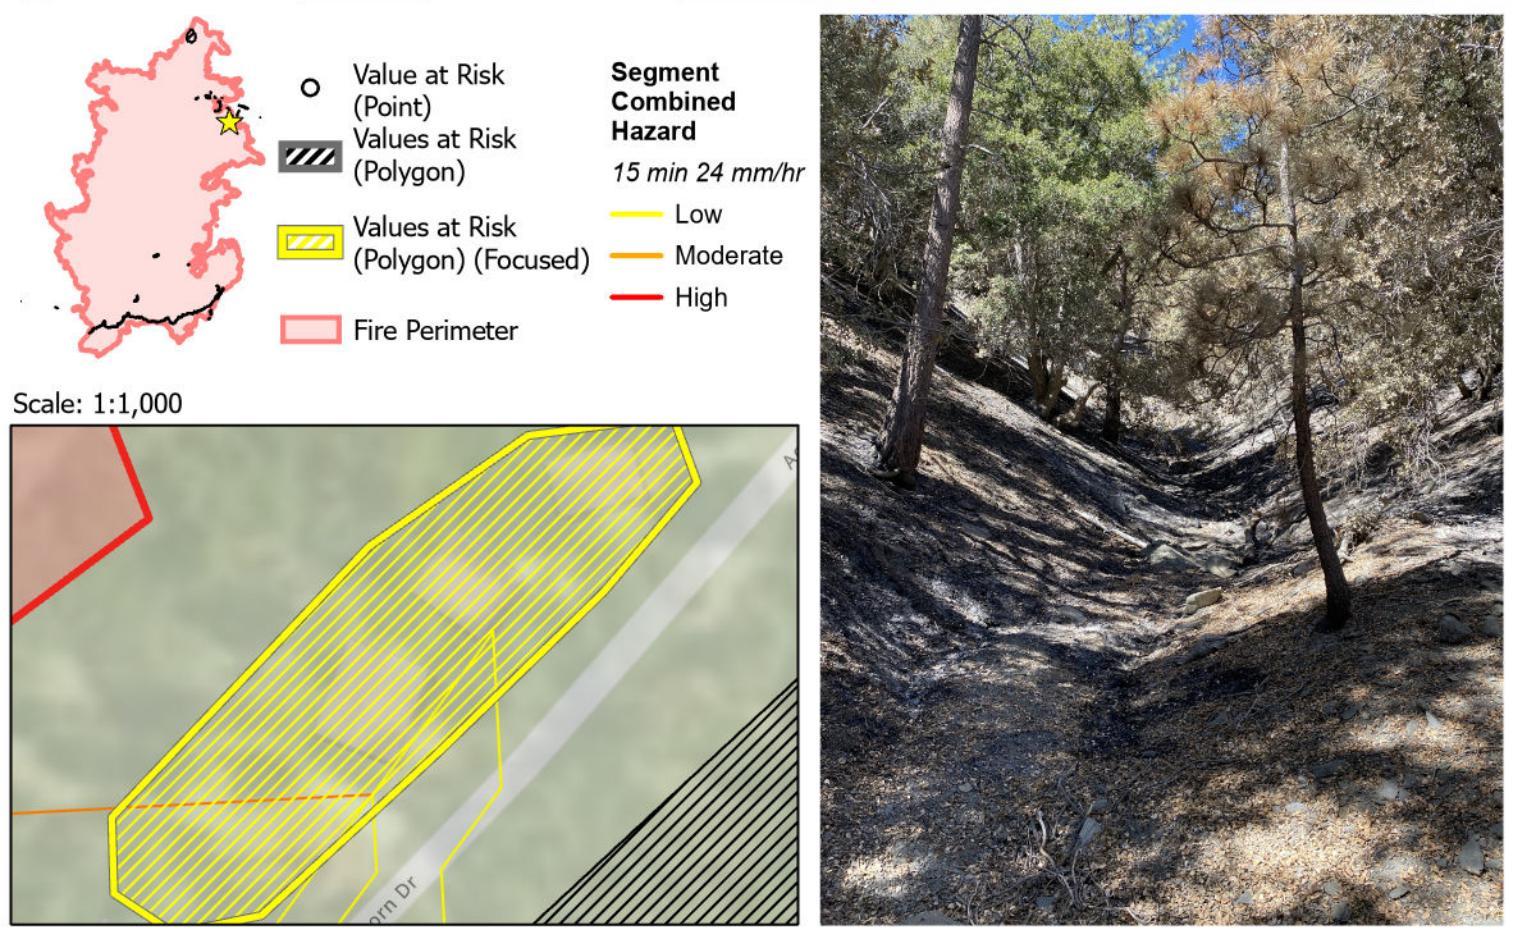
Description: Most of sbs within 350-acre catchment above is low.

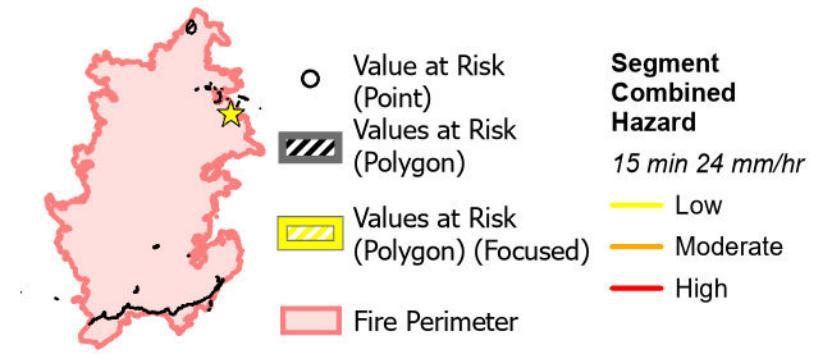
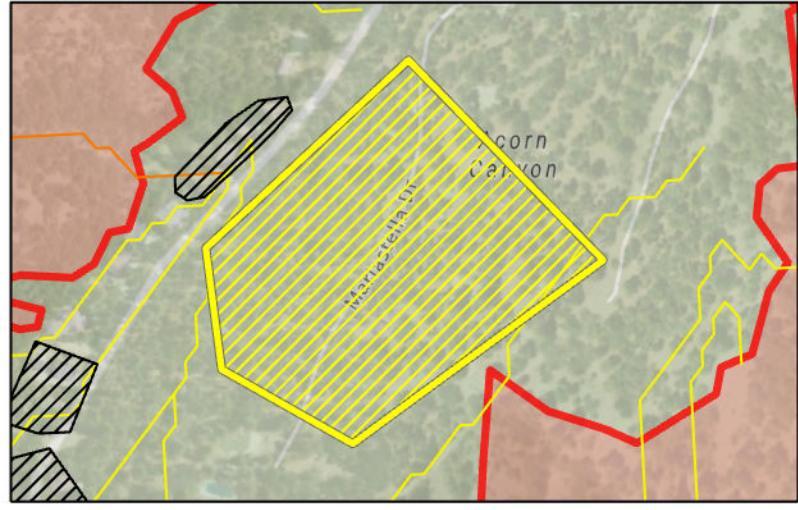
Description: Evidence of alluvial flow with houses cut into toe of fan. Most of 24-acre catchment is burned at low sbs.
