Watershed Emergency Response Team (WERT) 2024 Bridge Fire

CA-ANF-243334 October 24, 2024

REPORT TITLE: Watershed Emergency Response Team (WERT) Evaluation – 2024 Bridge Fire

Bridge Fire – WERT REPORT EXECUTIVE SUMMARY

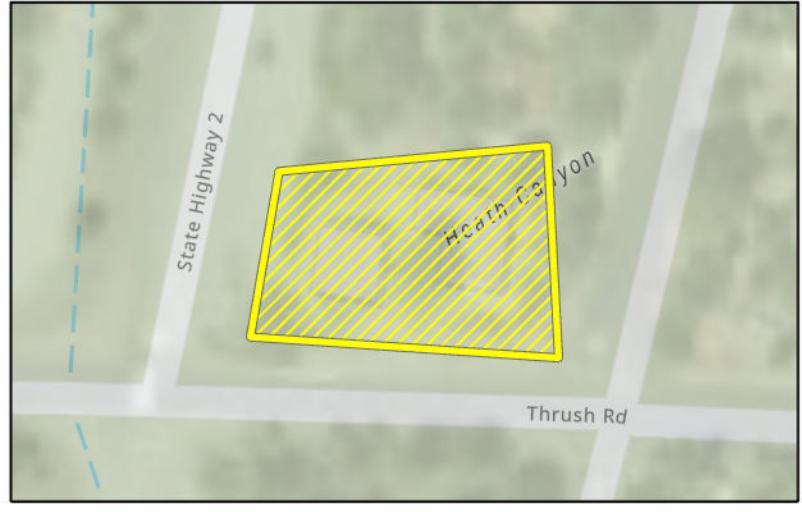
Field Observation or House adjacent to bridge crossing of Heath Creek, Gap in channel levee, k-rails in from of house suggests *Potential Hazard:* flows/debris may have impacted house in the past. potential hazard is flood and debris avulsing out of levee at Thrush Rd. crossing.

Potential Hazard to Life: moderate

Potential Hazard to Property: moderate
